**REPORT INTO THE INCIDENT
INVOLVING A ROYAL
ST. GEORGE YACHT CLUB RIB
IN DUBLIN BAY ON
23rd MAY, 2004**

The Marine Casualty Investigation Board was established on the 25th March, 2003 under The Merchant Shipping (Investigation of Marine Casualties) Act 2000

Published by The Marine Casualty Investigation Board
30th September 2005

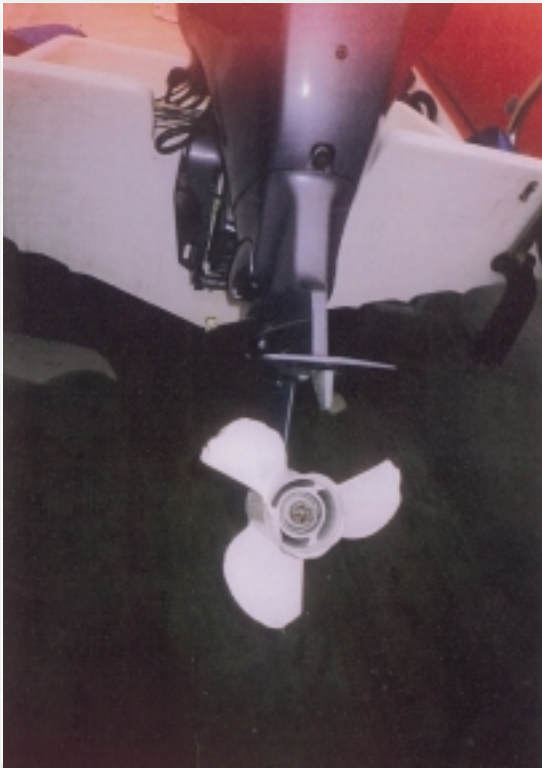
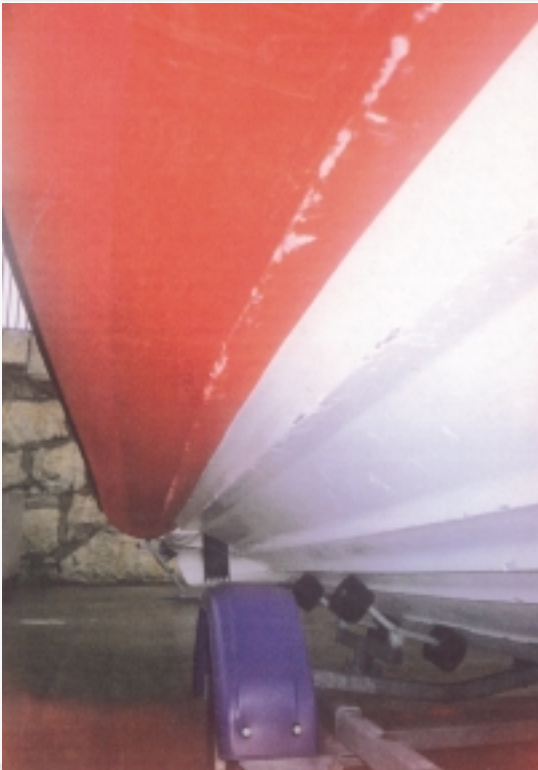
Appendix 9.4

- 5.7 An examination of the RIB revealed chipping of the coating on the hull area. This chipping was more evident on the starboard side than on the port side of the hull. The propeller blades were damaged from contact with a hard object. See photographs in Appendix 9.4.

- 7.2 The damage to the hull of the RIB is consistent with damage caused after going ashore onto rocks. The damage to the propeller appears to have been caused from contact with rocks and it would appear that some of the damage was caused prior to the engine stopping or cutting out.

Photographs of the damage to the RIB.

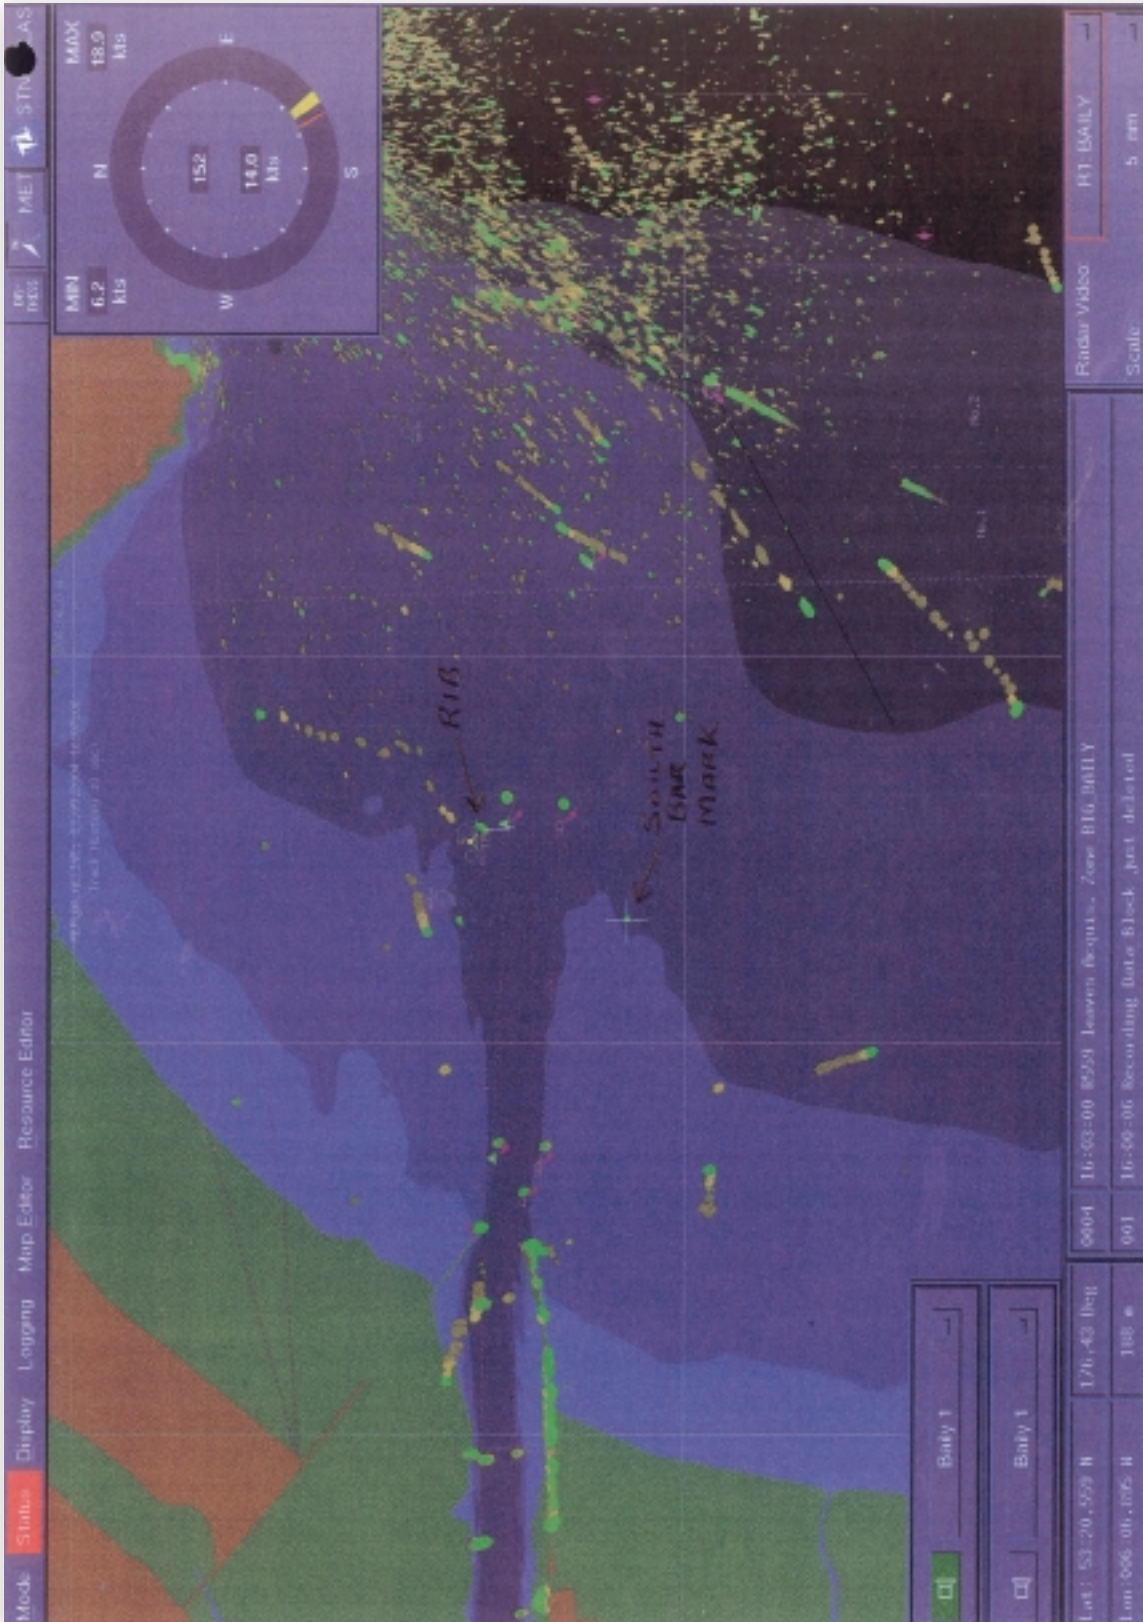
9.5.1 Recording for the time 16:07:06.

- 6.2** The recording for the time 16:07:06, given at Appendix 9.5.1, shows the RIB to the north west of buoy No. 3. At this time the wind recorded by Dublin port is from a direction of 152° at a speed of 14 knots.

- 6.3** The measured speed of the RIB, obtained from the radar recordings, between the times of 16:07:06 and 16:08:30 is about 23.9 knots over the ground.

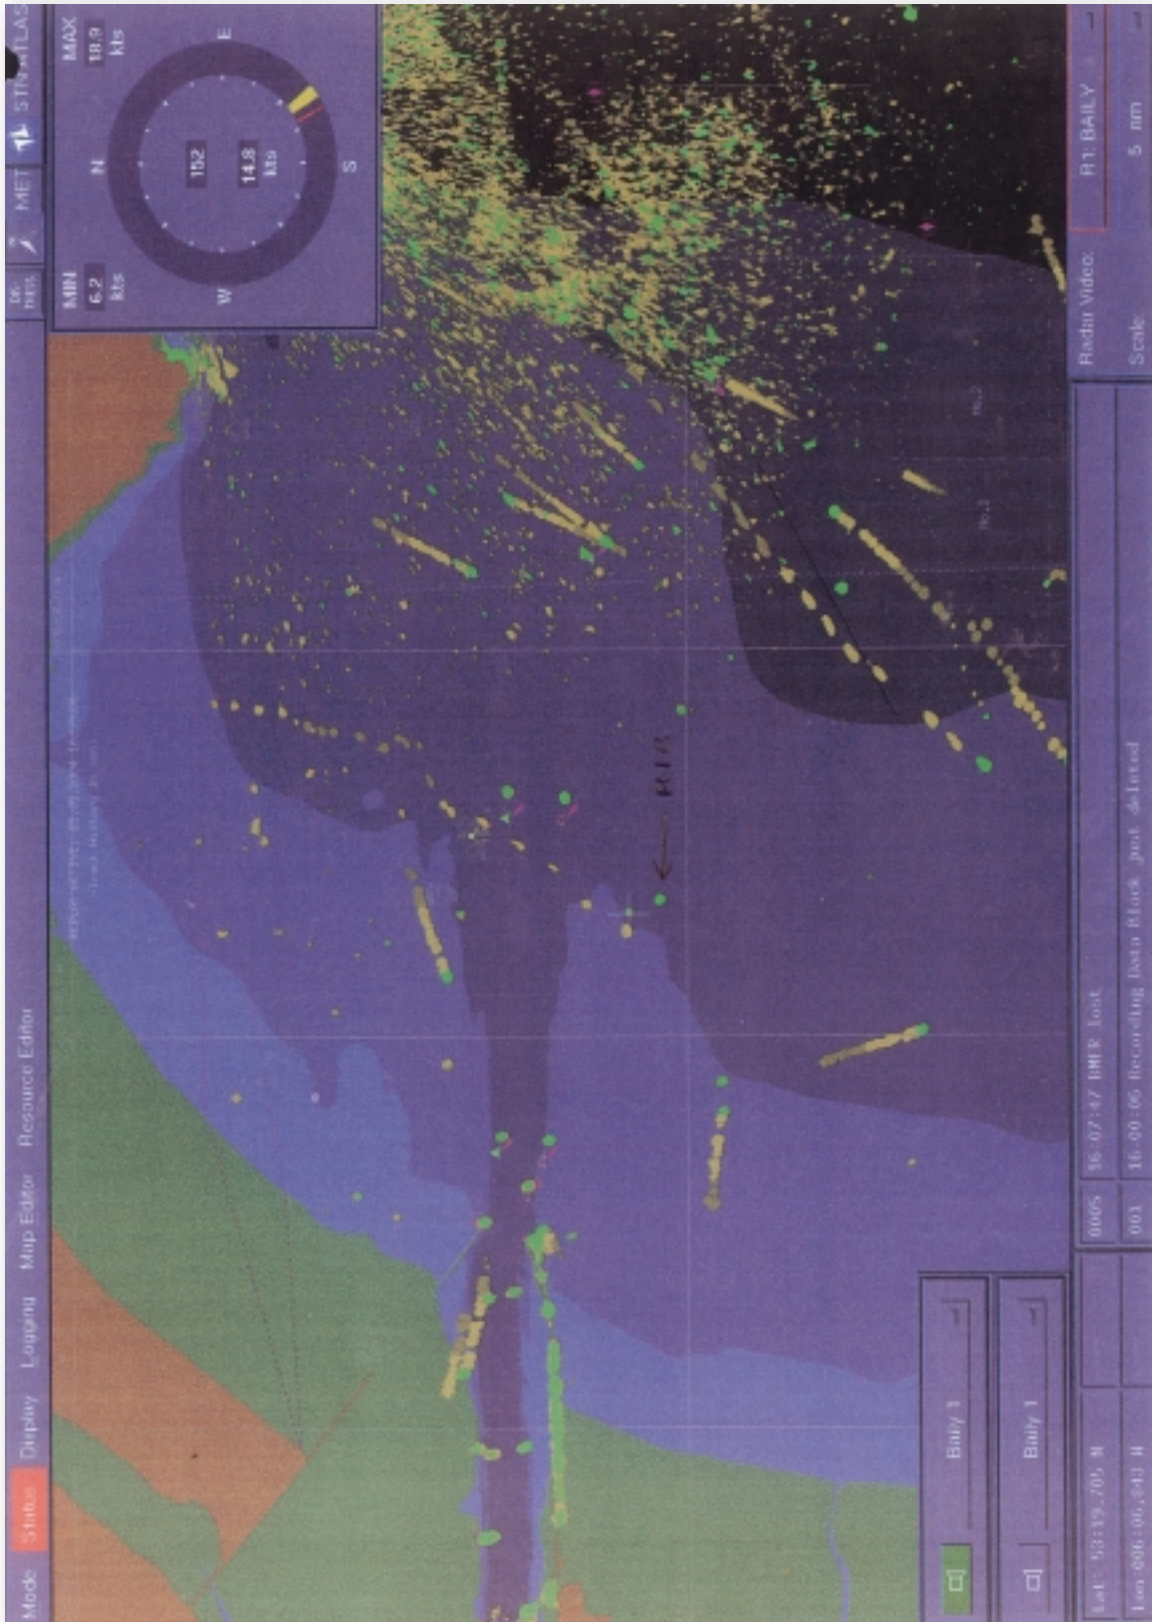
9.5.2 Recording for the time 16:09:06.

- 6.4** The recording for the time 16:09:06, given at Appendix 9.5.2, shows the RIB in a position to the south-south-east of the South Bar racing mark. At this time the wind recorded is from a direction of 152° at a speed of 14.8 knots. The RIB appears to have passed to the west of the South Bar mark and then altered to port.

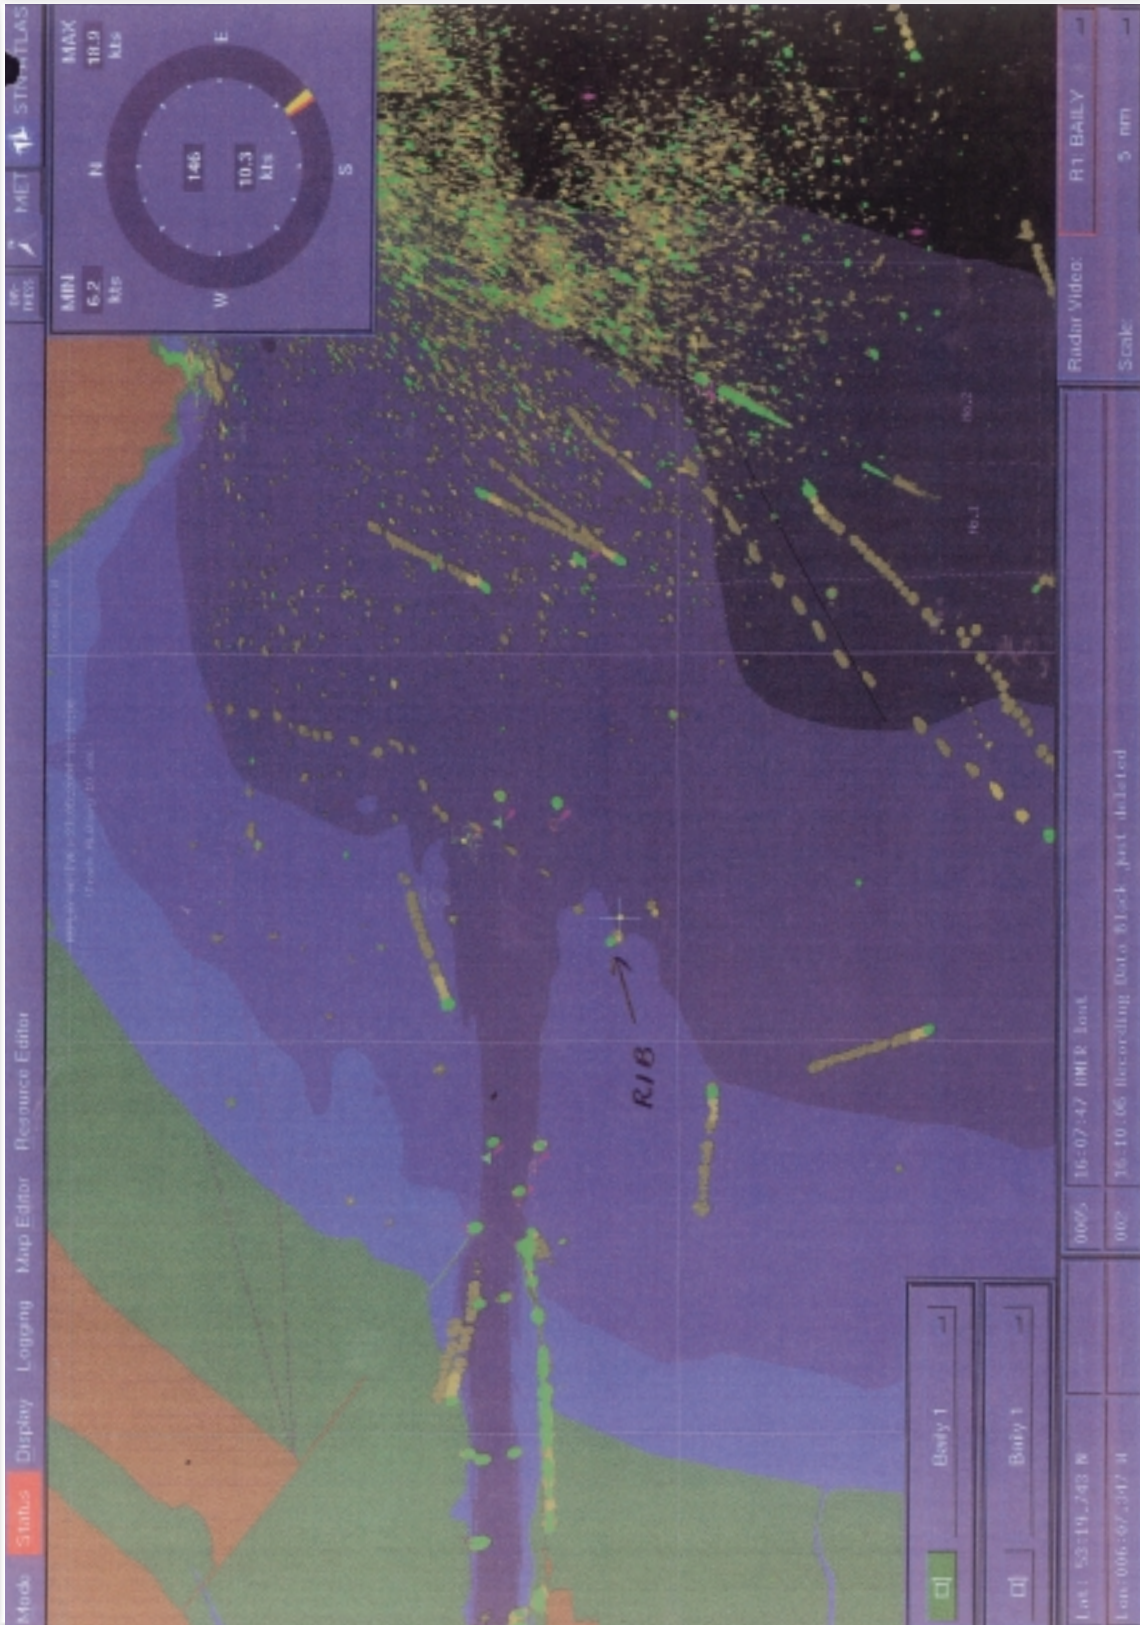
9.5.3 Recording for the time 16:10:06.

- 6.5** The recording for the time 16:10:06, given at Appendix 9.5.3, shows that the RIB has returned to a position close to the west of the South Bar racing mark. At this time the wind recorded is from a direction of 146° at a speed of 10.3 knots. It is not possible to establish the courses taken by the RIB between the times of 16:09:06 and 16:10:06.

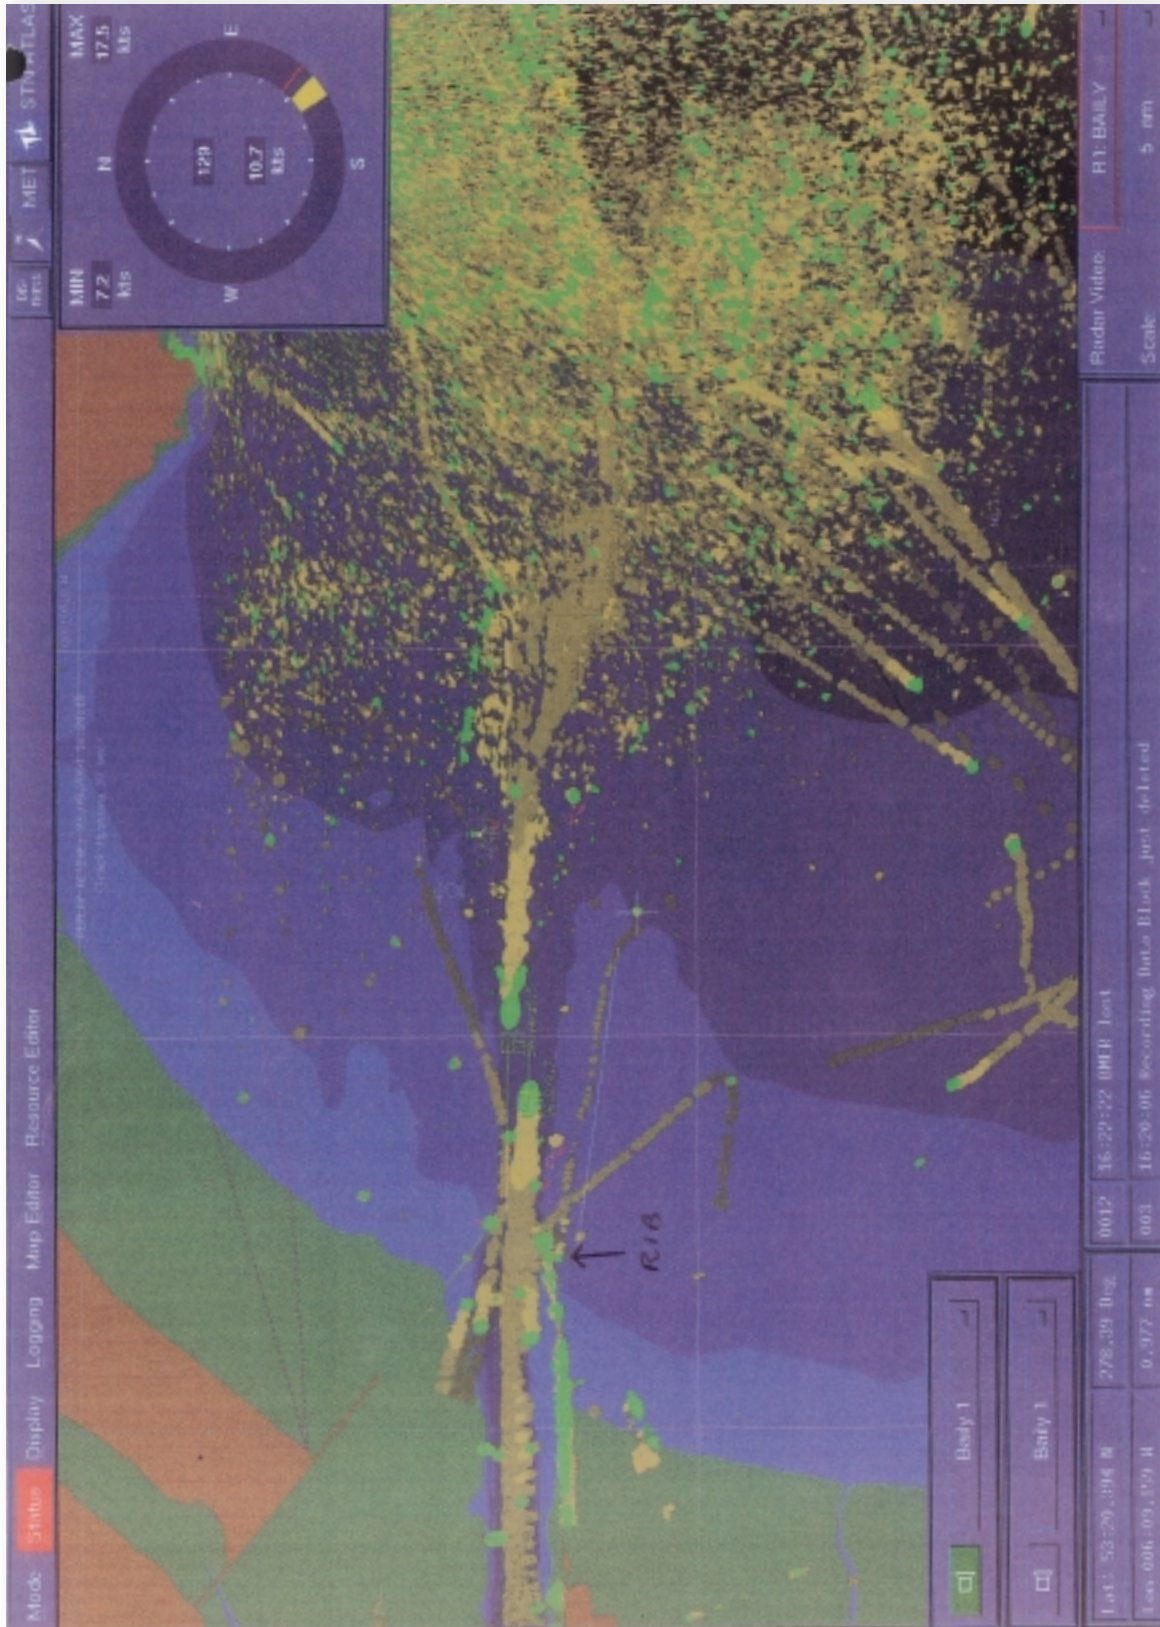
9.5.4 Recording for the time 16:24:18.

- 6.6** The radar recording for 16:24:18 hours is reproduced in Appendix 9.5.4. This shows the track history of the RIB from a position to the west of the South Bar racing mark until just before it went ashore on the Great South Wall to the west of the Poolbeg lighthouse. In this recording the vessel "BG Ireland" can be seen leaving the port and the High Speed Craft "Jonathan Swift" can be seen entering the port through the shipping channel.

- 6.7** The measured speed of the RIB, obtained from the radar recordings, between the times of 16:10:30 and 16:24:42, when the RIB went ashore, is about 4.16 knots over the ground.
