**REPORT INTO INVESTIGATION
OF A GAS EXPLOSION ON
THE PLEASURE CRUISER
“SANTA CHRISTINA” AT OLD
HARBOUR, BALLYLEAGUE,
LANESBOROUGH ON 18TH
SEPTEMBER, 2002.**

The Marine Casualty Investigation Board was established on the 5th, June 2002 under The Merchant Shipping (Investigation of Marine Casualties) Act 2000

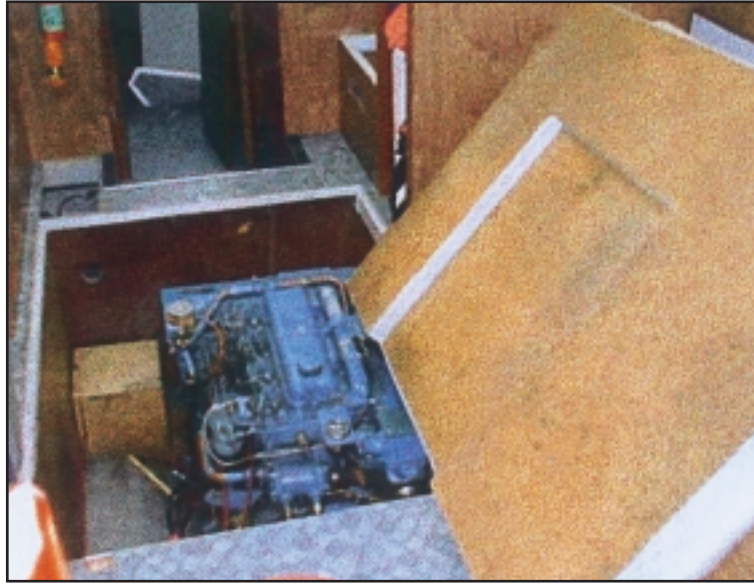
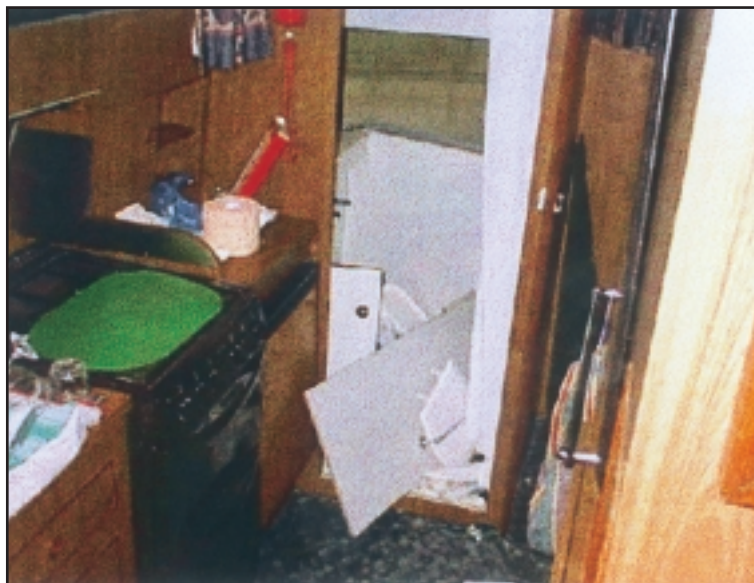
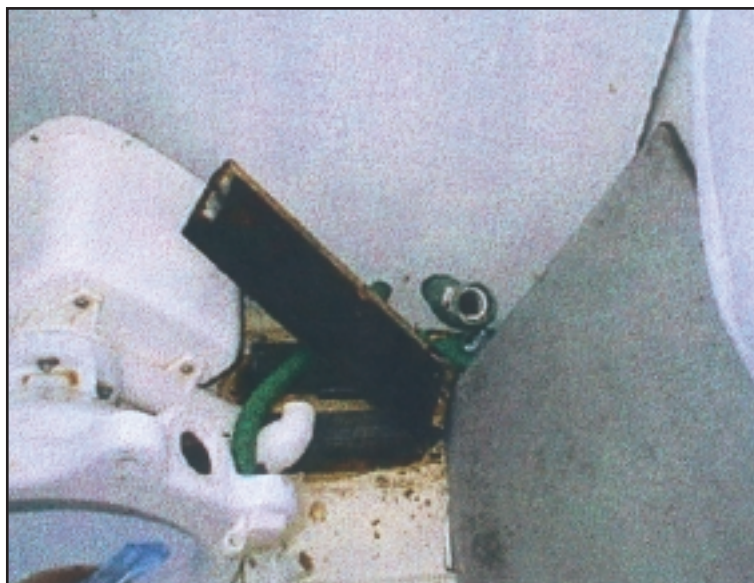
APPENDIX 8.4

8.4. Photos of interior damage to the "Santa Christina".

Internally I found that the fixtures and fittings of the vessel were in some disarray. All covers to the bilge had been blown upwards. Doors had been blown off the hinges and been propelled considerable distances. The rear wall consisting of plywood had been broken and forced inwards away from the void behind. The domestic gas cooker had moved slightly forward from its original position. The W.C. was uprooted and the compartment damaged. Some of the gas heaters, although still attached to the pipe line, had been shaken from the wall.

I noted all except one of the gas taps servicing the appliances were in the "off" position. The tap to the domestic gas cooker was in the "on" position. I noted also on this cooker that the second knob from the right, which governs the gas supply to the right front burner, was in the 11 o'clock position. This position is used when a low flame is desired on the relevant burner.

As a result of information received, I carried out a technical examination on the starter motor fitted to the diesel engine on this vessel. I found that the three retaining bolts were not tight resulting in the starter motor being loose in its housing. When grasped by one hand, it could be moved approximately ½ inch in any direction. Two of the bolts appeared to be so long that large nuts had been used on their shafts to take up the slack. The two self tightening nuts on these bolts were slack. The third retaining bolt and nut, although out of sight, was loose to the touch.

From my examination of the vessel and its equipment, it would appear that gas escaping from the right front burner of the domestic gas cooker entered the bilge. When an attempt was made to start the engine using the ignition key, the electrical arc already described occurred and was quite sufficient to ignite the gas present in the bilge. The subsequent explosion caused the injuries and damage report.
