**REPORT OF AN INVESTIGATION  
INTO A MARINE CASUALTY  
INVOLVING THE  
PASSENGER VESSEL  
SEA BREEZE III  
IN OR AROUND  
THE SKELLIG ISLANDS,  
CO. KERRY  
ON OR ABOUT  
7 JULY 2024**

**REPORT NO. MCIB/339  
(No.6 OF 2025)**

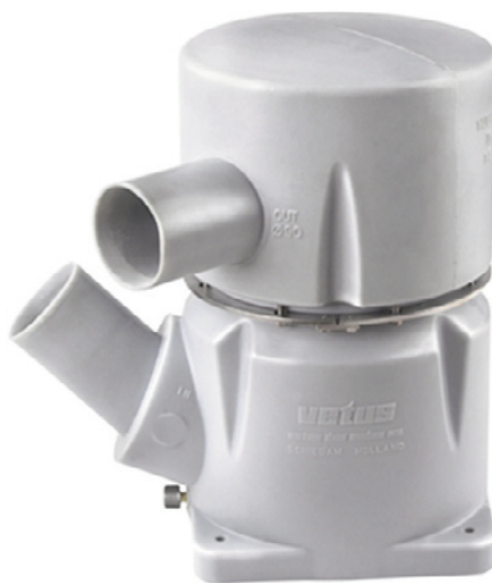
Figure 5: Example of Vetus waterlock installed on MV Sea Breeze III.

- 4.16 The top section of the Vetus waterlock is secured to the bottom section by means of a metal ring. In the event that the two sections became detached, then in much the same way as a loose or broken exhaust hose, exhaust water would be discharged into engine/steering gear compartments at a rate of up to 75.7 lts per minute. The affected engine would continue to operate and again it is unlikely that two waterlocks would simultaneously fail.

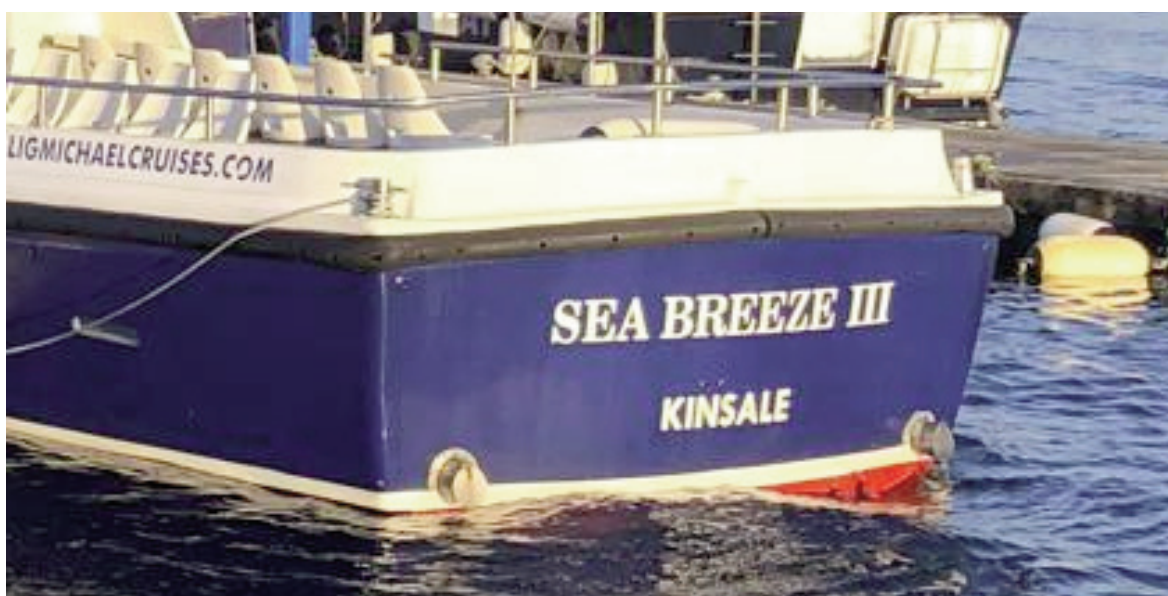
- 2.1.7 The exhaust gases and cooling water are discharged through two stainless steel exhausts located on the transom of the vessel. The exhausts are fitted with hinged flaps, designed to open to allow cooling water and gases to exit and stop and water surging back into the exhaust system.

Figure 6: Exhaust arrangement on MV Sea Breeze III.

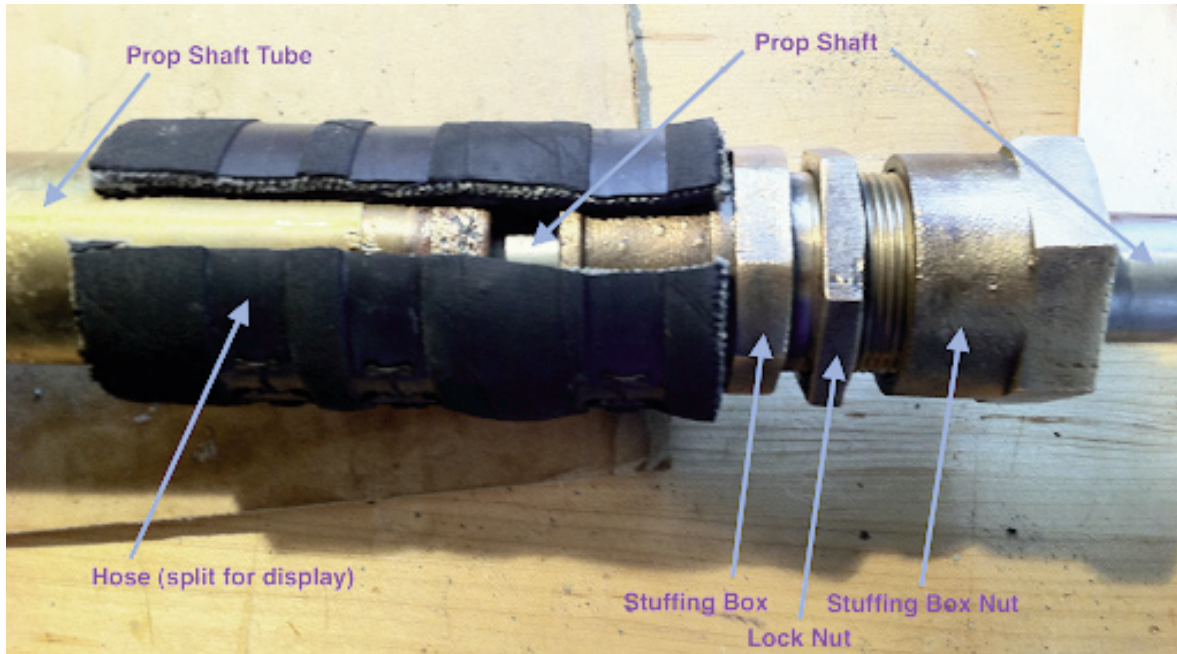
Figure 7: Example of the stern gland arrangement onboard MV Sea Breeze III.

- 4.11 The vessel has twin propeller shafts, each exiting through a stern gland incorporating a rubber hose. The rubber hose is typically secured in place using clamps; two forward and two aft. The hose adjoins the stuffing box, a gland which prevents leakage of water from the propeller shaft. Proprietary stuffing box hose incorporates five plies because hoses used in stuffing box applications can be submerged, vibrated and routinely twisted in forward and reverse, five plies equates to longer hose life. Good practice is that stuffing box hoses should be pre-emptively replaced approximately every five to seven years or when warranted by visible hose deterioration.

- 4.12 If the hose between the stuffing box and the shaft tube fails, the flow rate will be a function of the gap between the shaft tube and the propeller shaft, rather than any feature of the stuffing box itself. If, however, the seal/packing itself fails, then the flow rate will be dictated by the gap between the stuffing box body and the propeller shaft. The Merchant Shipping (Passenger Boat) Regulations 2002 do not set any minimum standards for propeller shaft systems i.e. a maximum permissible flow rate per minute should a seal fail.

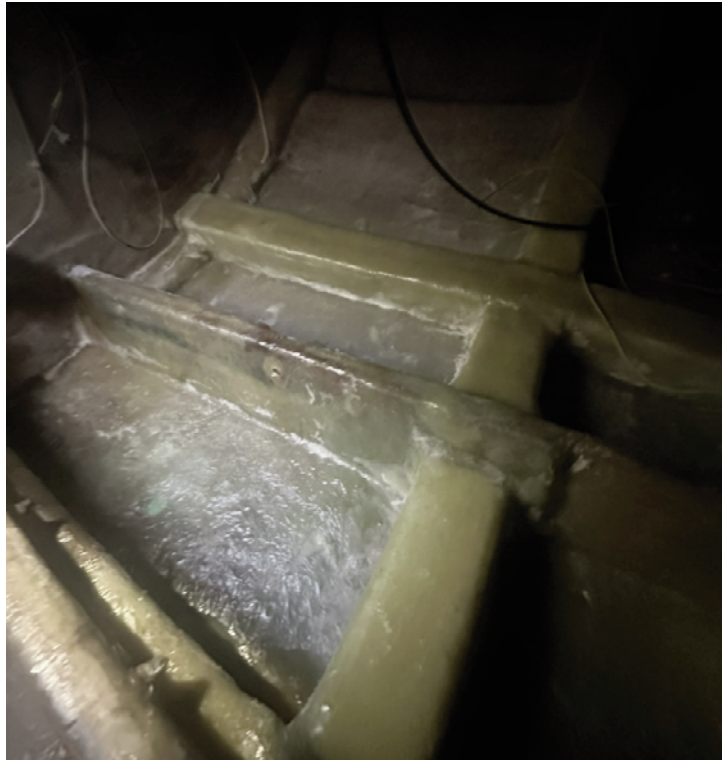
*13.5 The cracking in the hull under the wheelhouse should be cleaned back to sound material and reinforced. The stiffeners should be cut out and rebuilt where cracked. The crack noted externally in that area should be cleaned back and repaired. The hull has been repaired and extra stiffeners have now been fitted (Fig. 9, 10)”.*

Figure 8: Fibreglass repairs to the hull with extra stiffeners added.

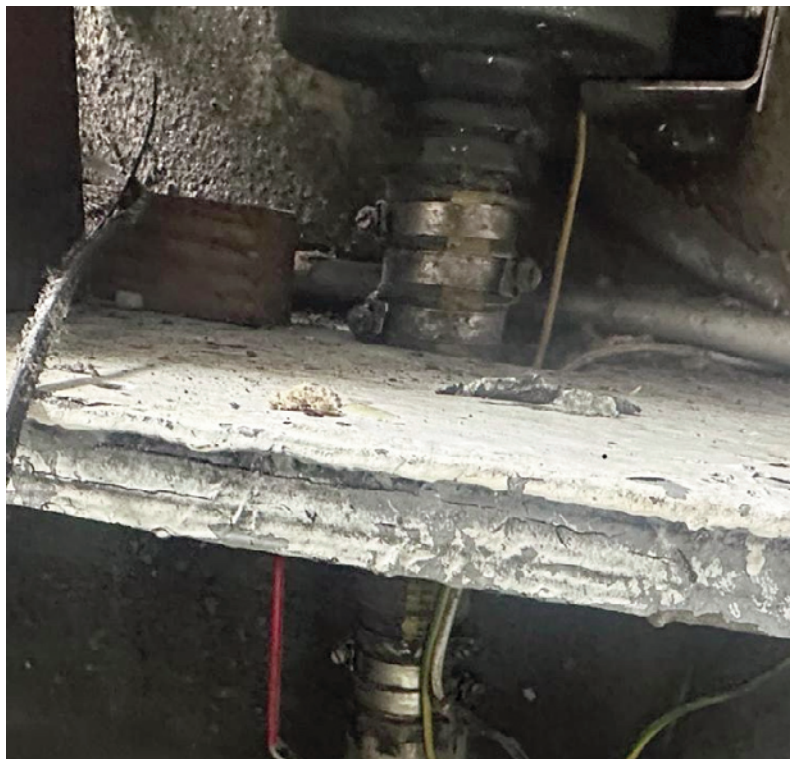
*13.3 Ensure all through hull fittings are secure with freely operating valves. The fire pump intake pipe, seacock and through hull fitting should be replaced. The toilet seacocks should be replaced. All seacocks serviced/replaced and all tested and working.*

Figure 9: Replacement sea cock.

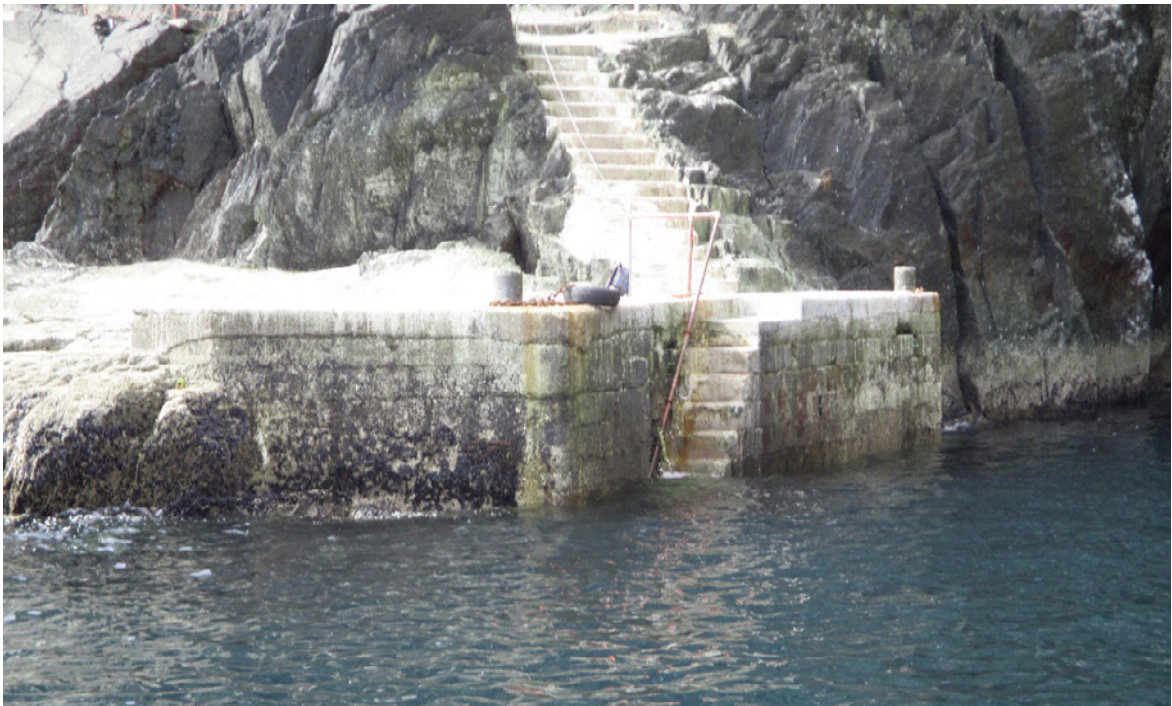
Figure 10: Concrete landing dock Great Skellig (July 2024).

- 3.9 The landing dock is not fitted with fenders, but rather each vessel carries its own fenders onboard. The Skipper advised that there was nothing unusual in his port side approach alongside. The weather conditions can sometimes make manoeuvring challenging, but on this occasion, berthing was speedily achieved. The Skipper was very clear that there was no hard impact with the landing dock, and this fact was confirmed by the Crewmember. The absence of a passenger list meant that it was not possible to interview the passengers to confirm this point or to ascertain if any passenger had video footage of the landing.

- 6.3 The Minister with responsibility for the Office of Public Works should consider installation of a solar powered closed-circuit television system to monitor the landing dock on Great Skellig. The camera to have a publicly accessible live feed so sea conditions can be reviewed in advance of any approach to the landing dock and vessel movements recorded.

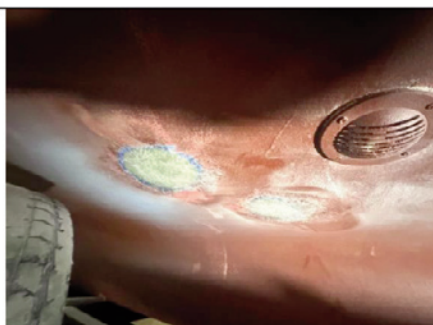
Fig. 11

*14.2 Remove all underwater through hull fittings that are no longer in use and carry out local repairs to the hull in those areas. The large transducers have been removed and the hull repaired (Fig. 11).*
