**REPORT OF INVESTIGATION
INTO
LOSS OF A CREWMEMBER
OVERBOARD FROM
MFV "SKELLIG LIGHT II"
ON
28th DECEMBER 2008**

**REPORT No. MCIB/165
(No. 4 of 2010)**

Report MCIB/165 published by The Marine Casualty Investigation Board
17 June 2010

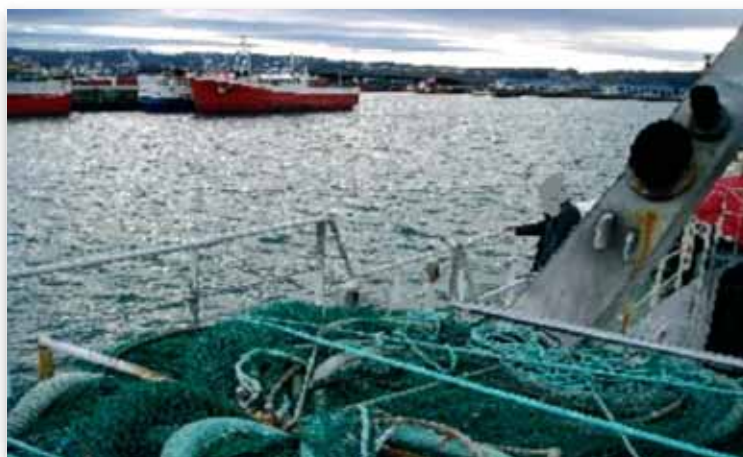
Mr. Portas was working on the edge of the platform on the left of the photograph above.

- 3.2 The nets had raised the working floor of the area to within 18 inches of the top of the handrail.
- 3.3 The underfoot surface was irregular; almost solid in places when standing on head or footropes and very uncertain in way of the nets where the area underfoot was liable to subside suddenly.
- 3.4 The weather at the time was wind: Easterly 5 to 6, sea state: rough to very rough.
- 3.5 The vessel was in position Lat. 49° 14'N Long. 11° 36'W as indicated in Appendix 8.2.

- 4.1 The Skipper reported that Mr. Portas stepped or fell backwards and the handrail caught him at the back of his legs inevitably leading to him falling overboard.

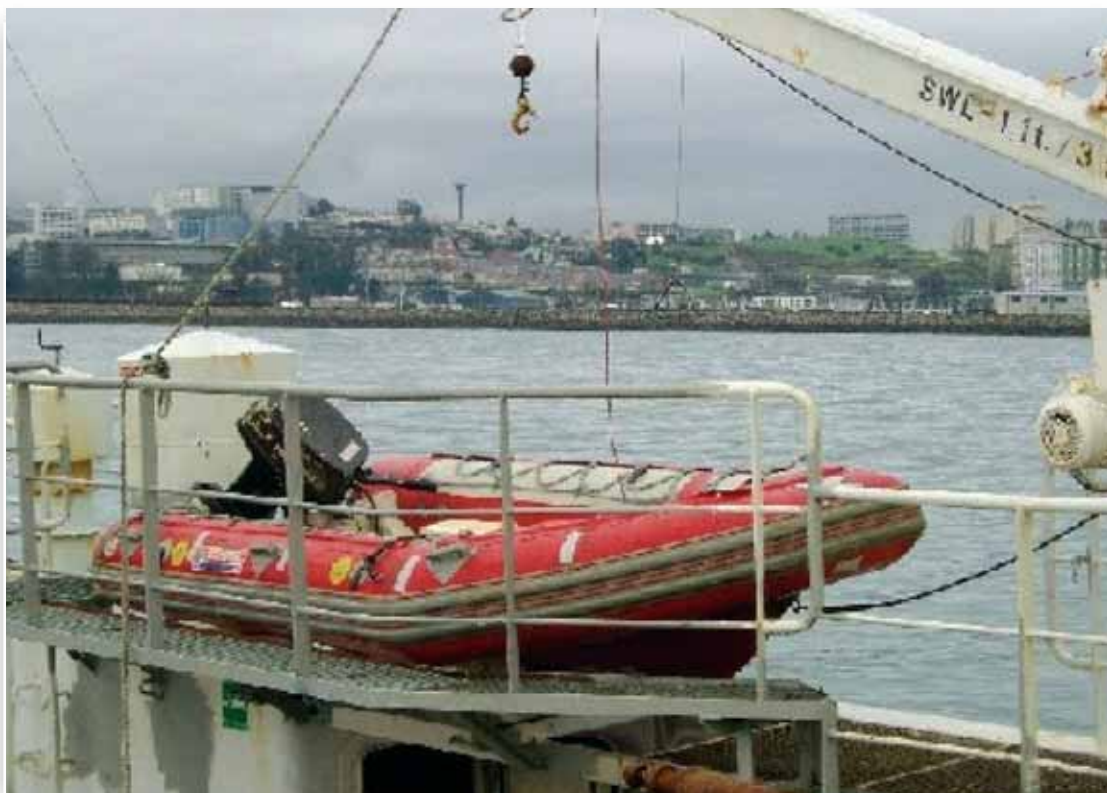
- 4.6 On lowering the rescue boat to the water, the crew were unable to start the engine. The boat was lifted back on board at circa 09.30 hrs. At about the same time a rope was fouled around Mr. Portas arm and he was recovered on board.

Rescue boat in stowed position. Note the lowering gear is not connected and the boat consequently is not ready for immediate use.

- 6.6 The attempt to launch the rescue boat was unsuccessful because the engine could not be started. There is no report of concerns about the weather conditions, which were described as sea state rough to very rough by Met Éireann (see Appendix 8.3).

The MCIB considers that the photograph of the rescue boat used in the report is indicative of general approaches to safety on board the vessel.
