**REPORT OF INVESTIGATION
INTO THE COLLISION OF
M/V “STENA EUROPE” AND
M/V “OSCAR WILDE”
AT ROSSLARE HARBOUR
ON
26th OCTOBER 2012**

**REPORT No. MCIB/227
(No.12 of 2013)**

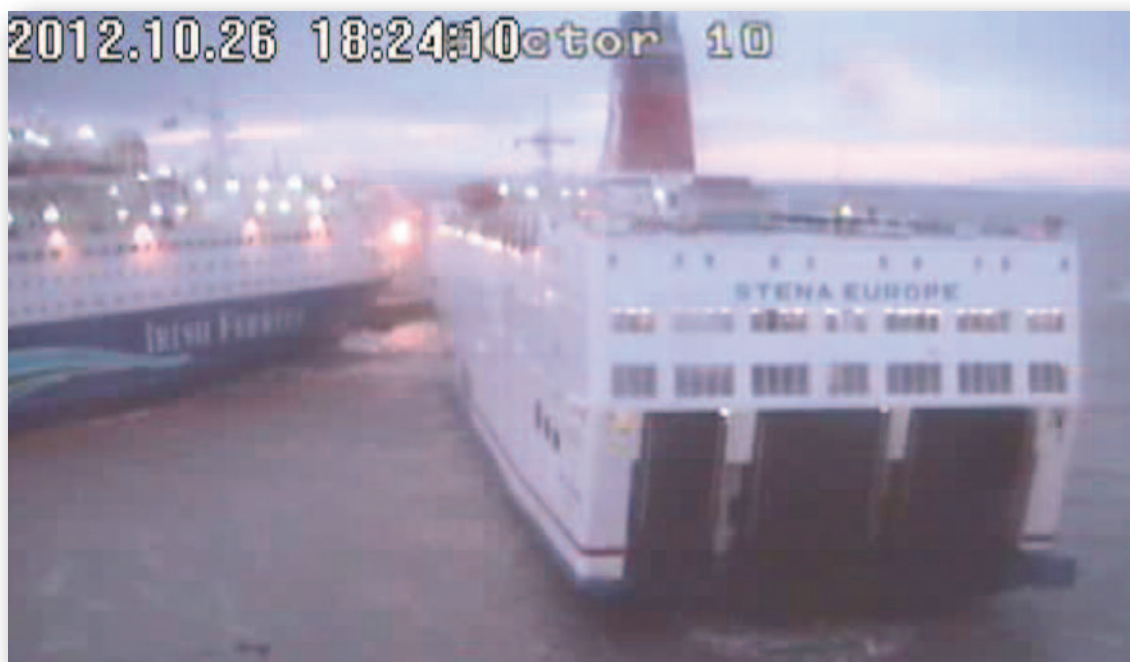
The CCTV camera times were noted as fast by 3m and 59 sec.
CCTV Photo 1- Vessels not in contact- Corrected time 18:20:11

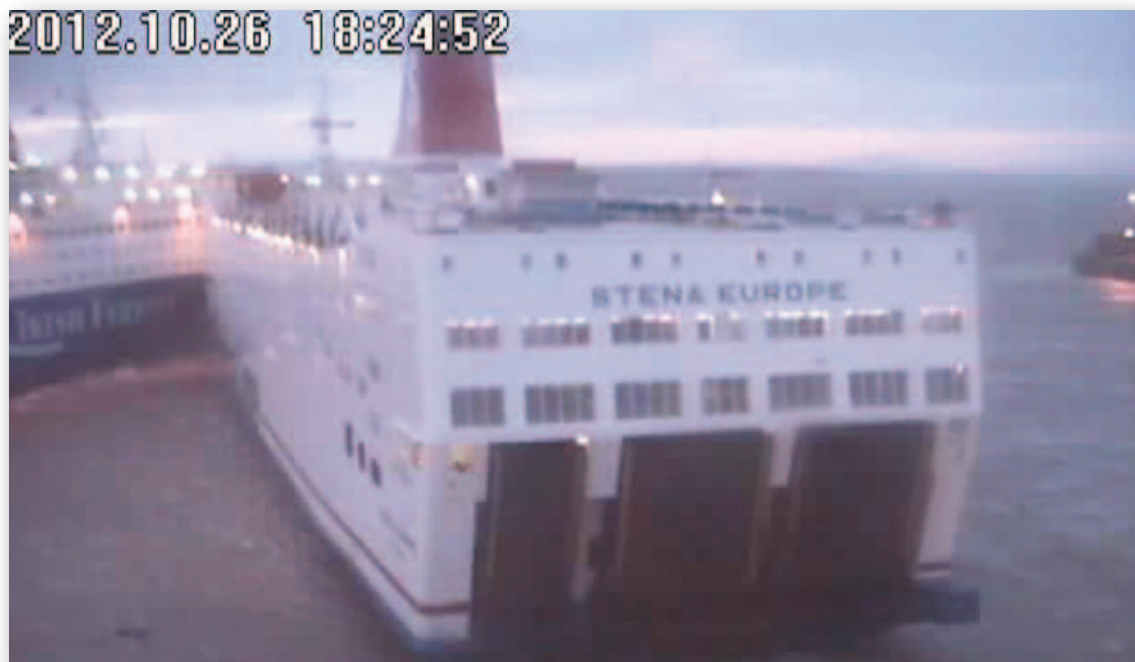
CCTV Photo 2- Vessels in contact - Corrected time 18:20:53

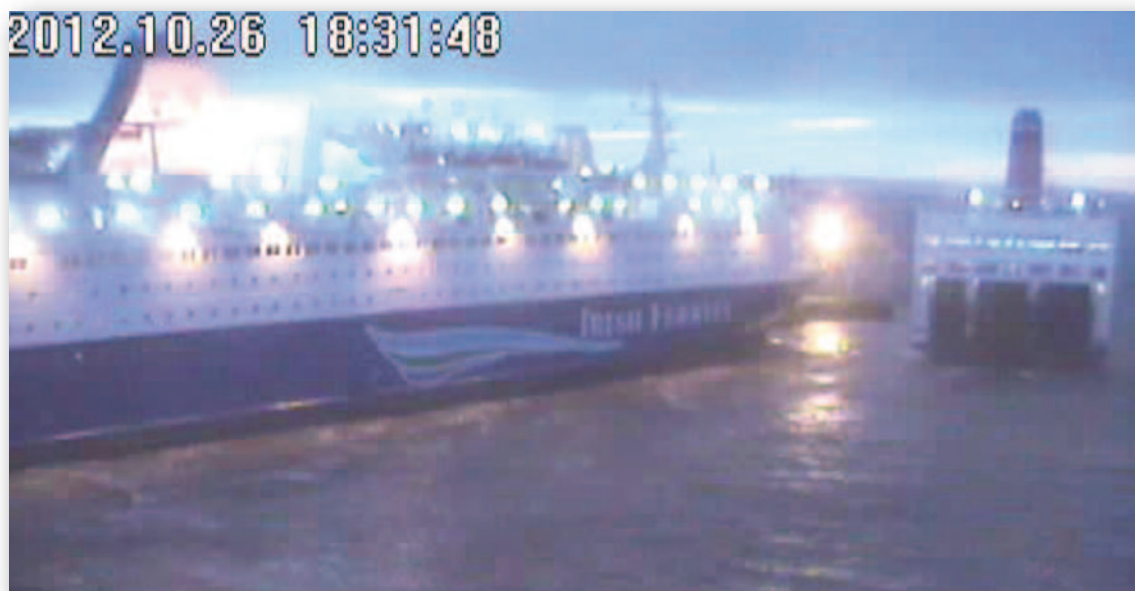
CCTV Photo 3- "Stena Europe" clear of "Oscar Wilde" - Corrected time 18:27:49
