**REPORT OF INVESTIGATION
INTO THE SINKING OF THE
FV “STRATH MARIE”
OFF INISHOWEN HEAD,
CO. DONEGAL
ON
14th MARCH 2008**

**REPORT No. MCIB 158
(No. 3 of 2010)**

Report MCIB 158 published by The Marine Casualty Investigation Board
18th June 2010

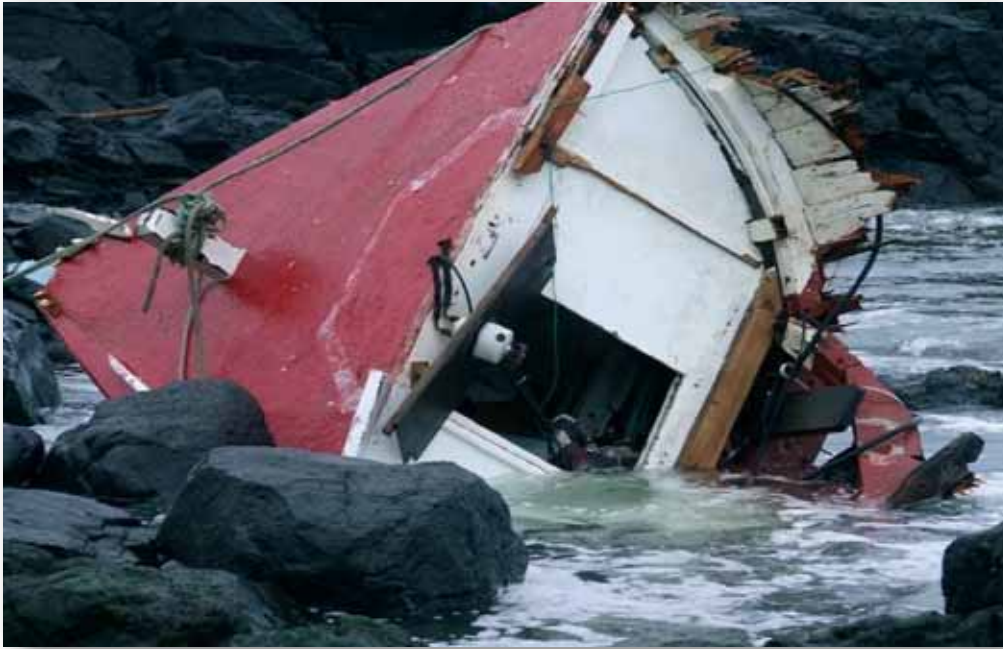
- 5.4 On 26th March 2008 at 08.06 hrs. Belfast Coast Guard reported that the bow section of a halfdecker had been washed ashore at Portmore Rd., Portstewart, Co. Derry. The wreckage was identified as part of “Strath Marie”.

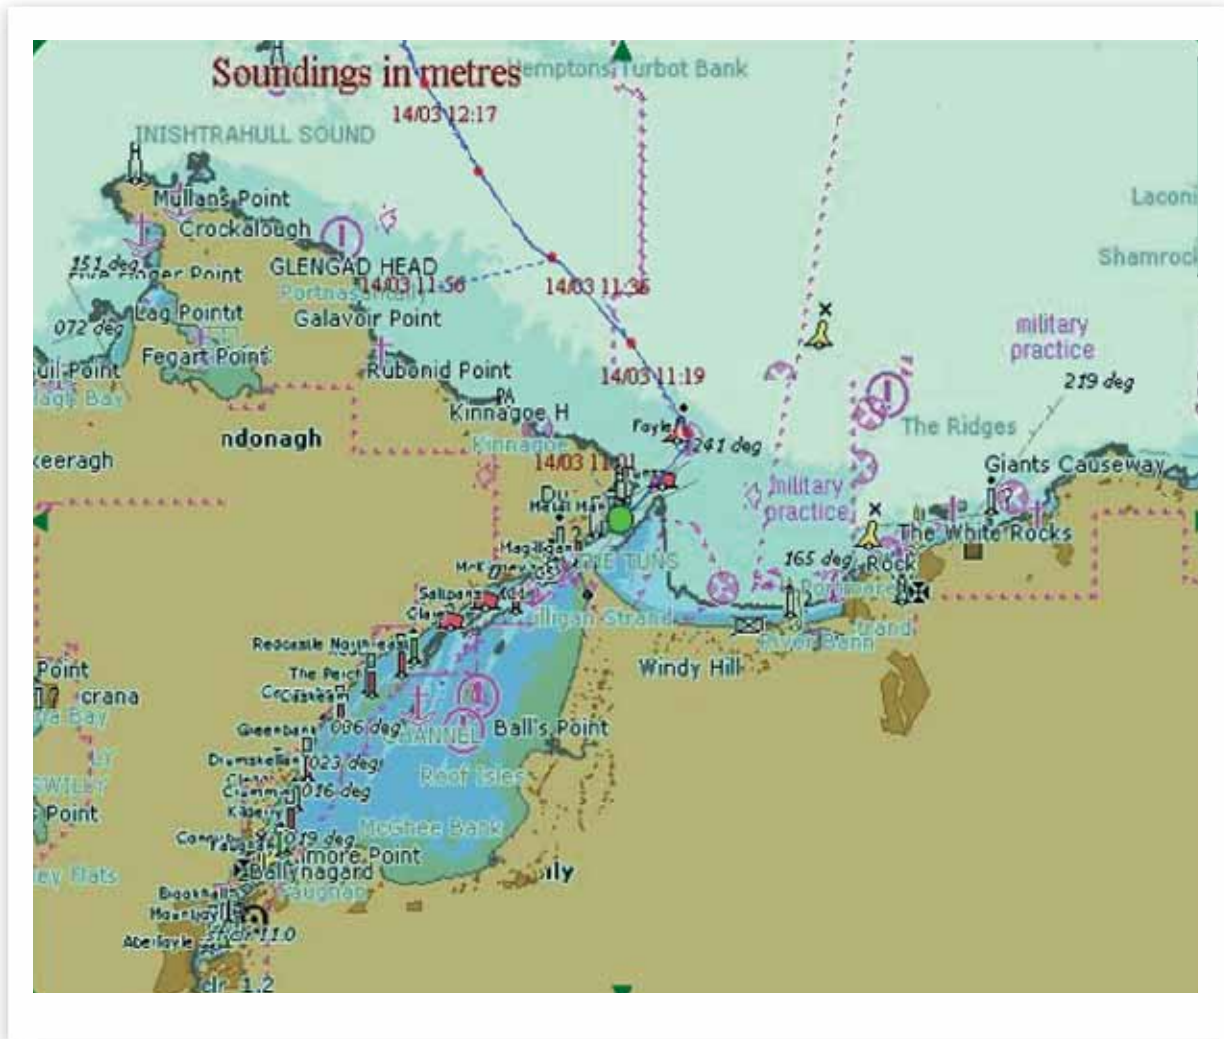
Appendix 9.10 Print out of AIS track of “Sten Odin”.

when an alteration of course to port was observed on the recorded AIS track to port. At 11.55 hrs. the vessel was approximately in position with Dunmore Head bearing 236° true at a distance of 5.6' (about 7 miles NE x E from Culdaff). This alteration of course was of a maximum extent of approximately 27° to 28° and lasted approximately six minutes. There was a slight reduction of speed during the alteration (to 9.5 knots approximately). The vessel resumed track on a course of approximately 320° true at approximately 12.01 hrs. There were no other vessels transmitting an AIS signal in this vicinity at this time. The track of the "Sten Odin" as per AIS recording correlates with the scanned copies of the charts received. The course recorder record (scanned) of the vessel which is maintained in Norwegian local time (one hour ahead of GMT) also indicates an alteration of course to port but the time appears out of sync with the charted and AIS records. Refer to Appendix 9.9 on Admiralty Chart 2811 for plot of course and Appendix 9.10 for print out from AIS.

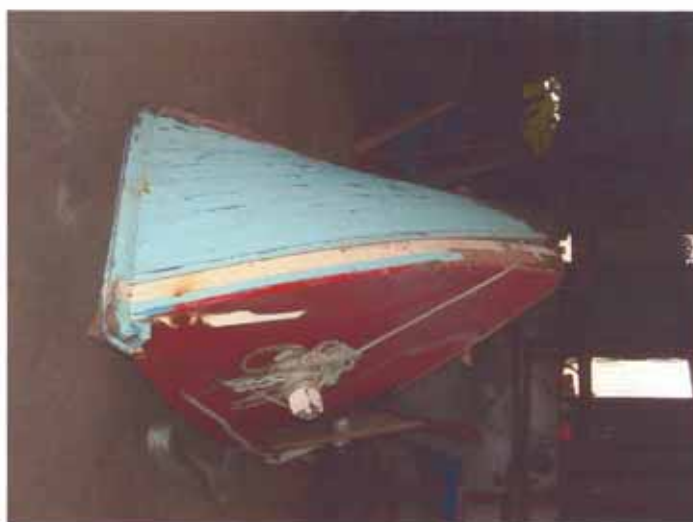
Frames of Oak in sections lapped over approx 3-400mm and bolted through. No evidence of decay in either frames or planking. Stringers, 70-80x32mm in section, at turn of bilge and 300mm below gunwale level with decay where broken at fixings, Fig. 2. (also see below) Keel not present. This has pulled cleanly away from the planking and frames. Plywood bulkhead slightly displaced from its' original location.

Figure 1. Bow section of vessel

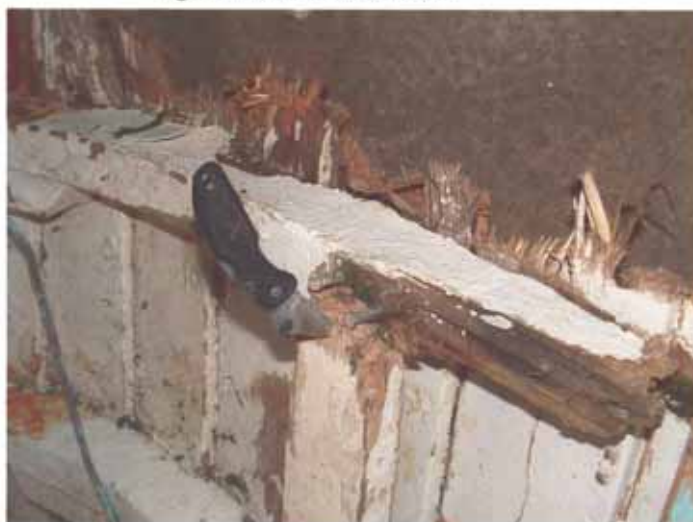
The samples taken for identification were also examined for the presence of fungal hyphae (strands) in the cells, indicative of decay. The larch and oak samples were essentially free of such hyphae or boreholes in the cell walls, while the samples of pine and spruce stringers had such hyphae present.

Figure 2. Decayed end of stringer. Note good condition of planking at break.

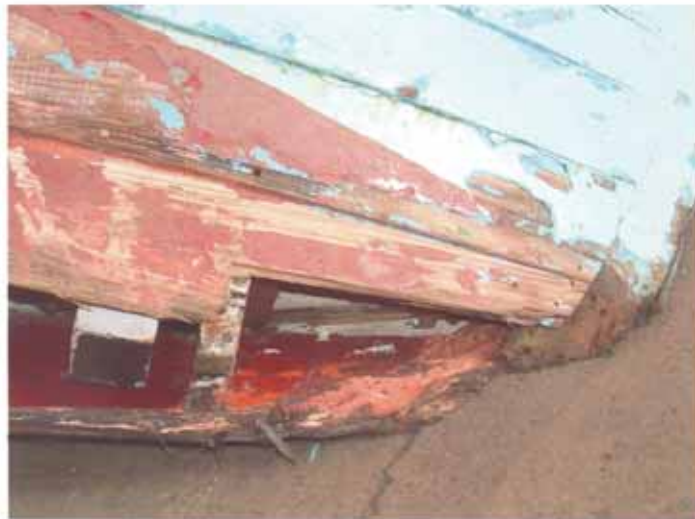
Figure 3. Foot of bow, with scarf joint in stem, base of Samson post, and missing keel

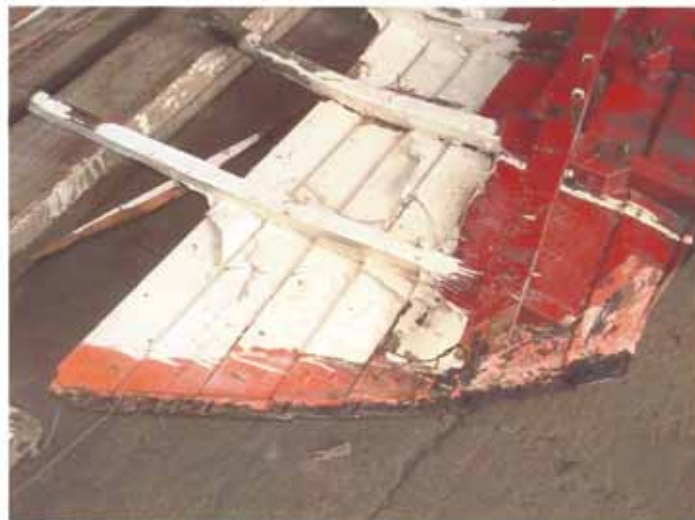
Eight sections of hull planking of various sizes were present. The largest piece, approx. 3x1m in area on portion of four frames, originated from the port side forward of the sternpost. No evidence of decay here. Many round galvanised nails in good condition still present in aft end of planking. See Fig. 4. Other pieces of planking also sound, albeit with slightly brash fractures in some pieces. Fasteners generally intact.

Figure 4. Port aft planking showing nails pulled from stempost.
