**REPORT OF THE
INVESTIGATION INTO
THE FAILURE OF THE
PILOT LADDER FROM
THE M.S "SYBILLE"**

The Marine Casualty Investigation Board was established on the 25th March, 2003 under The Merchant Shipping (Investigation of Marine Casualties) Act 2000

EXAMINATION, SAMPLING AND TESTING BY REALISATION METHOD TO DETERMINE ROPE RESIDUAL STRENGTH AND LIKELY CAUSE OF FAILURE of PILOT'S LADDER from 'MV SYBILLE'

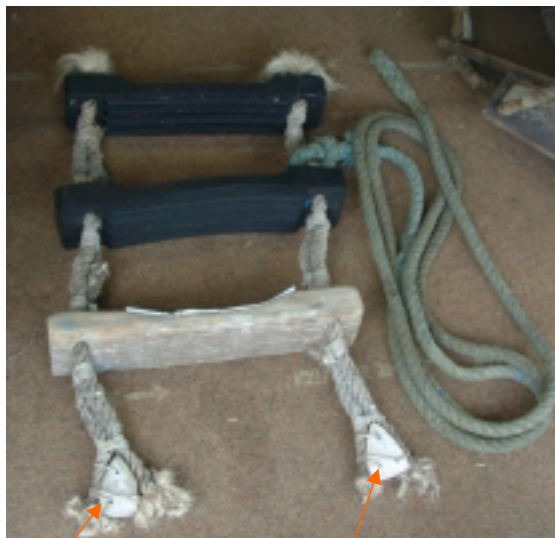
Photograph 1 shows a general view of the ladder part, with the legs identified. The fail zones are to the foreground [bottom of photograph]

Photo 1 General view of ladder part

left-hand fail zone

right-hand fail zone

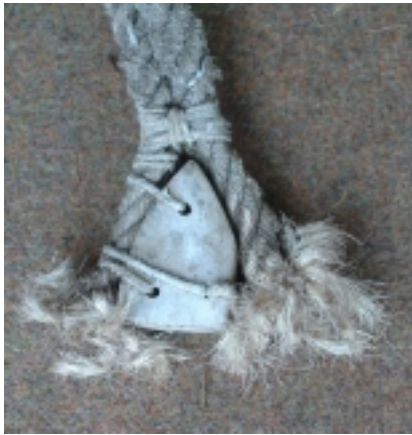
Photo 2 Close-up of left-hand fail zone

It can be seen that both legs failed where they emerge from the wooden spreaders. It is assumed there is a short free length of rope, before the rope pairs are threaded through the next ladder span.

Localized flex fatigue will have occurred at these positions.

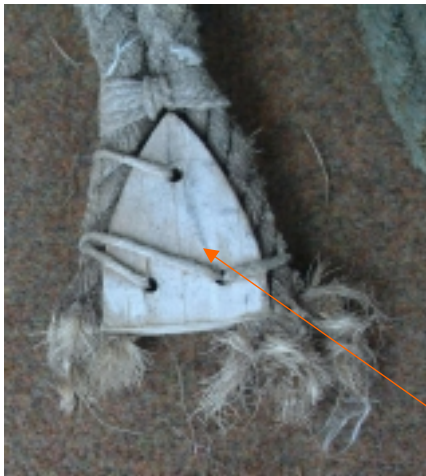
Photo 3 Close-up of right-hand fail zone

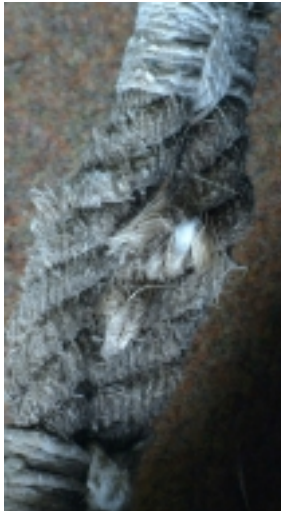
As well as the general external abrasion damage seen, there was also rope-on-rope abrasion, between the pairs of ropes in each leg.

Photographs 4 and 5 show examples of external abrasion damage seen, these being from the left-hand leg of the ladder.

Photo 4 External abrasion

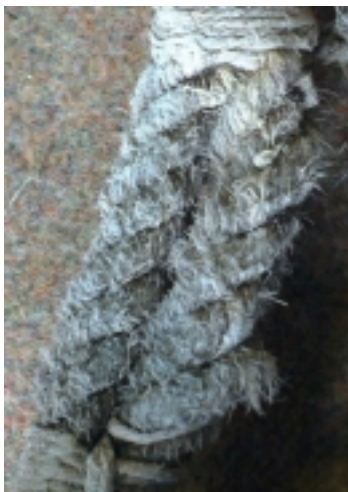
Photo 5 External abrasion

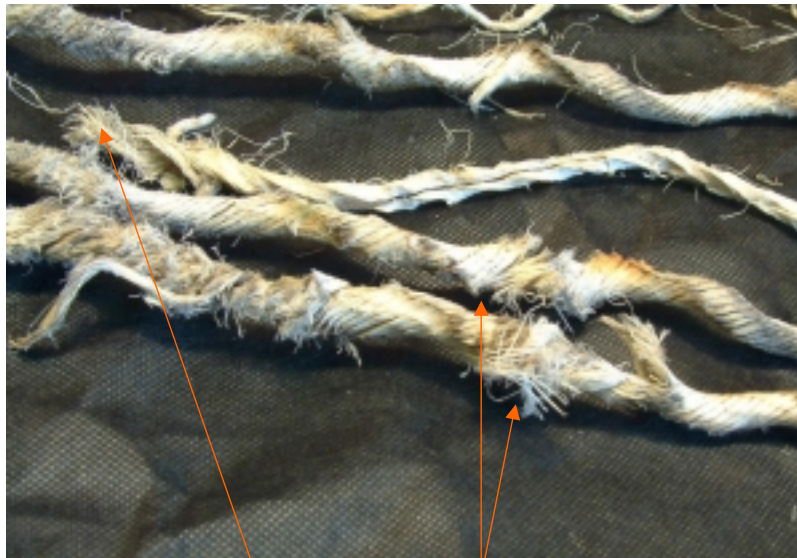
Photo 6 View of 3 of the four strands, and core

break of core yarns

damage

The damage can be clearly seen. Above the lower two strands, the inner core is laid out. This was found to be broken in two places along the one metre length sampled for testing, and therefore was not tensile tested.

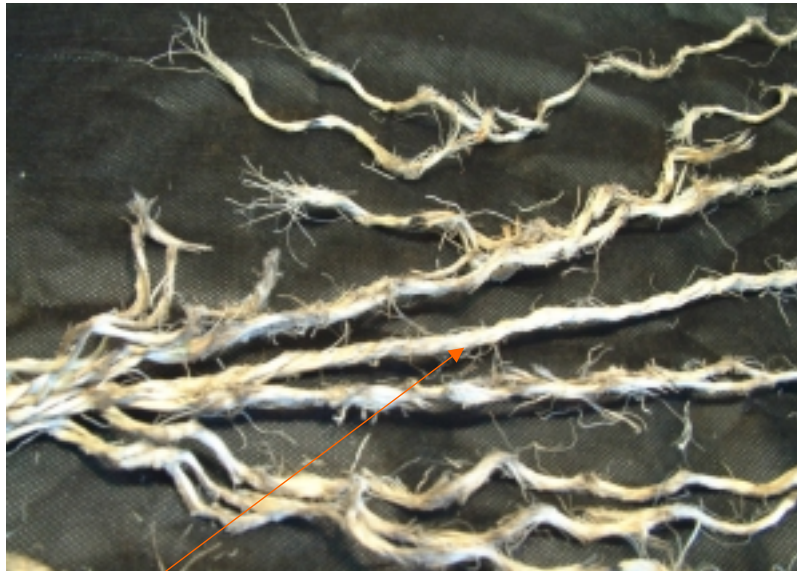
Photo 7
View of untwisted fourth strand, to show constituent rope yarns

inner rope yarns

Considerable damage is seen to the outer rope yarns, with several completely broken

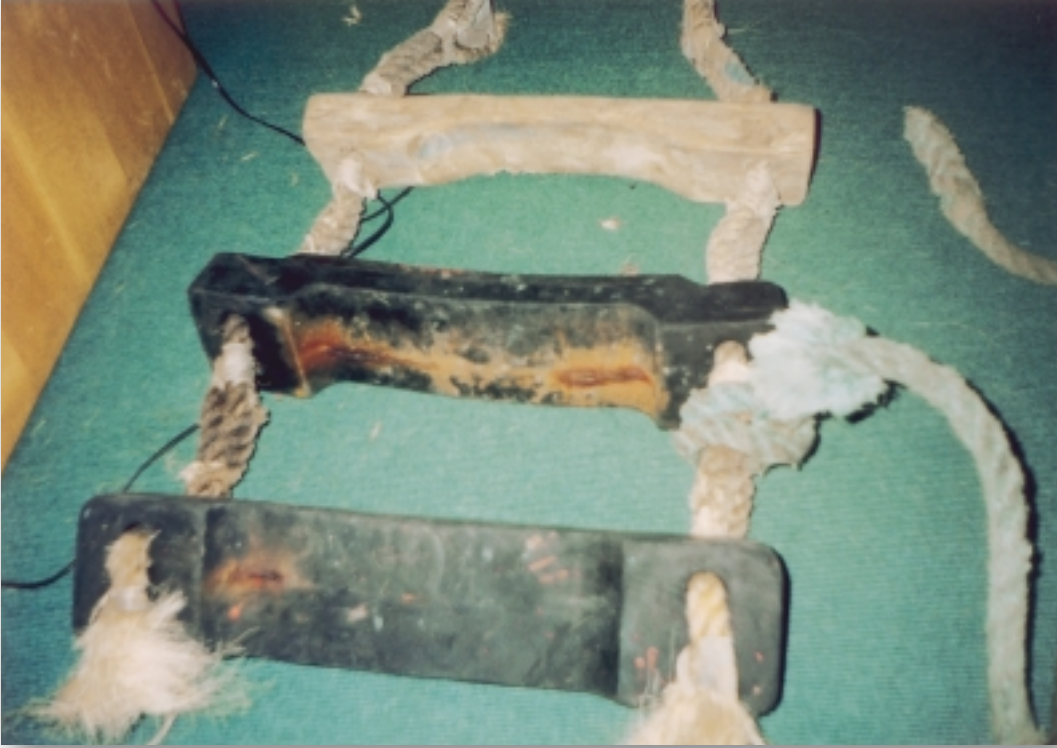
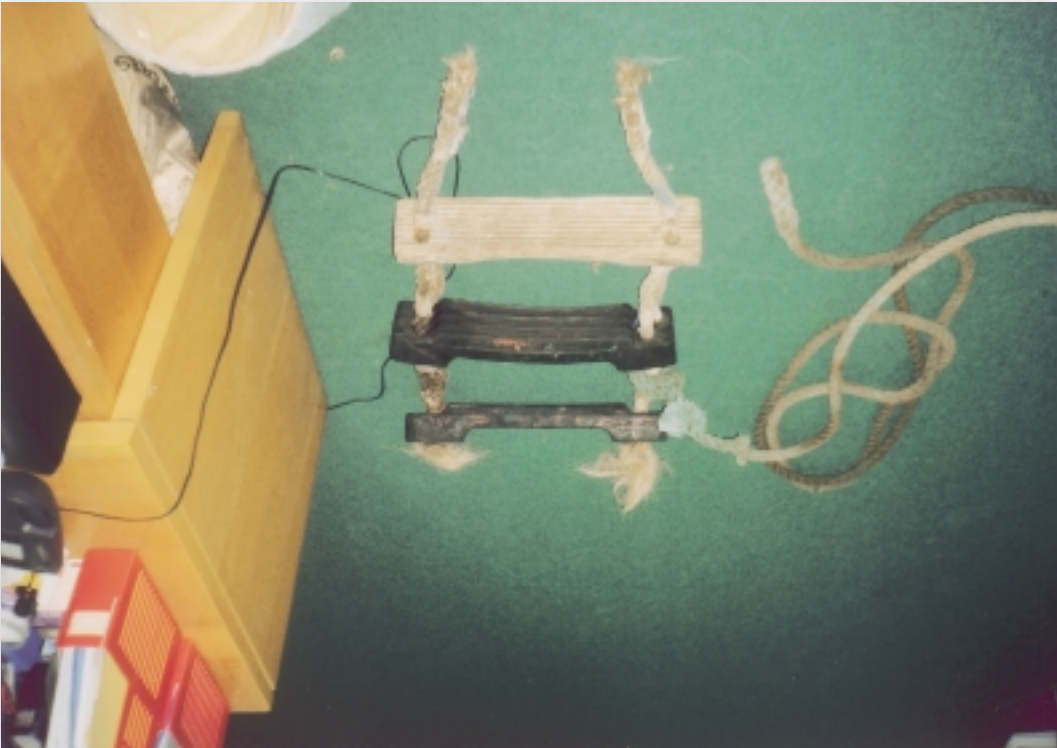
Photograph numbers 1 and 2 showing section of pilot ladder that fell into the pilot vessel.

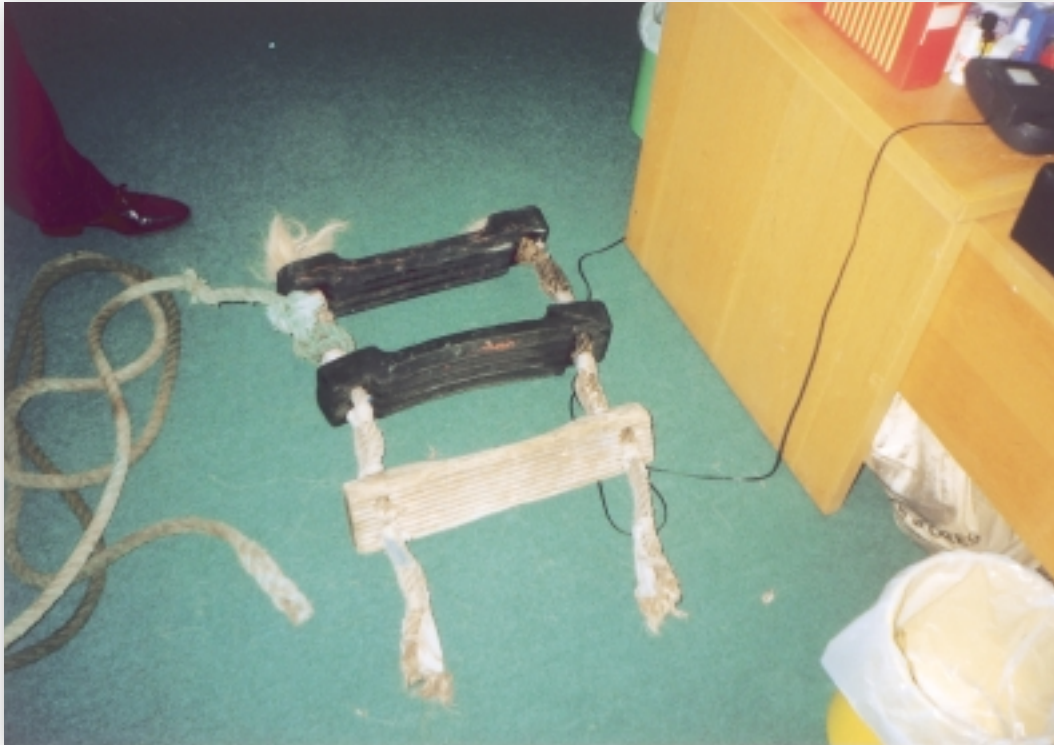
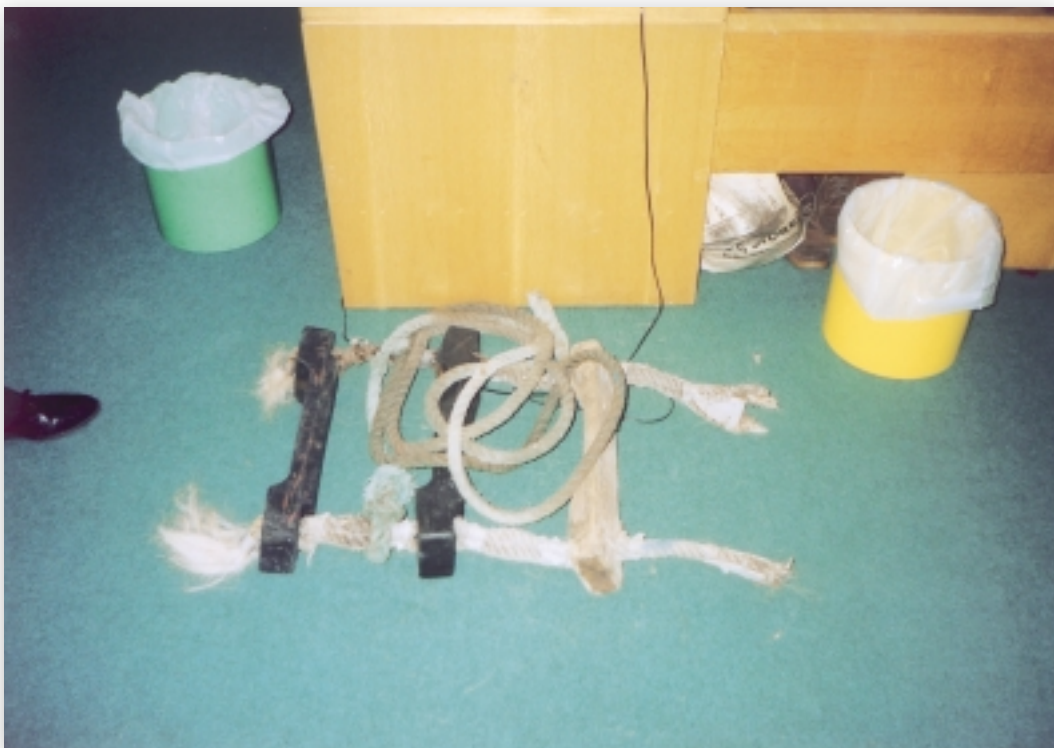
Photograph numbers 3 and 4 showing section of pilot ladder that fell into the pilot vessel.

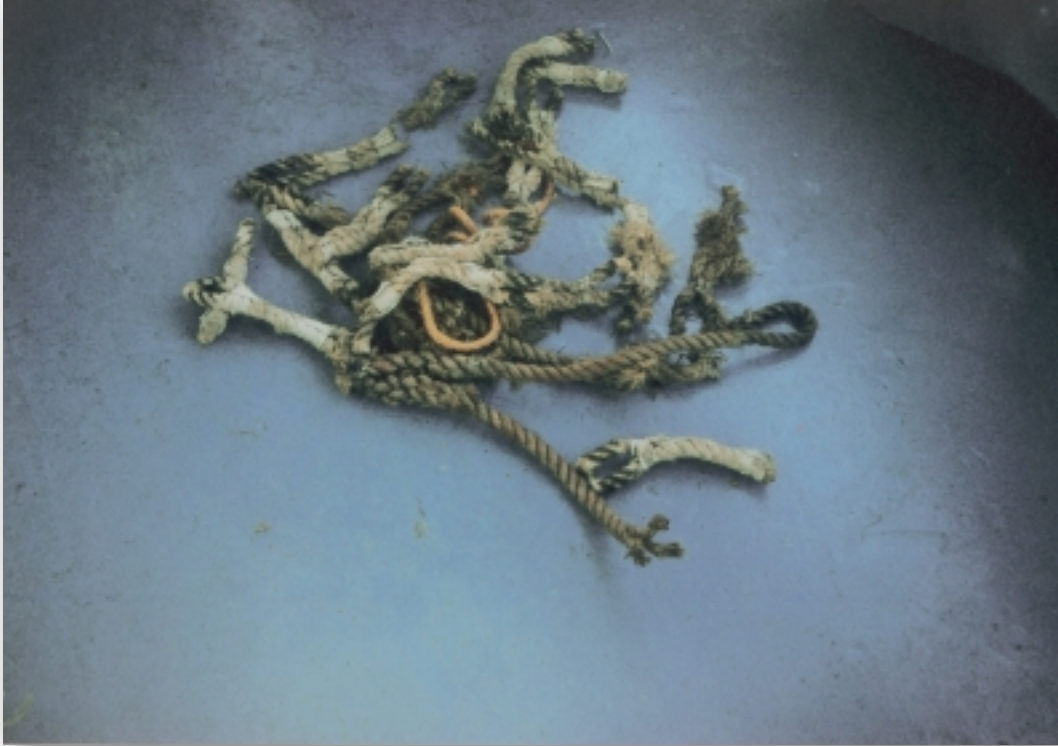
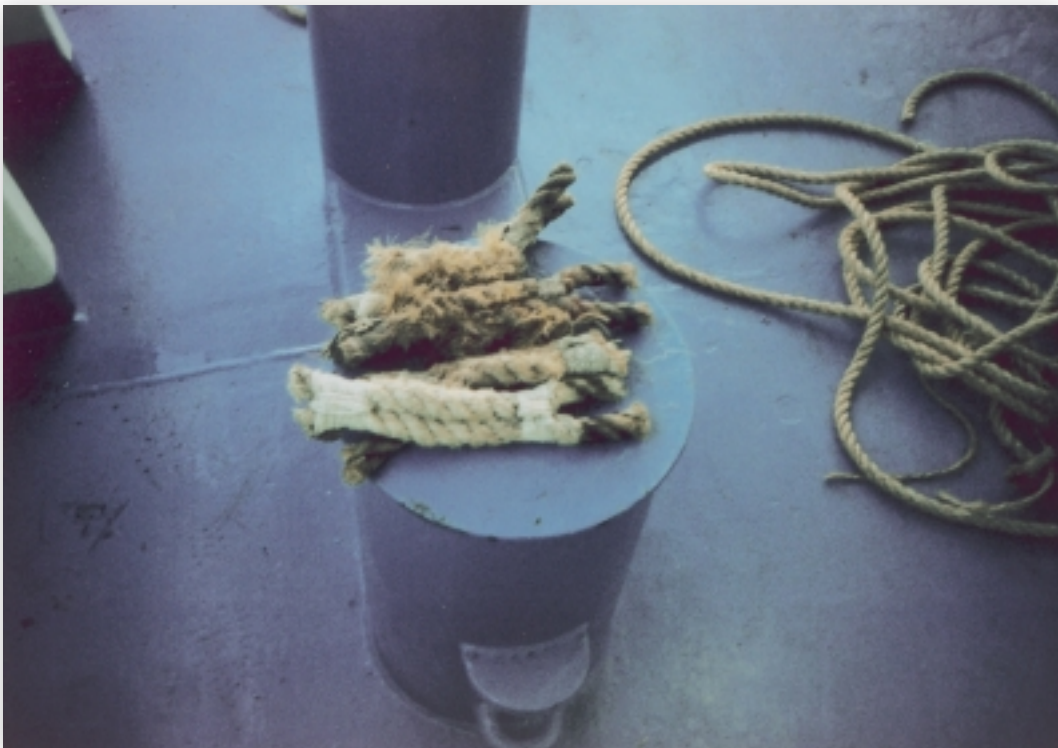
- 5.3 The port side ladder had been chopped and all that remained was the steps. The rope remains were in the same condition as the starboard pilot ladder.

Photograph numbers 5 and 6 showing sections of the port side pilot ladder that were removed from the remainder of the ladder on the M/S "Sybille"

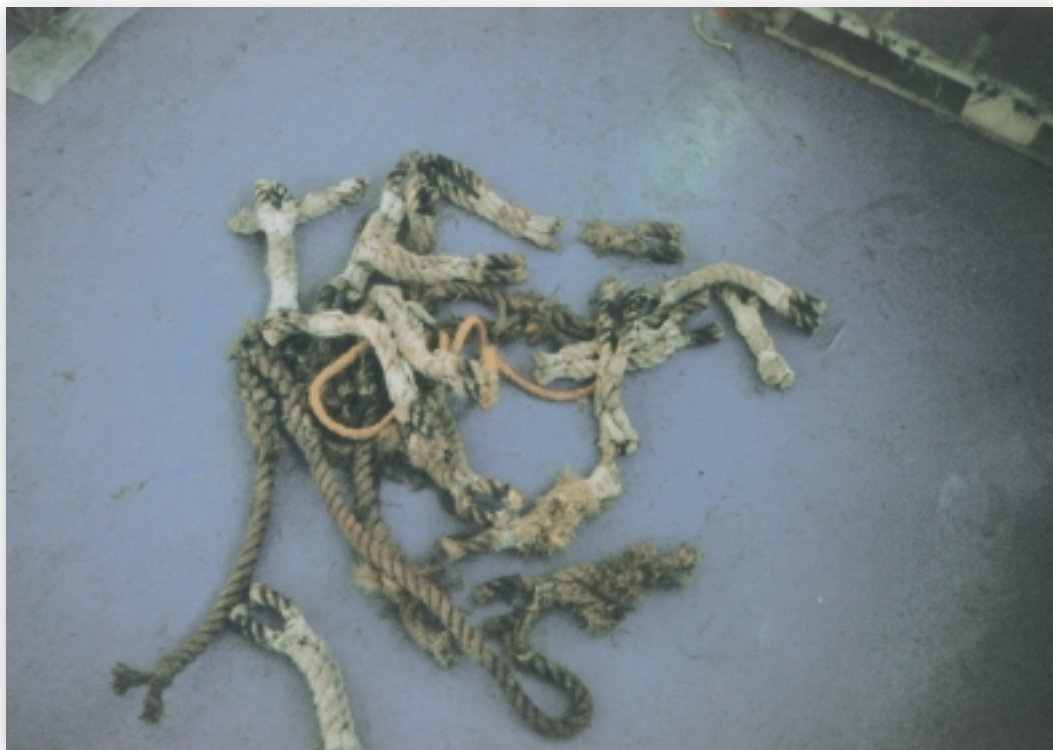
Photograph number 7 showing sections of the port side pilot ladder that were removed from the remainder of the ladder on the M/S "Sybille"

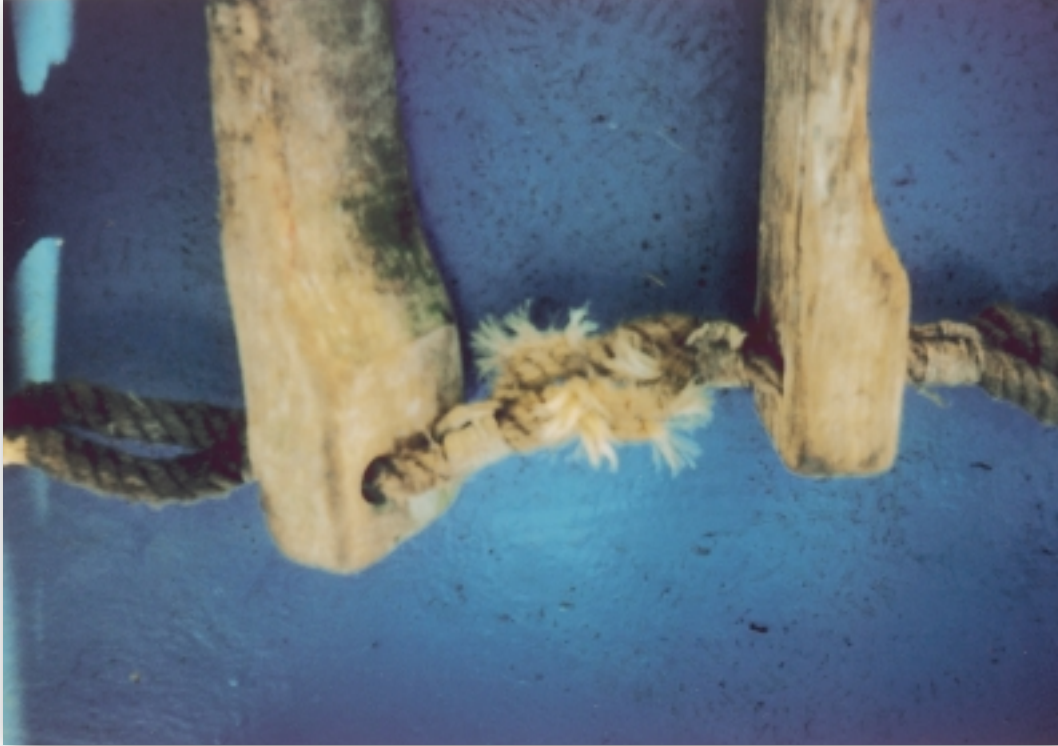
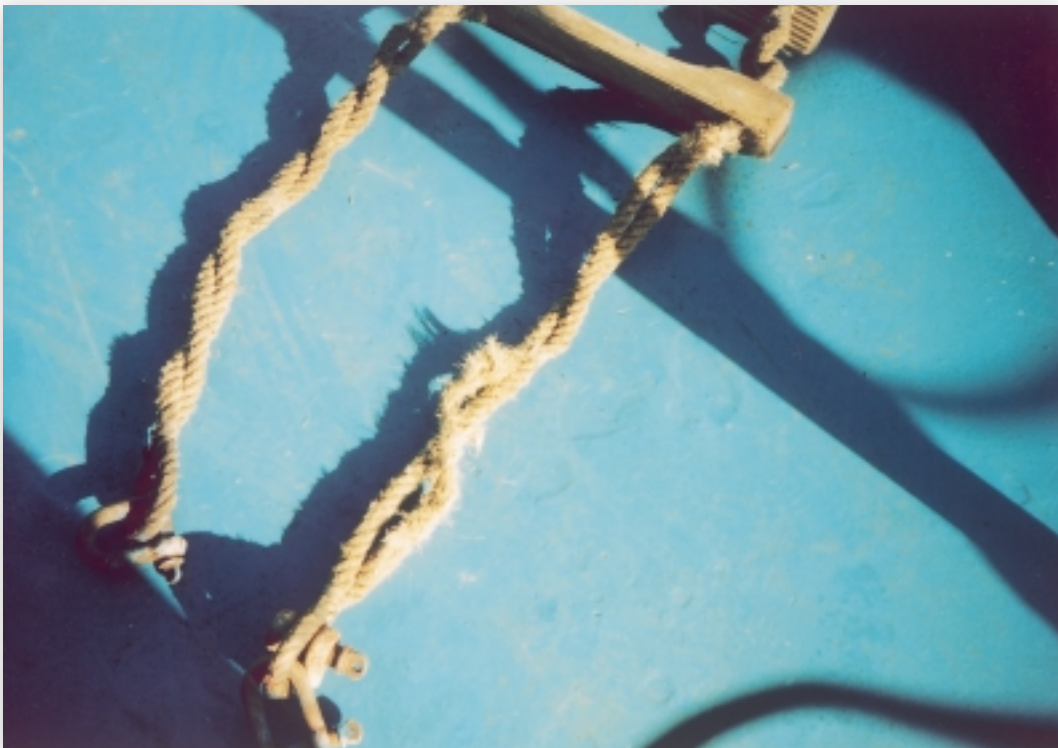
Photograph numbers 8 and 9 showing sections of the starboard side pilot ladder (broken one)

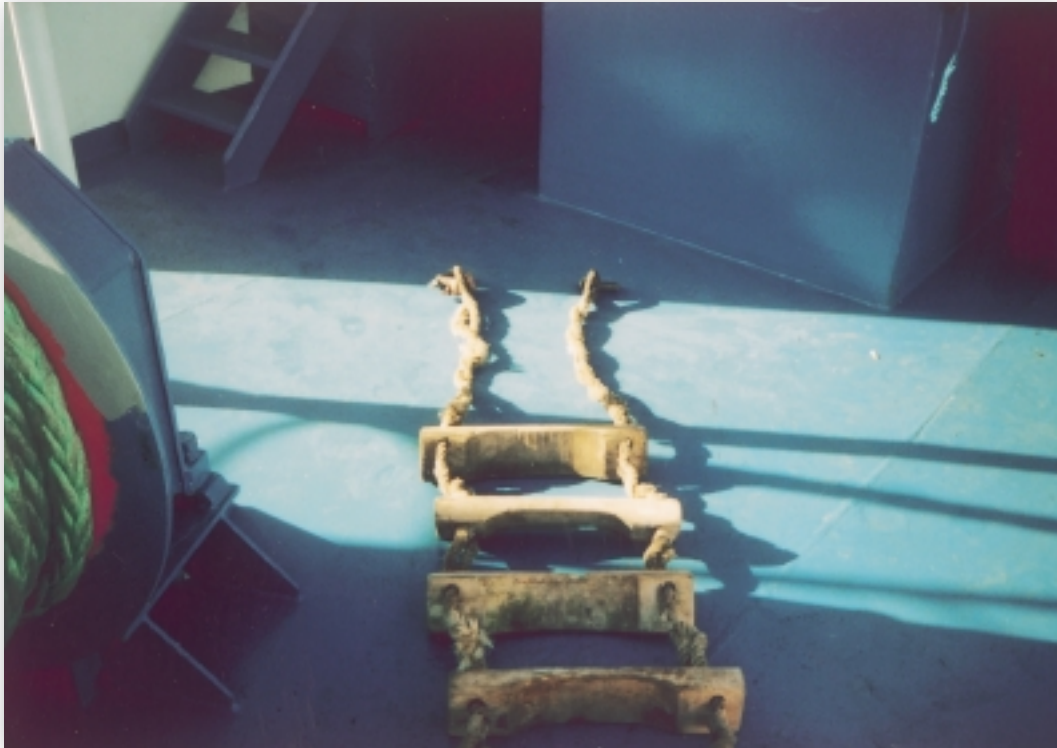
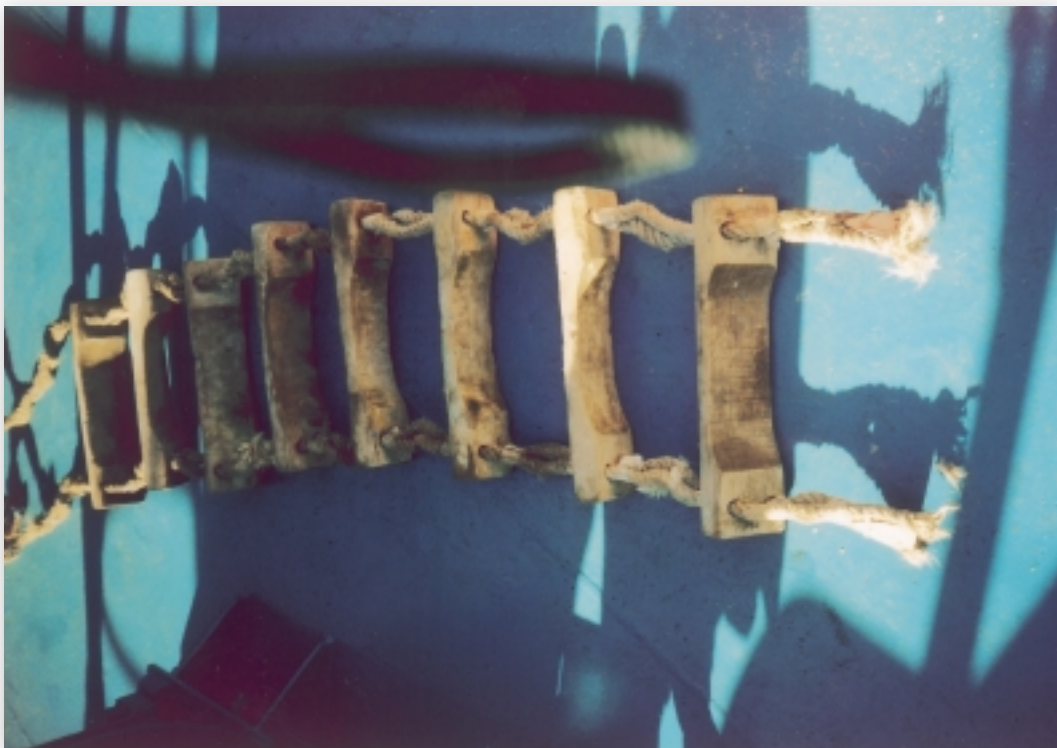
Photograph numbers 12 and 13 showing starboard ladder. Section that remained on the M/S "Sybille"

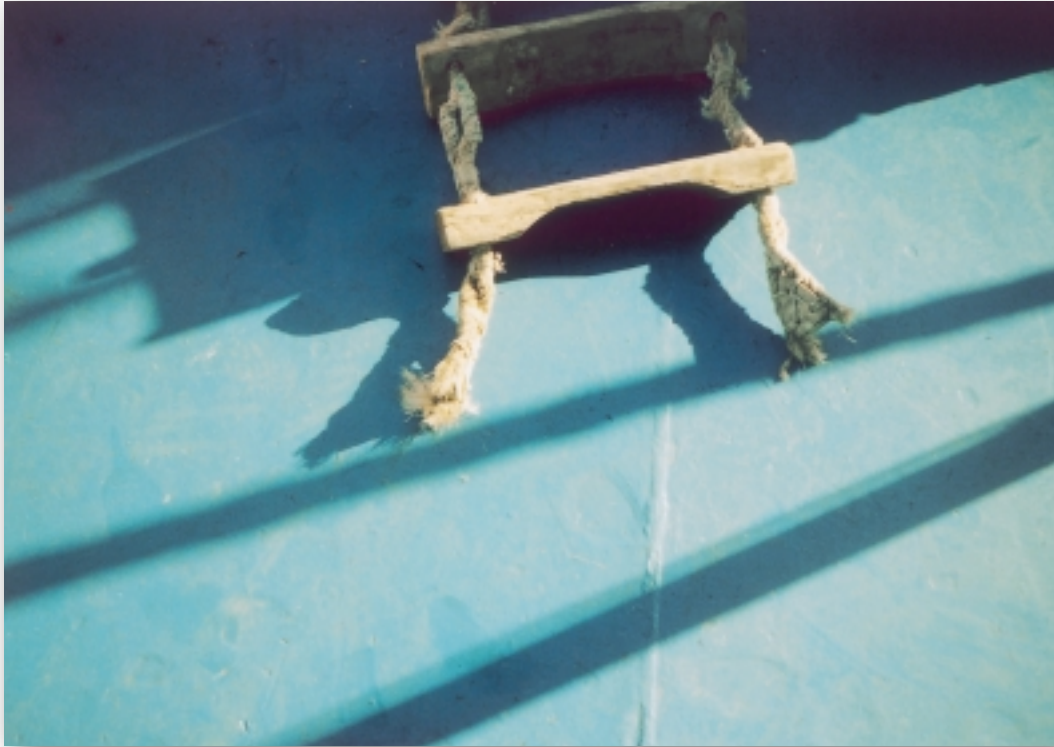
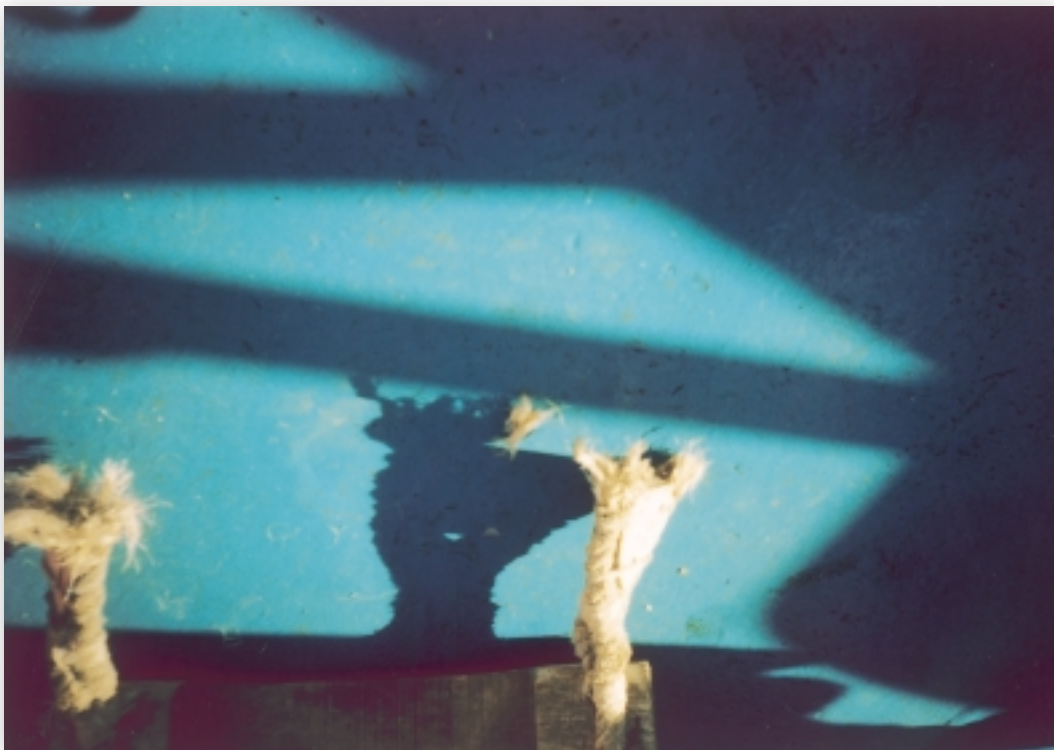
Photograph numbers 14 and 15 showing starboard ladder. Section that remained on the M/S "Sybille"
