**REPORT OF THE
INVESTIGATION INTO AN
INCIDENT RELATING TO THE
CRUISER "WINKELRIED" ON
THE LOUGH REE**

Published by The Marine Casualty Investigation Board
16th October 2006

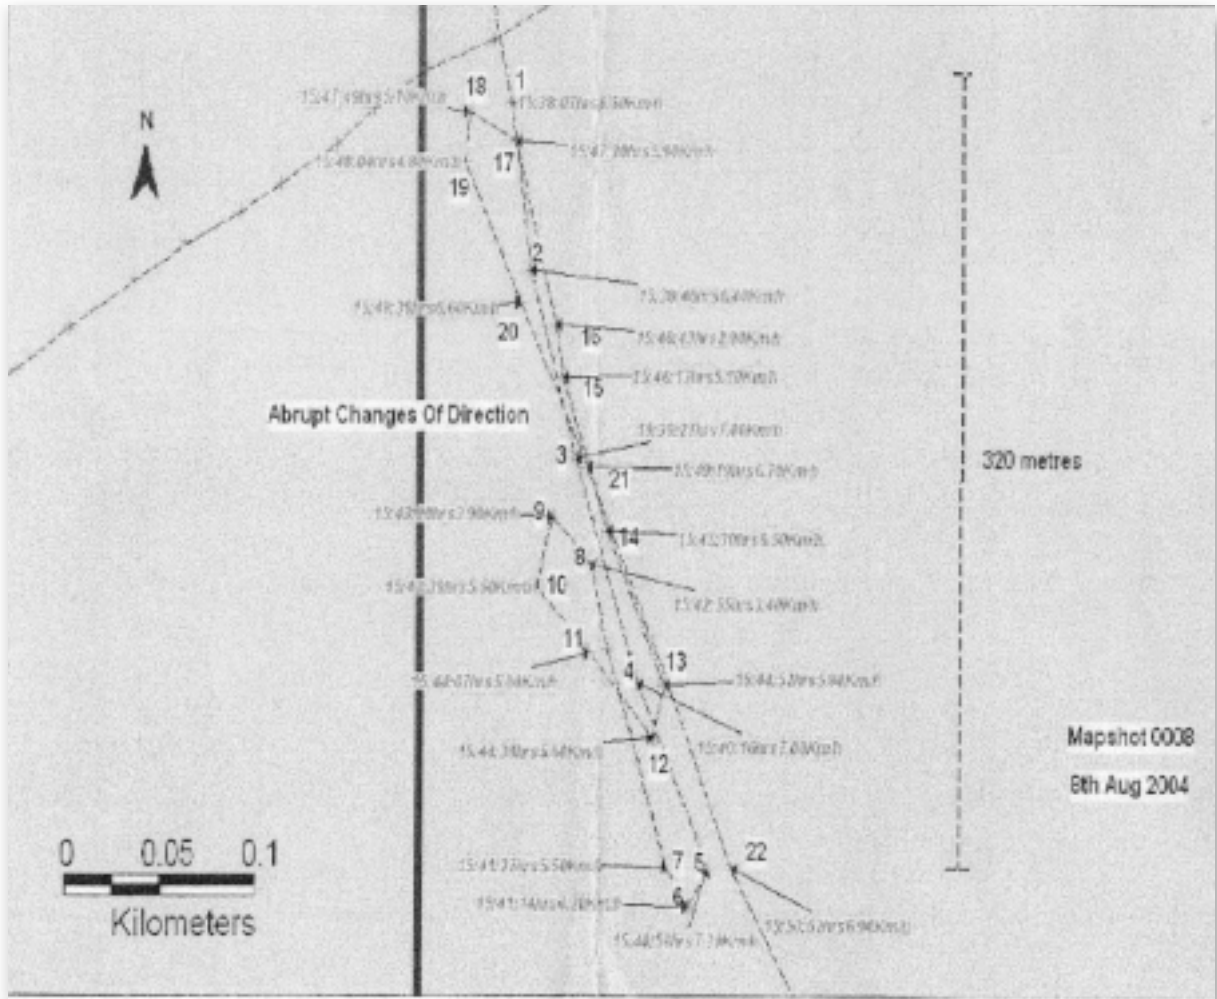
Appendix 7.2
GPS Download Printout

- 3.7 A company specialising in GPS (Global Positioning System) hardware downloaded the route followed by the vessel as stored in the memory of the GPS. This company, CharterNav (now GPS Ireland) based in Crosshaven, Co. Cork printed out the route of the vessel onto an ordnance survey map. (See Appendix 7.2)

- 3.7.1 This printout indicates that the vessel left shortly after 14.00 hours and proceeded north up Lough Ree.
 - 3.7.2 At approximately 15.23 hours the vessel was north west of Inchmore Island when it turned south.

- 3.7.3 At approximately 15.41 hours the vessel commenced a series of four 180 degree turns; the last turn was made at 15.47 hours approximately. (See Appendix 7.2)

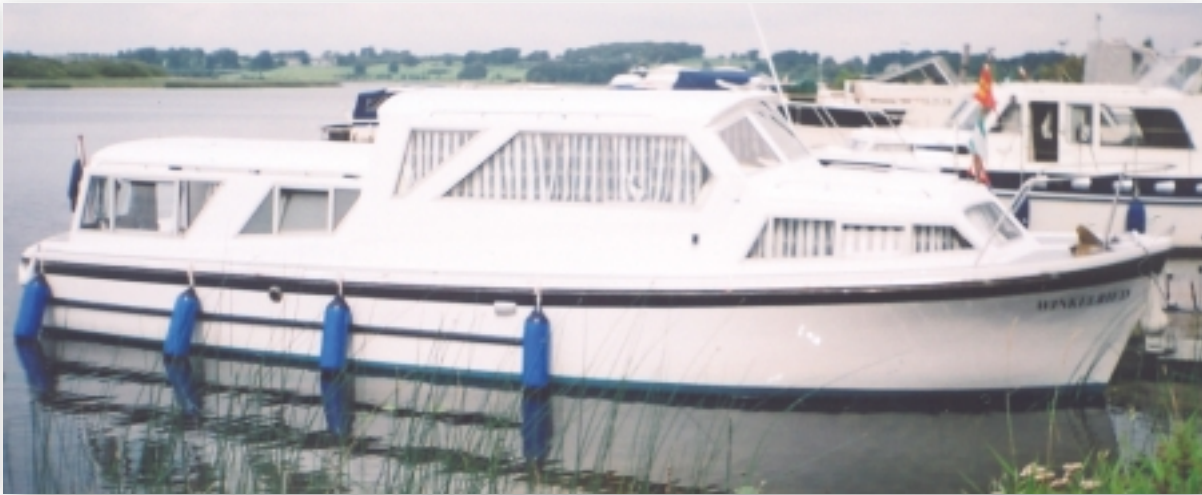
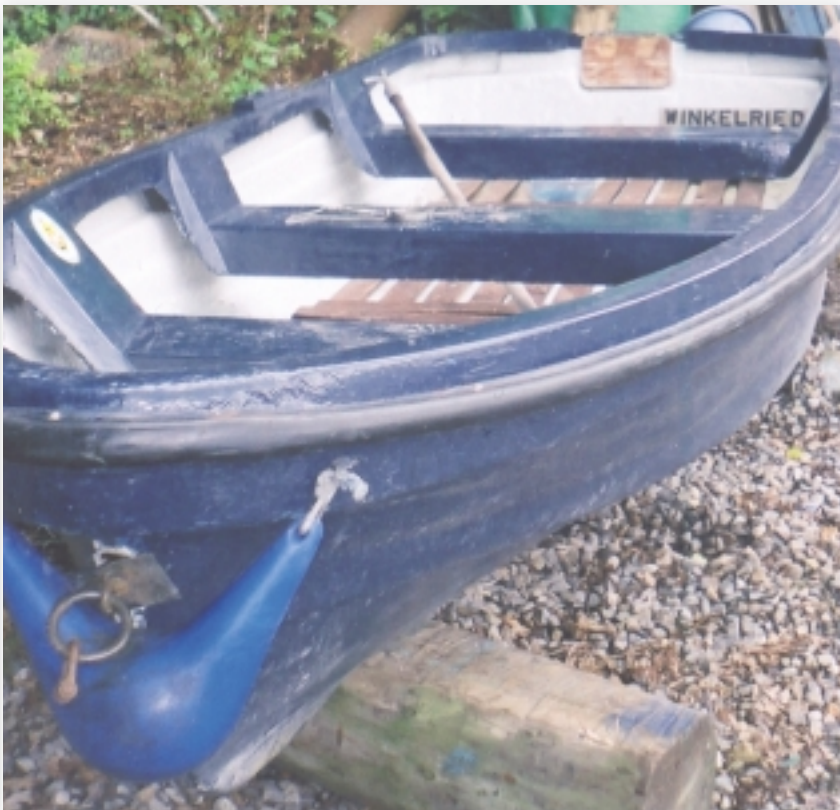
Appendix 7.4
Photographs of the "Winkelried".

- 3.1 Mr. and Mrs. Borner were Swiss Nationals who had been coming to the River Shannon for many years. According to local information they first came to the Lough Ree area in 1969. The Borners' purchased the "Winkelried" (see photo 1 at Appendix 7.4) in 1989.

- 3.2 The Borners were well known in the local boating community and were considered to have had a good local knowledge of the Lough Ree area.
- 3.3 The Borners set out on the "Winkelried" at approximately 14.00 hours on Sunday the 8th August. The "Winkelried" had a dinghy in tow. (See photo 2 at Appendix 7.4)
