REPORT OF INVESTIGATION INTO A GAS EXPLOSION ON BOARD THE '*MAURENELLA*' AT LOWTOWN, GRAND CANAL,

CO. KILDARE

ON 21st APRIL 2010

REPORT No. MCIB/182 (No. 11 of 2010)

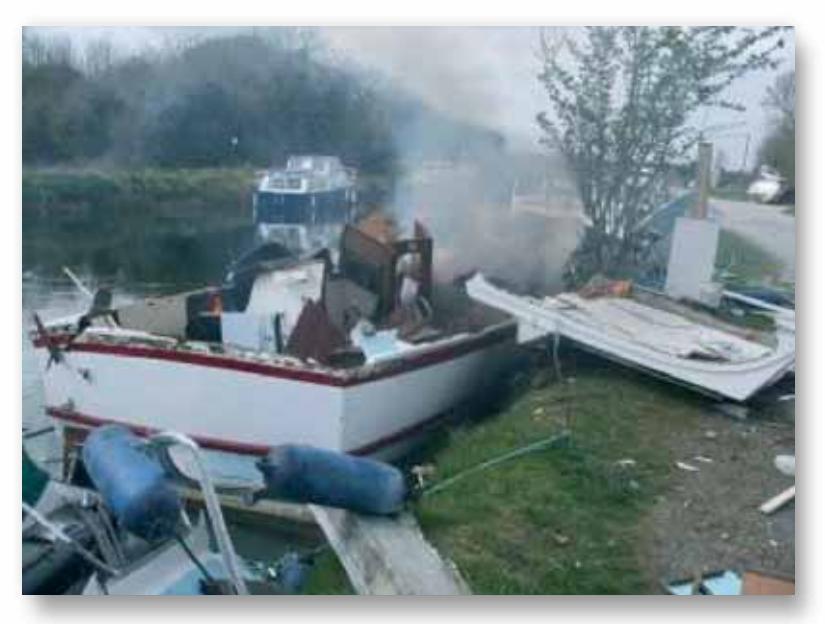
- 4.1 As the engine was started an explosion occurred followed by fire.
- 4.2 The entire superstructure of the vessel was blown off and the interior was substantially damaged (see photo 3).
- 4.3 Mr. McGrath fell into the engine compartment, sustaining a severe injury to his left eye, a fractured right wrist and general bruising/abrasions. He managed to scramble clear and onto the canal bank. The emergency services attended the incident and he was taken to Naas General Hospital by ambulance.

Photo 3 - Vessel in the immediate aftermath of the explosion

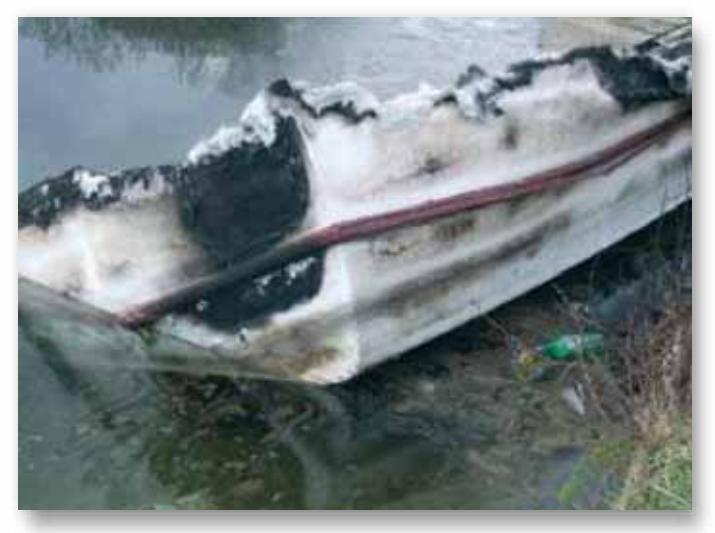
Photo 4 - Vessel as first sighted

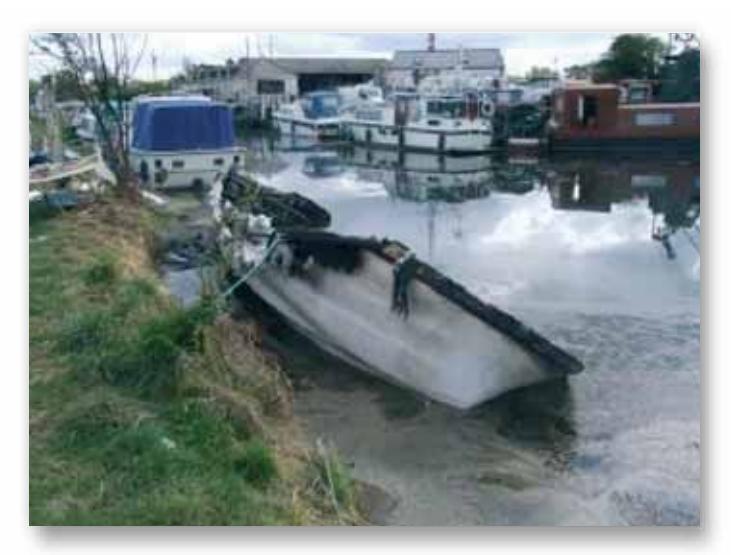
Photo 5 - Vessel in canal

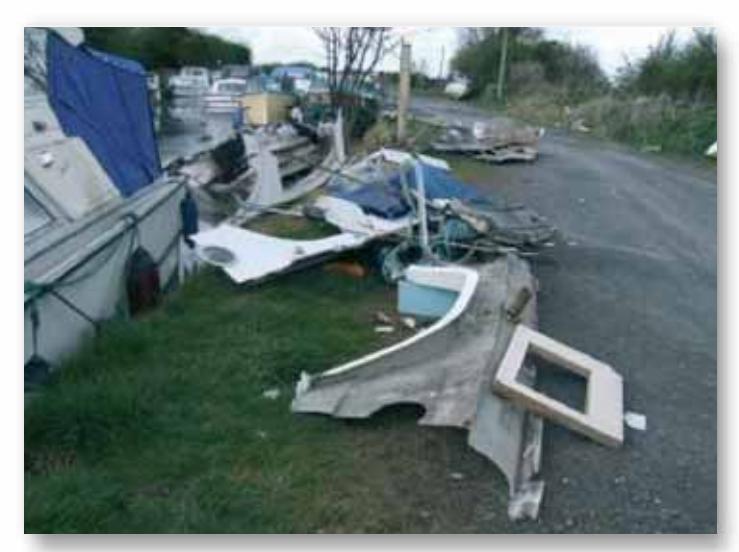
Photo 6 - Remains of superstructure on canal bank

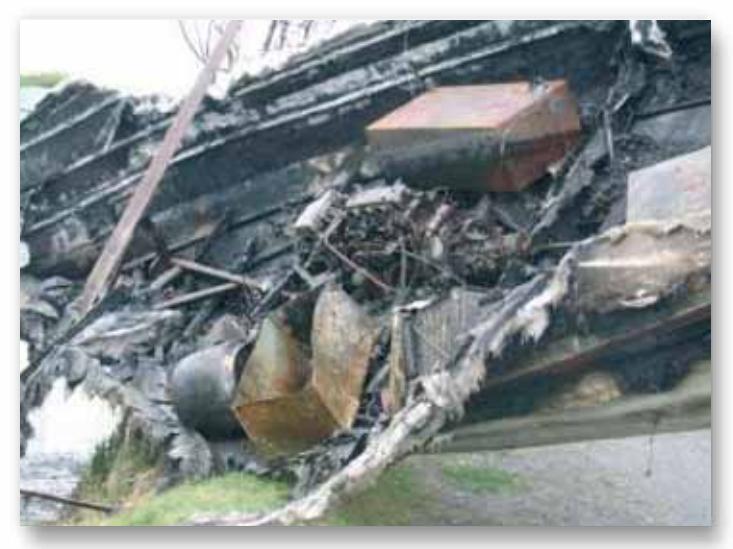
Photo 7 - Inside of vessel as it was lifted from the water

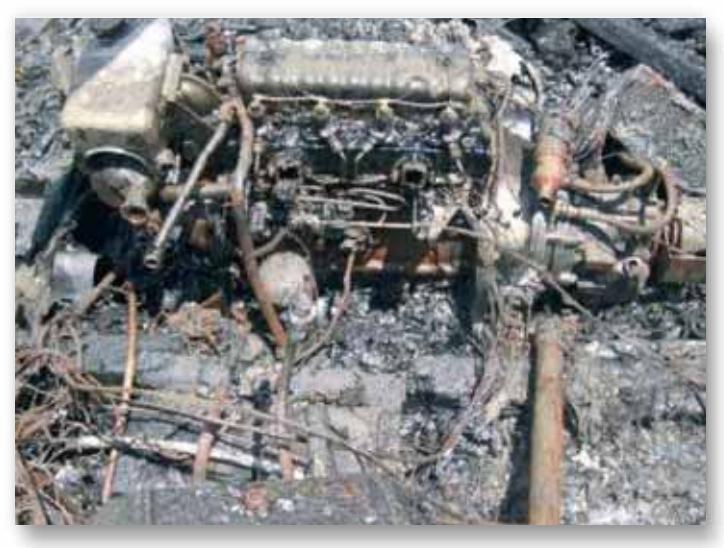
Photo 8 - Shows inlet manifold missing from engine

- 6.2 Virtually nothing was left apart from the hull moulding. The heat of the fire was sufficient to melt the cast manifolds on the engine, while only fragments of copper piping remained, sufficient only to determine what purpose they served.
- 6.3 There was no other source of gas on board the vessel other than that used for heating and cooking. The gas fired equipment included a cooker, a refrigerator and three open flame heaters (see photo 10).

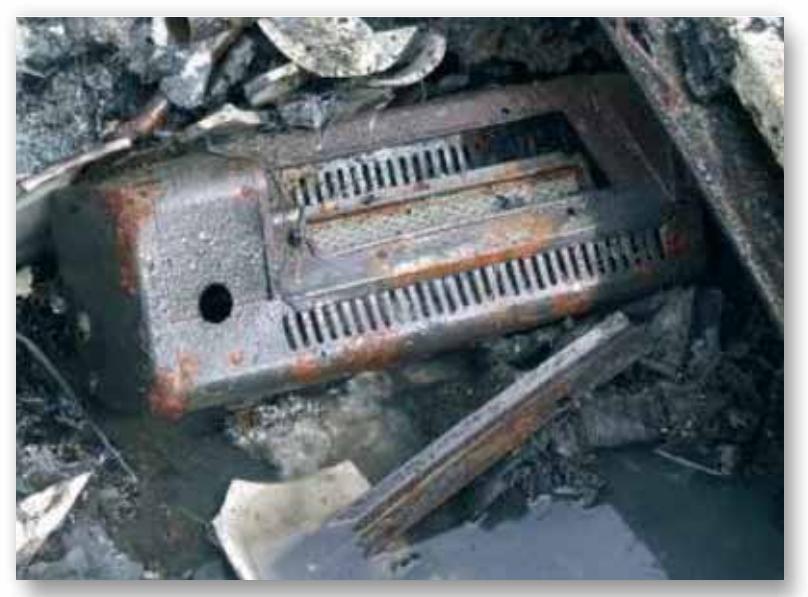
6.1 The Owner had partially dismantled the gas system by disconnecting a gas heater mounted on the port aft face of the forward galley bulkhead (see photo 9). The pipe was not blanked off. When the cooker was switched on gas leaked from the disconnected pipe. When the engine was turned over to start the vessel exploded.

Photo 9 - Remains of gas heater

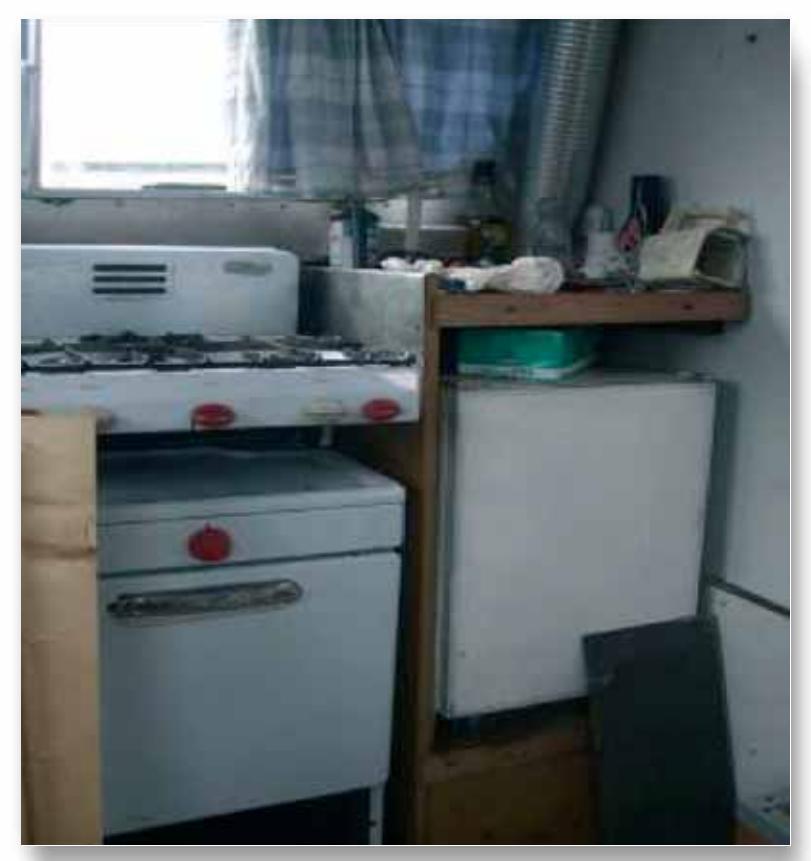
Photo 10 - Galley arrangement

- 6.4 None of the gas fired equipment on board had a flame supervision device.
- 6.5 There was no gas leakage detection system.
- 6.6 It was not possible to conclusively determine what was the source of the ignition. The possible primary sources of a spark are considered to have been:
 - 1) Sparks caused by the brushes of the alternator;
 - 2) A flame-back occurred through the air intake caused by overuse of the engine pre-heating fuel system.
- Note: The Perkins 4 108 series engines have two different engine pre-heat systems. Both utilise an open coil glow plug to heat the fuel. One system incorporates a secondary fuel tank which releases fuel into the system once the glow plug reaches the correct temperature.
