**REPORT OF THE  
INVESTIGATION INTO  
MAN OVERBOARD  
FROM ANGLING BOAT  
'BLUEBIRD II'  
ON  
15th AUGUST 2016**

**REPORT NO. MCIB/263  
(No.6 OF 2017)**

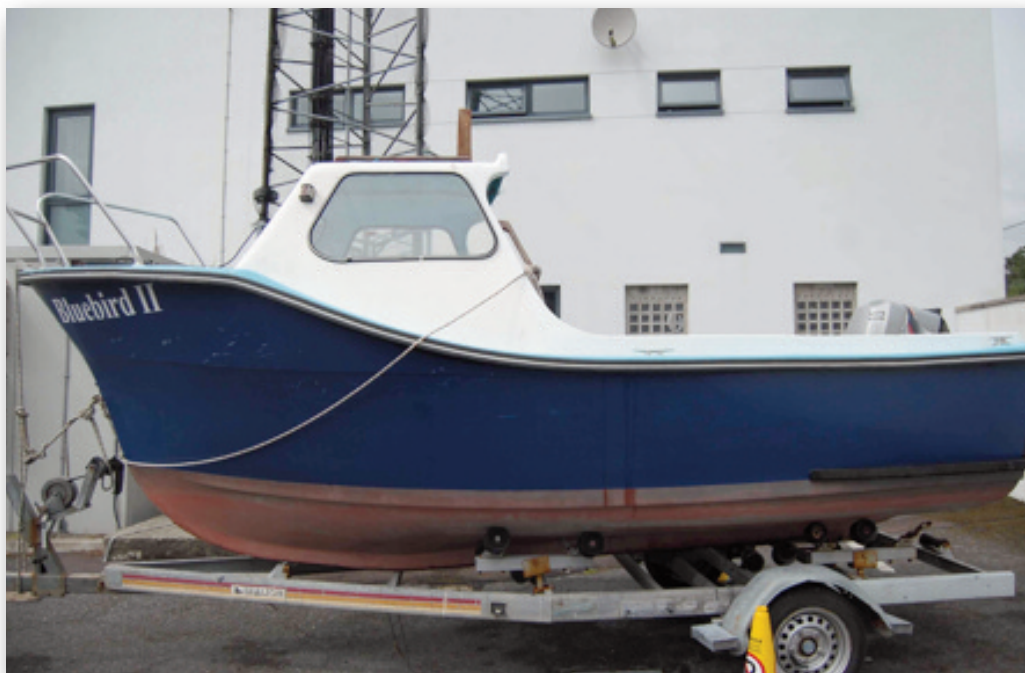
Photograph No. 1: Overview of the vessel, hull in good condition.

2.2.1 The vessel is an inshore pleasure fishing craft and was found to be in good condition. The vessel was constructed in Devon of polyester resin using female mould construction techniques (see Appendix 7.1 Photograph No. 1). The vessel is an open vessel with a tank type floor with effective deck grip. The deck is positioned 75 to 80 cm below the gunwales. It has a small open wheelhouse forward with a small storage area suitable for storing safety equipment and dry items (see Appendix 7.1 Photograph No. 2).

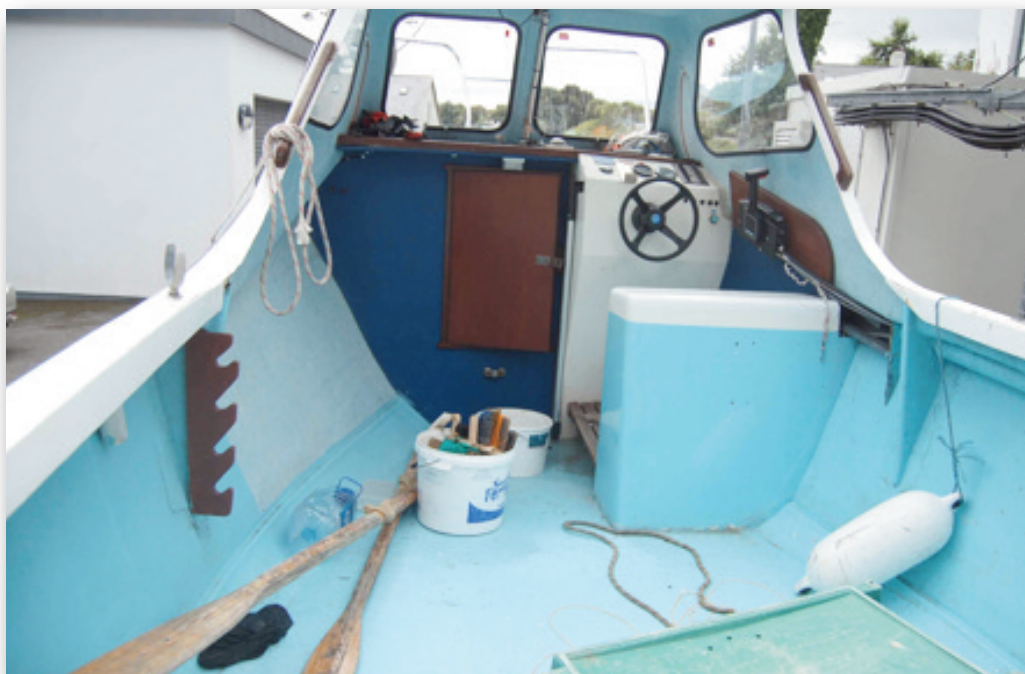
Photograph No. 2: Deck and Bulwarks

- 4.3 The vessel was in good condition and the bulwarks were of good height. It is probable that the casualty was using the bulwarks when standing or moving around the vessel. The use of the bulwarks as support would have put his centre of gravity over the bulwark.

- 5.4 The bulwarks and deck grip were found to be effective, however it is clear that the casualty was not completely mobile as a result of his hip operation. As the casualty's crutches were stored it is probable that he was using the bulwark for support. If he was using the bulwark as support, his centre of gravity would have been over the bulwark. This would have greatly increased the chances of a man overboard.

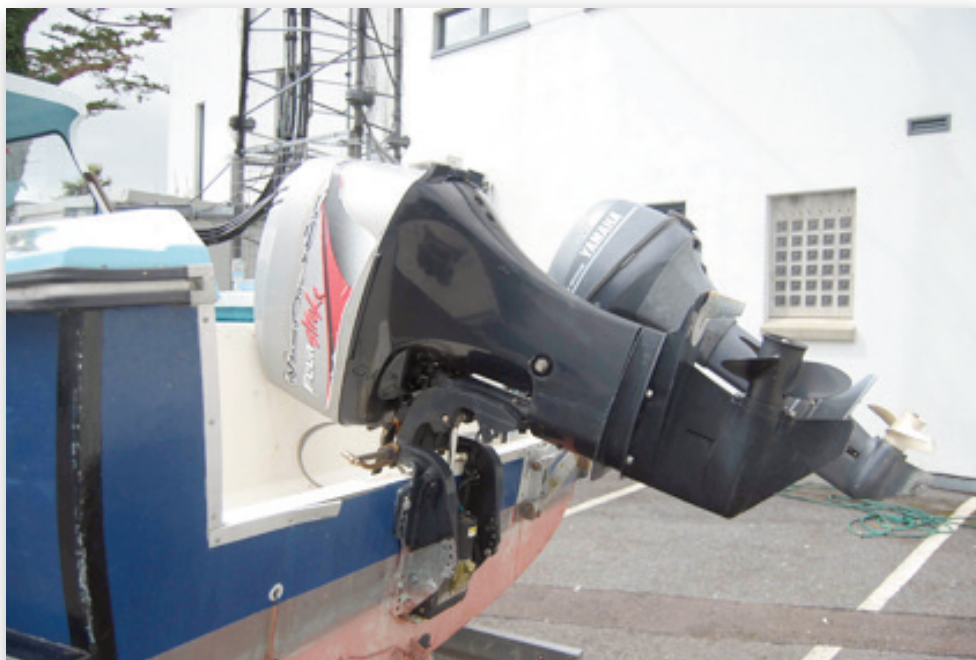
Photograph No. 3: Outboard Engine.

The vessel is propelled by a 50 hp four stroke Mariner outboard engine with a 15 hp four stroke Yamaha outboard as a backup emergency engine. Both engines were found to be in good order with the kill cord working correctly when tested on the main engine (see Appendix 7.1 Photograph No. 3).

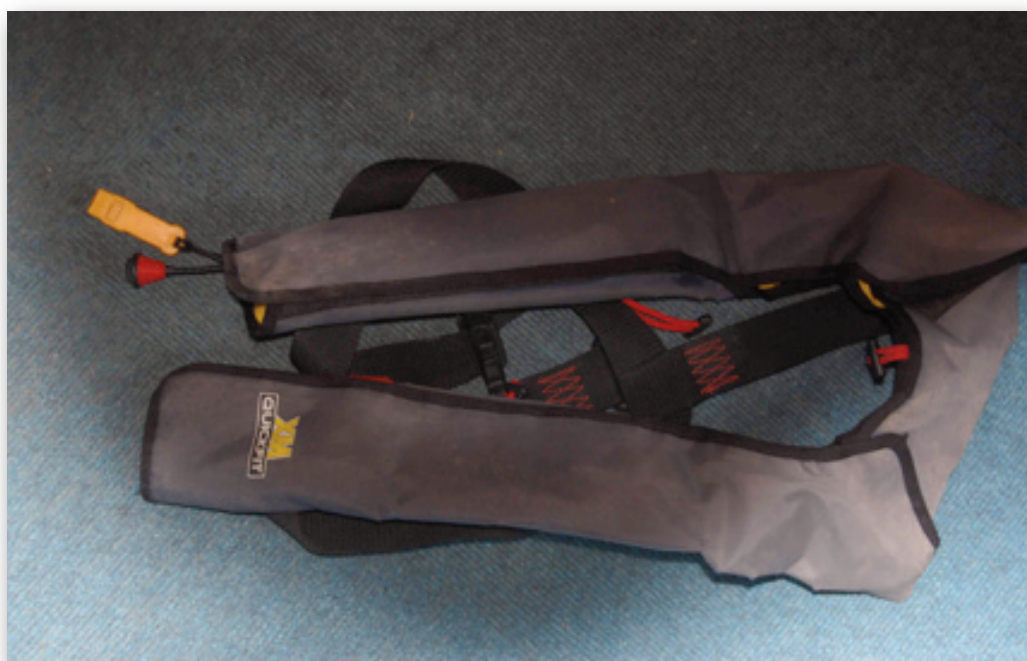
Photograph No. 4: PFD.

1 x PFD, a XM Quickfit, in good order with good gas bottle and firing pin (see Appendix 7.1 Photograph No. 4).

- 4.4 The vessel was not fitted with a VHF radio nor did it carry an EPIRB or a PLB. The casualty used his mobile phone for contact with his family during this outing. The casualty's PFD, as shown in photograph 4 of Appendix 7.1, mobile phone and wallet were found aboard the vessel.

- 5.2 When the casualty entered the water he was not wearing his PFD, which would have greatly increased the chances of his survival.
- 5.3 The vessel was not equipped with an EPIRB or a PLB. If the casualty had been wearing a PLB, he could have used it to raise the alarm. It would also have given a location to the shore rescue services.

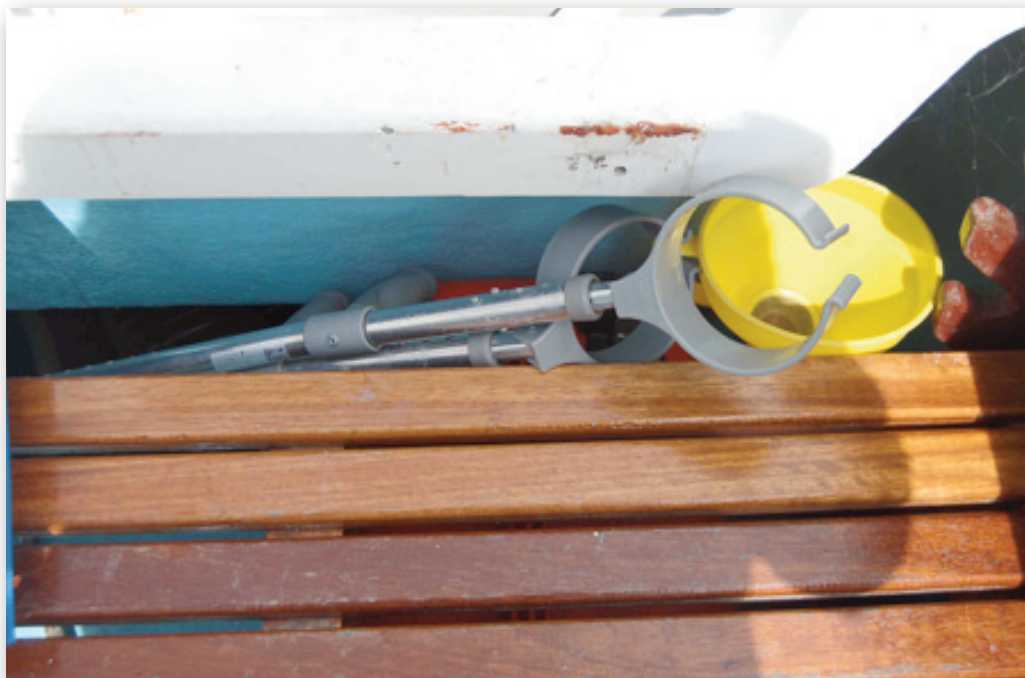
Photograph No. 5: Crutches stored behind aft bench.

2 x crutches tucked in behind a small bench aft (see Appendix 7.1 Photograph No. 5).

- 4.2 The casualty was an experienced amateur angler, but he had reduced mobility due to a hip operation. The casualty used crutches and required assistance to embark or disembark the vessel. The casualty's crutches were found stored in a space behind a bench aft.
