REPORT OF AN INVESTIGATION INTO A MARINE CASUALTY INVOLVING MULTIPLE ROWING VESSELS IN OR AROUND SALMON WEIR, RIVER CORRIB, CO. GALWAY 14 JANUARY 2023

> REPORT NO. MCIB/325 (No.4 OF 2024)

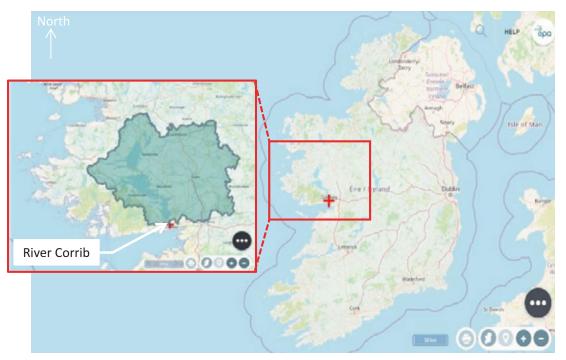
Lough Corrib into Galway Bay, over a length of approximately six kilometres (km). A feature of this river is that it has a large catchment area of approximately 3,113 km<sup>2</sup> relative to its short six km length, and at a relatively high average flow rate of 104 cubic metres per second<sup>1</sup>. See Figures 1 and 2.

Figure 1: The River Corrib's large catchment area. Source: Environmental Protection Agency https://gis.epa.ie

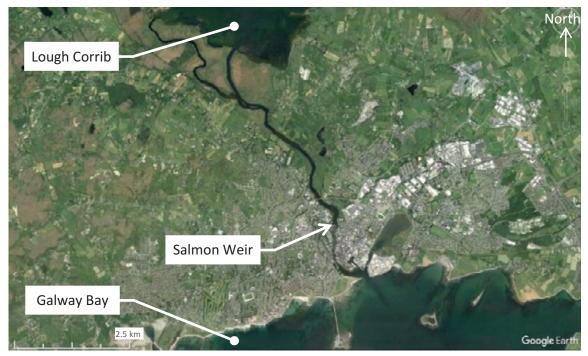
Figure 2: The River Corrib, which flows south into Galway from its source in Lough Corrib. Source: Google Earth.

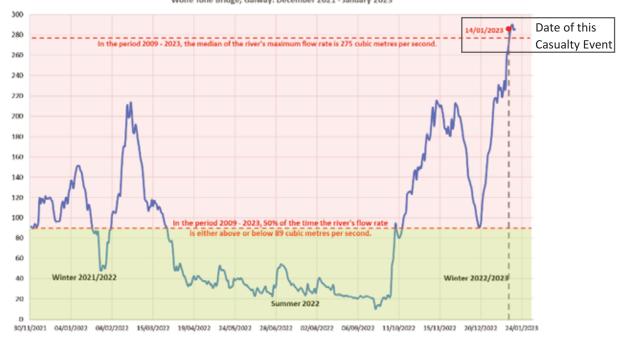
River Corrib Flow Rate (cubic metres per second) Wolfe Tone Bridge, Galway: December 2021 - January 2023

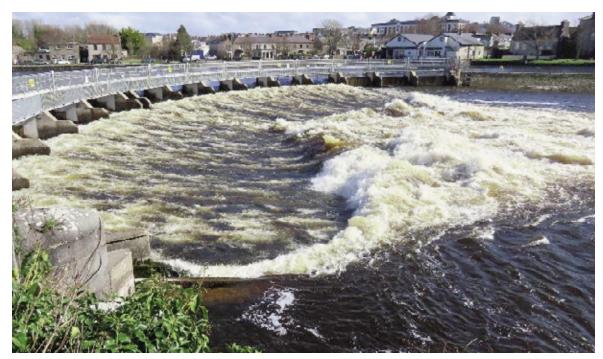
- 2.4.1 The main feature on the River Corrib in Galway city is the Salmon Weir, also known as the Regulating Weir. This is under the active control of the Office of Public Works, which controls the opening and closing of the 16 sluice gates to regulate the amount of water passing down the weir. These managing actions affect the depth of water upstream in the River Corrib, Lough Corrib and Lough Mask, and the River Corrib's flow rate both upstream and downstream of the weir. The effect of this can be seen in the significantly different conditions that typically occur at the weir during winter and summer conditions. See Figures 6 and 7.

Figure 6: The Salmon Weir during winter flow conditions (in March 2023), when all 16 sluice gates are open.

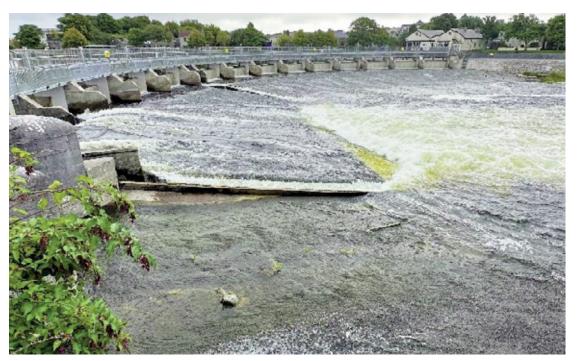
Figure 7: The Salmon Weir during summer flow conditions (in August 2023), when only two of the 16 sluice gates are open.

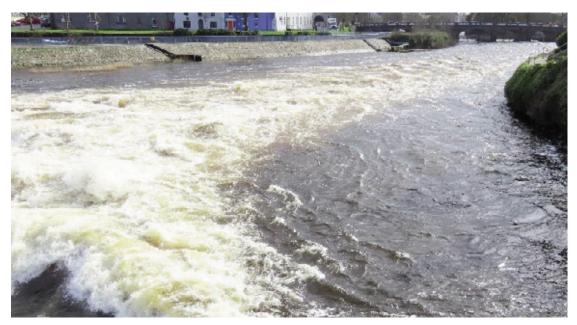
2.4.3 The weir presents a number of hazards for persons on or in the river, and for anyone attempting to rescue a person or object from the river. Downstream of the weir is fast flowing whitewater, with a riverbank that is difficult to access from shore or to egress from the river. See Figure 8.

Figure 8: The whitewater extending downstream from the weir. The Salmon Bridge is in the background, located 250 m downstream from weir.

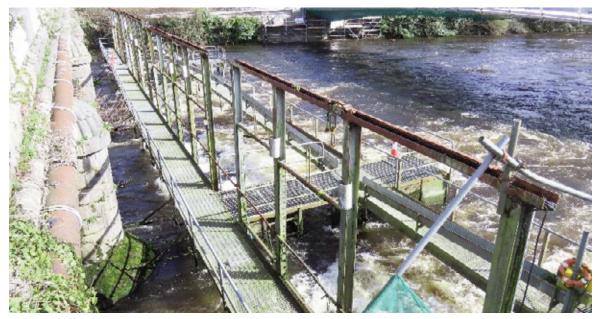
Figure 10: The river-wide obstacle at the Salmon Bridge, viewed from downstream.

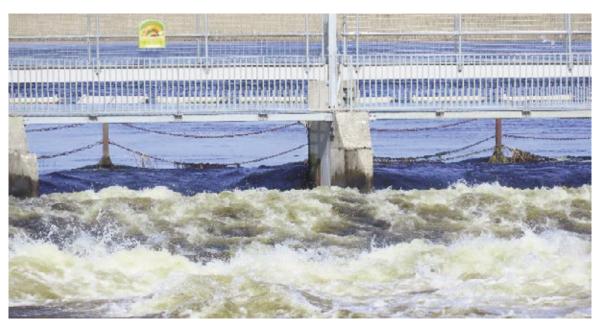
2.4.6 Located immediately above the top of the weir is a series of steel chains on steel poles that act as a final barrier against objects or persons in the water being carried down through the weir. See Figures 11 and 12.

Figure 11: The chain protection, immediately above the Salmon Weir. Viewed from downstream.

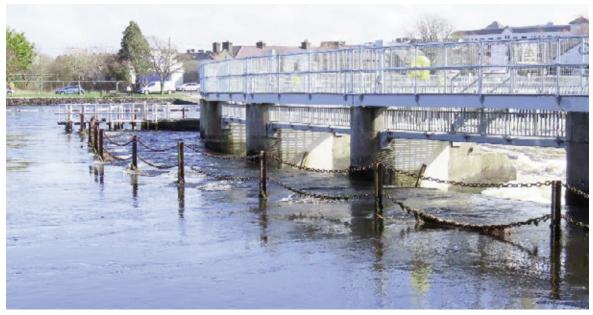
Figure 12: The chain protection, immediately above the Salmon Weir. Viewed from upstream.

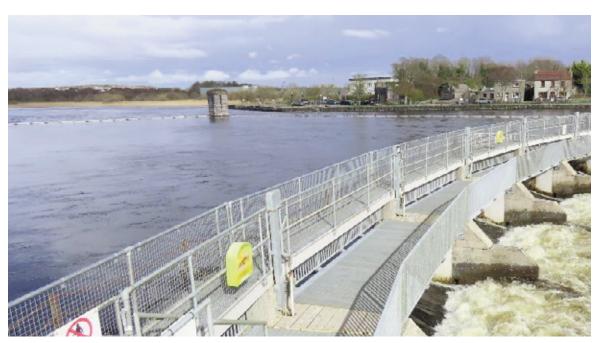
2.4.7 Located 100 m upstream of the weir is a river-wide safety boom formed from steel floats interlinked with steel chains. This had the effect of creating an area of enclosed water above the weir. See Figures 13 and 14.

Figure 13: The enclosed water, extending 100 m upstream from the weir.

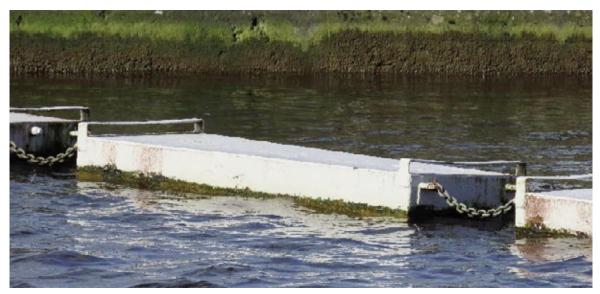
Figure 14: Example of the safety boom in place above the weir.

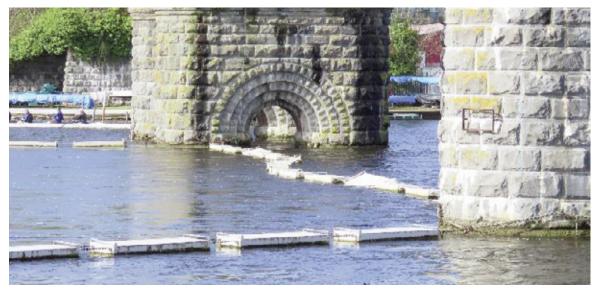
2.4.8 When these safety booms were installed in the 1980s the old railway bridge piers from a defunct Victorian era railway line were utilised as fixings points for the chains/supports for the safety booms. See Figures 15 and 16. As the railway bridge had crossed the river at right angles, the use of the railway bridge piers as the safety booms' anchor points created a physical barrier at right angles to the river. The safety booms are also anchored with chains to the river bed. This arrangement means that the section of safety booms across the middle part of the river are enclosed on both sides by the walls of the bridge piers, and the safety booms have sagged downstream. This means that objects or persons entering onto this part of the safety booms can only progress downstream into the weir or await human extraction back upstream against the flow; they cannot extract themselves. This is the situation that occurred during this casualty event.

Figure 15: The safety boom protection, 100 m upstream from the Salmon Weir.

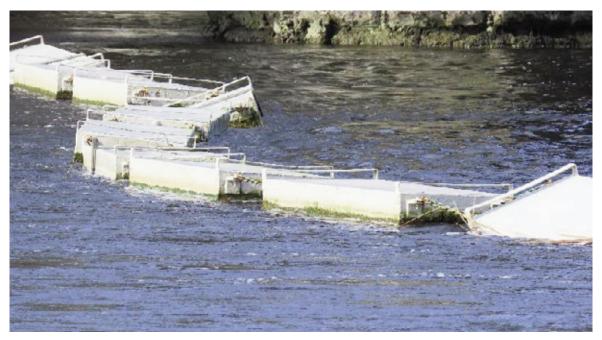
Figure 16: The safety boom protection, 100 m upstream from the Salmon Weir.

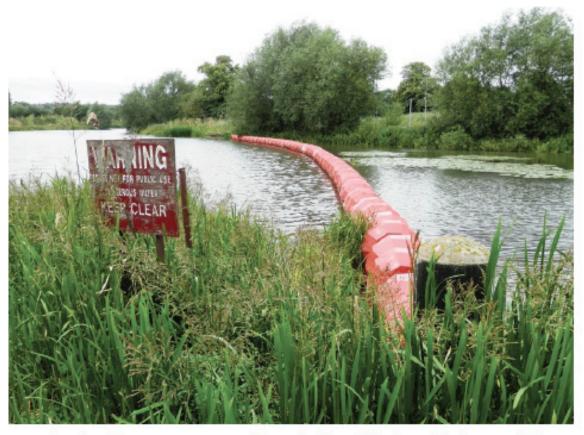
a A safety boom upstream of a weir should be installed at an oblique angle to direct debris towards one bank where it can be removed.

Figure 17: Recommendations relating to the alignment of safety booms relative to the direction of water flow. Source: Figure 10.6a, *River Weirs: Design, Maintenance, Modification and Removal*, Construction Industry Research and Information Association, 2016.

2.4.9 On the subject of physical barriers at a weir, modern authoritative guidance<sup>17</sup> recommends that safety booms are installed at an oblique angle relative to the river's direction of flow, not at right angles. See Figure 17. This guidance states that:

"Safety booms should be provided if there is a risk of boats accessing or overtopping the weir crest. Those designed to restrain loose powered craft can be a dangerous barrier to unpowered craft, particularly in strong stream or spate conditions. Booms also collect debris, which can be dangerous to the public and costly to remove.

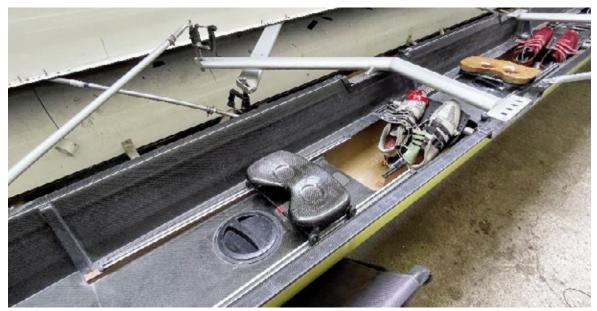
2.6.5 Each rowing position in the boats was fitted with a sliding seat, with fixed footrests comprising fitted shoes having quick release 'Velcro' fasteners. Aluminium outriggers with oar rowlocks were fitted to receive the oars. See Figure 21.

Figure 21: Example of the seating position in a competitive rowing boat, configured for sweep rowing (with only a single oar per rower).

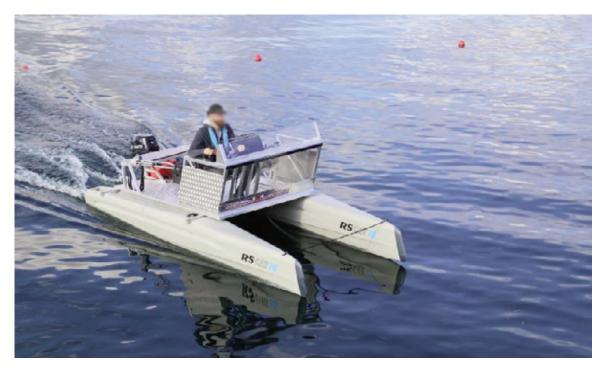
2.7.1 The coach's launch boat that accompanied the crews from the University of Galway Boat Club was a powerboat of catamaran design, powered by an outboard petrol engine, built by Rowing Solutions of the United Kingdom, and known colloquially as a Cat. See Figure 22. This boat type is designed<sup>22</sup> for a maximum of four persons, or a maximum load of 400 kg including occupants. It is marketed for use as a coaching boat for competitive rowing.

Figure 22: Example of the Cat powerboat used by the University of Galway Boat Club's coach during this casualty event. Photo Source: www.rowingsolutions.com

- 2.7.4 Operators of the Cat boats who spoke with the MCIB as part of this investigation all commented on how this boat benefitted from a high seating position and was therefore useful for observing and directing rowing crews under their control; however, the Cat boats lacked the power and manoeuvrability needed to operate as a rescue boat in the conditions presented by the River Corrib upstream of the Salmon Weir. In particular, the boat could not be relied upon to extract either itself or another vessel off the safety booms above the weir. Implicit in that description is the understanding that rowing clubs operating in Galway city were aware that this was a realistic scenario that could be encountered during a rowing session. The MCIB notes that those particular conditions operating as a rescue boat, towing against a strong flow, and extracting a vessel that had grounded or allided<sup>24</sup> are not conditions that a Category D craft has been type-tested to perform in.

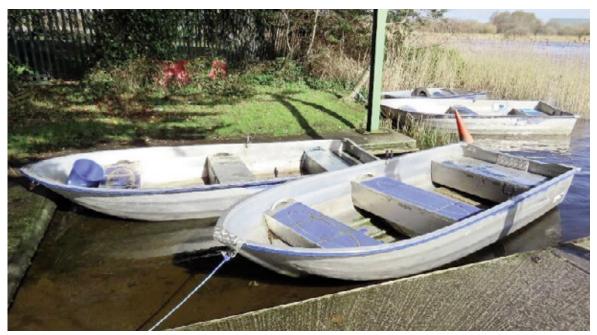
- 2.7.2 The coach's launch boat that accompanied the crews from Coláiste Iognáid Rowing Club was the Sportsman 400, which is an aluminium, flat-hulled powerboat, powered by an outboard petrol engine, made by Linder Boats of Sweden, and known colloquially as a Tinny. See Figure 23. This boat type is designed<sup>23</sup> for a maximum of four persons, or a maximum load of 420 kg including occupants. This is the same design of boat that was being used by the coach of Coláiste Iognáid Rowing Club to oversee that club's rowing activity that took place at the same time as this marine casualty.

- 2.7.3 The Cat and Tinny are also the two primary types of coach's boats operated by the other rowing clubs based in Galway city. Both types of coach's boat have been declared by their manufacturers as Category D vessels in accordance with the EU Recreational Craft Directive, meaning they have been declared as suitable for use in conditions such as winds that do not exceed Beaufort force 4.

Figure 23: Example of the Tinny powerboat that was used by the Coláiste Iognáid Rowing Club coach, and also other club cloaches that assisted in rescuing the crews of University of Galway Boat Club from the weir's safety booms.

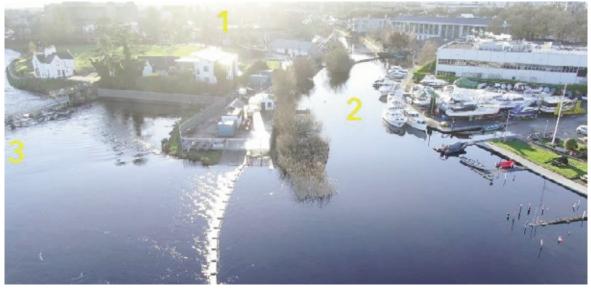
Figure 26: Aerial overview of part of section of river where this casualty event occurred. Image Source: Galway Aerial Cinematography.

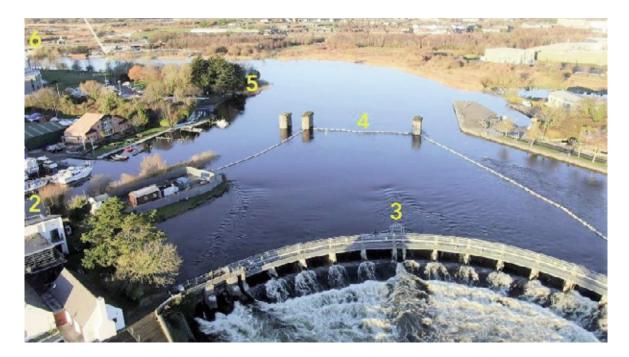
Figure 27: Aerial overview of part of section of river where this casualty event occurred. Viewed looking north, showing: 2. The Eglinton Canal; 3. The Salmon Weir; 4. The weir's safety booms; 5. The Jes corner; 6. Quincentennial Bridge. Note: University of Galway Boat Club's boathouse (1) is out of view, to the south of Eglinton Canal (2). Source: Galway Aerial Cinematography.

- 2.14.4 The initial part of their trip involved the University of Galway Boat Club's crews:
  - Launching from the University of Galway Boat Club's boathouse (1) and progressing in a northerly direction up against the flow on the Eglinton Canal (2).

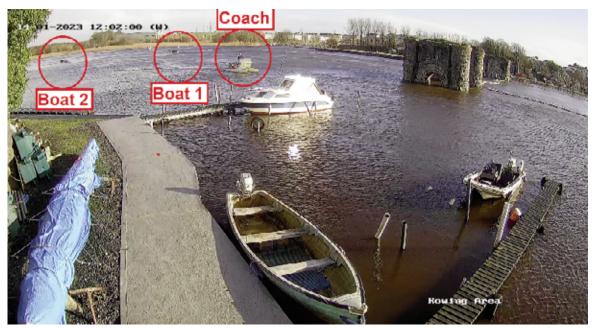
2.14.9 **Time stamp 12:02:00** - The coach's launch boat is ahead of the group, followed by Boat 1 and then Boat 2. The trees in leaf are swaying in the wind. Gusts of wind are visible across the water surface, blowing in a westerly direction (from the bank out across the river towards the opposite side). See Figure 29.

Figure 29: CCTV still image at time stamp 12:02:00, showing the respective positions of the vessels from the University of Galway Boat Club. Source: CRYC

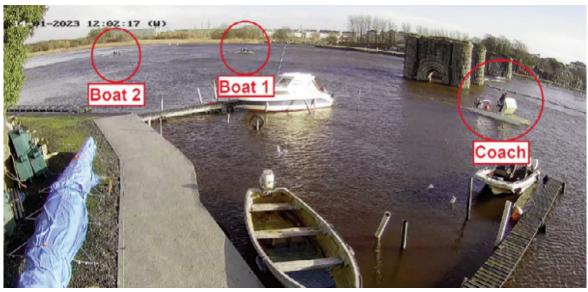
2.14.10 Time stamp 12:02:17 - 17 seconds has elapsed. The coach's launch proceeded downstream of the old railway piers while Boat 1 and Boat 2 continued on their downstream course towards the piers' safety booms. The swaying trees and wind gusts continue. The rowing boats are on a direct course for the safety booms but the crews are not taking effective action to divert their course. See Figure 30.

Figure 30: CCTV still image at time stamp 12:02:07, showing how the coach's launch downstream of the safety booms while the two rowing boats continued on their course towards the safety booms Source: CRYC

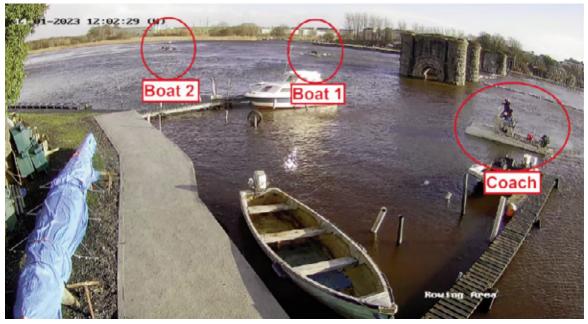
2.14.11 **Time stamp 12:02:29** - A further 12 seconds has elapsed. The coach realised the impending situation and turned her launch boat to progress back upstream. Boat 1 and Boat 2 continued on their downstream course but the crews are not taking effective action to divert their course. See Figure 31.

Figure 31: CCTV still image from time stamp 12:02:29, showing how the coach had realised the impending situation and had turned her launch boat to progress back upstream. Source: CRYC

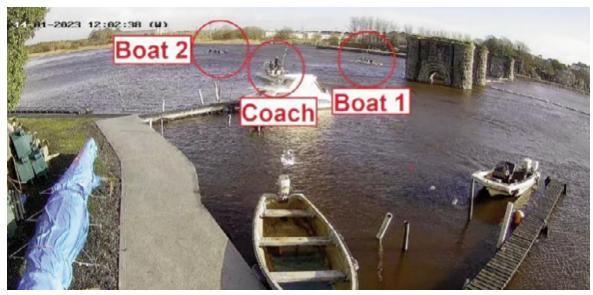
2.14.12 Time stamp 12:02:38 - A further seven seconds has elapsed. The coach has returned to a position upstream of the old railway piers. Boat 1 has started to turn right towards the west bank but has progressed too far downstream to be able to bypass the old railway piers. Boat 2 has continued its downstream course. See Figure 32.

Figure 32: CCTV still image from time stamp 12:02:39. Source: CRYC

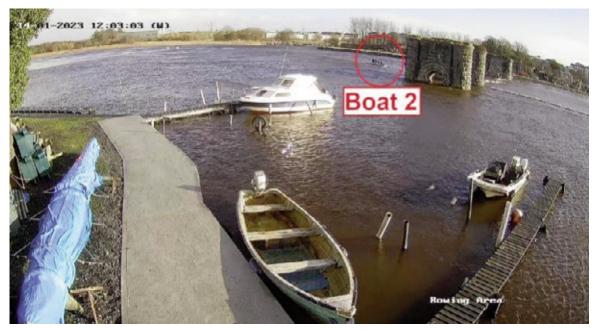
2.14.13 Time stamp 12:03:03 - A further 25 seconds has elapsed. Boat 1 has passed behind the old railway piers and is about to imminently allide with the safety booms, out of camera view. The coach has approached Boat 1 but starts to turn to manoeuvre back upstream. Boat 2 has continued its downstream course and has started to turn right towards the west bank but has progressed too far downstream to be able to bypass the old railway piers. See Figure 33.

Figure 33: CCTV still image from time stamp 12:03:03. Source: CRYC

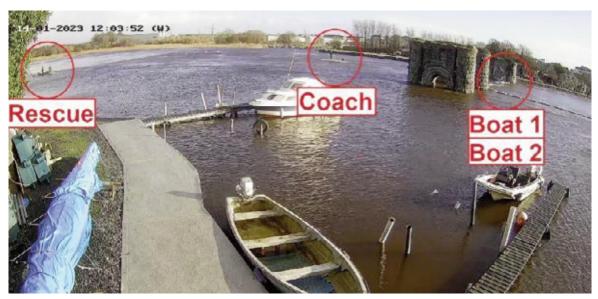
2.14.14 Time stamp 12:03:52 - A further 49 seconds has elapsed. Boat 1 and Boat 2 have allided with the safety booms. The coach's boat remains in a holding position upstream of the old railway piers. A launch boat containing two persons motors towards the scene from the direction of Coláiste Iognáid Rowing Club to start the process of removing crews to shore. The wind gusts continue. See Figure 34.

Figure 34: CCTV still image from time stamp 12:03:52. Source: CRYC

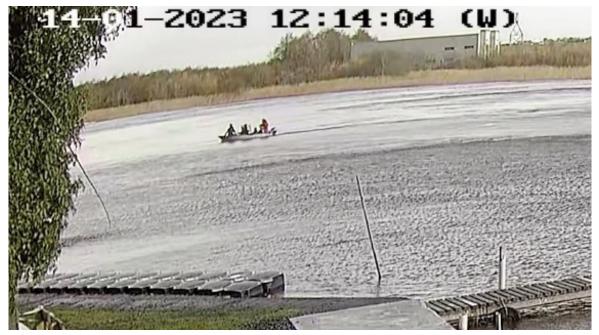
2.14.16 Time stamp 12:14:04 - 12 minutes four seconds has elapsed. The coach's launch boat remains in a holding position upstream of the old railway piers. The wind gusts continue. The rescue of the crews by two Tinny launch boats continues, as they take some of the rescued crews towards Coláiste Iognáid Rowing Club. The coach's Tinny boat from the Coláiste Iognáid Rowing Club, containing the crew from the capsized Octuple, arrives from upstream along the east bank and motors across the river back towards their clubhouse. See Figure 36.

Figure 36: CCTV still image from time stamp 12:14:04. Source: CRYC

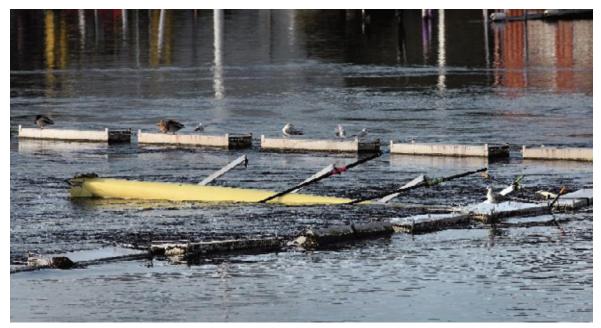
Figure 38: Part of Boat 1 on the safety booms above the weir. Source: Joe Shaughnessy/Connacht Tribune

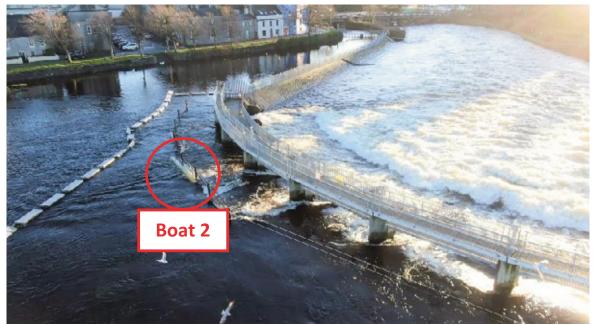
Figure 39: Boat 2 on the chains immediately above the weir. Source: Galway Aerial Cinematography

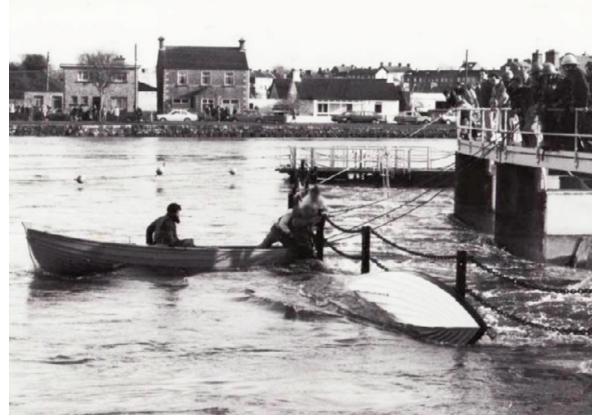
• 41 years ago, in November 1982<sup>38</sup>, before the safety booms were in place above the weir, a rowing boat capsized in strong winds and high flow near the old railway pillars. The crew and boat drifted onto the safety chains immediately above the weir. See Figures 41 and 42. Two coach's boats that were effecting rescue then capsized, resulting in a total of 12 persons in the water. All were eventually saved after being rescued. This incident led to the installation of the safety booms that are currently in place above the weir.

Figure 41: The November 1982 incident. Source: Rowing Ireland Connaught Branch

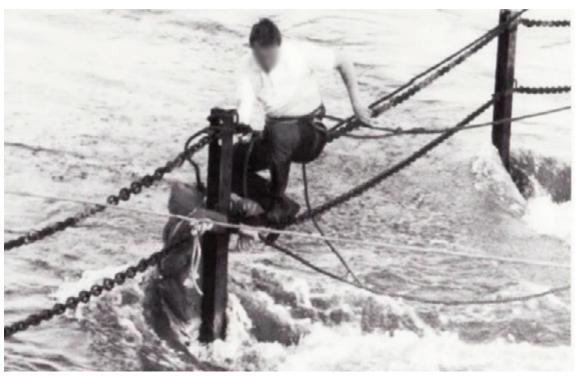
Figure 42: The November 1982 incident. Source: Rowing Ireland Connaught Branch
