**REPORT OF AN INVESTIGATION
INTO A MARINE CASUALTY
INVOLVING A
RECREATIONAL VESSEL
IN OR AROUND NIMMOS PIER,
GALWAY HARBOUR,
CO. GALWAY
ON OR ABOUT
25 AUGUST 2023**

**REPORT NO. MCIB/330
(No.2 OF 2025)**

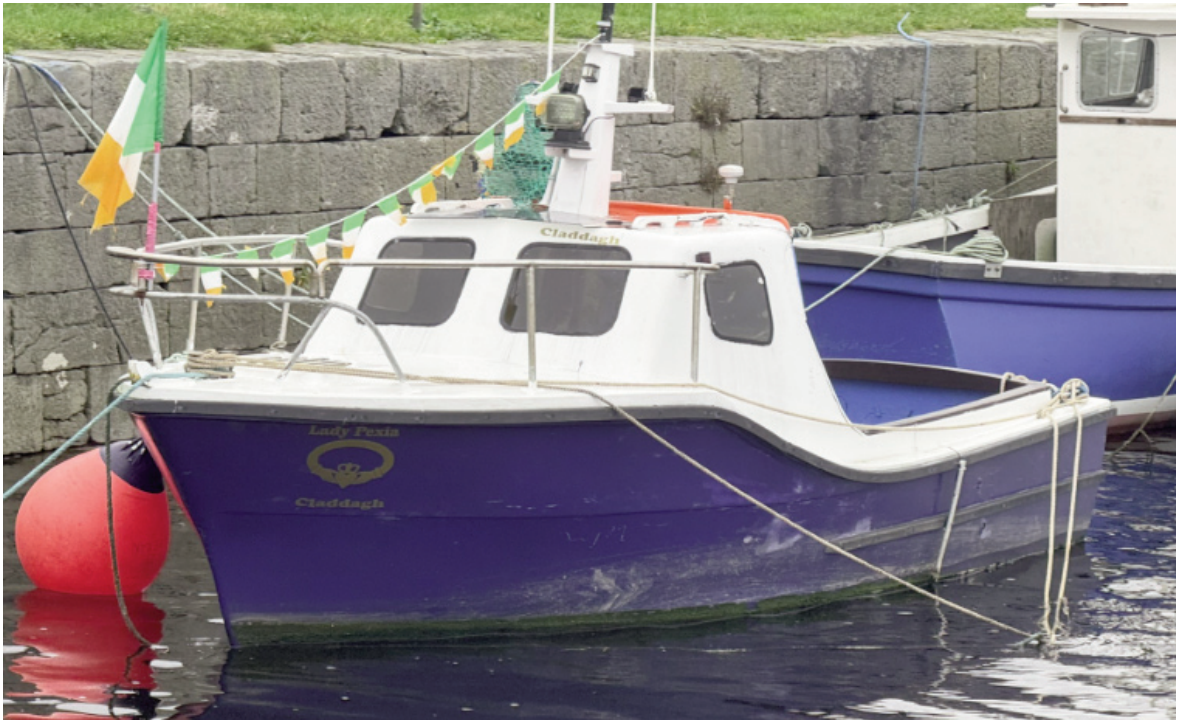
Photograph No. 1: Recreational boat Lady Pexia.

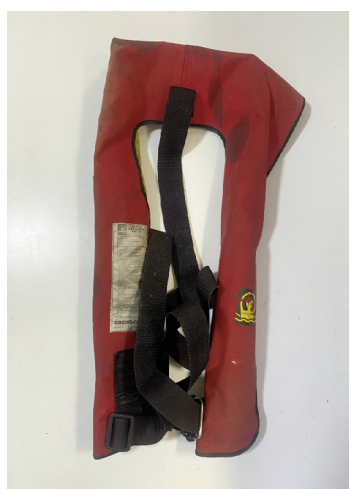
- 2.4.2 The PFD allocated to the Casualty was a Crewsaver brand Crewfit inflatable PFD. The Casualty’s PFD was inspected by the MCIB on 16 May 2024 and found to be in poor condition and would not have inflated. The PFD was fitted with a whistle and a manual inflation activation device, and oral inflation tube. There was no light present.

Photograph No. 4: The external condition of the Casualty’s PFD.

- 4.5.3 During an inspection conducted by the MCIB in May 2024, the Casualty's PFD was found to be in poor condition, with an empty CO2 cylinder - an indicator of prior activation or accidental deployment without subsequent servicing. The state of the PFD suggests that it had not been properly inspected before use, compromising its ability to function effectively in an emergency.

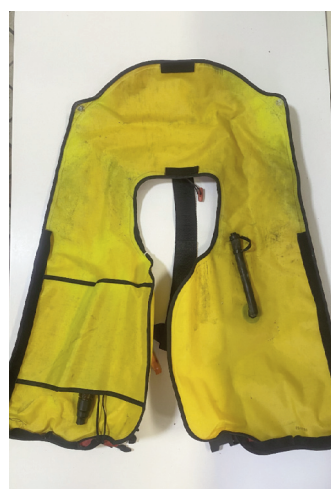
Photograph No. 5: Internal condition of the Casualty’s PFD on inspection.

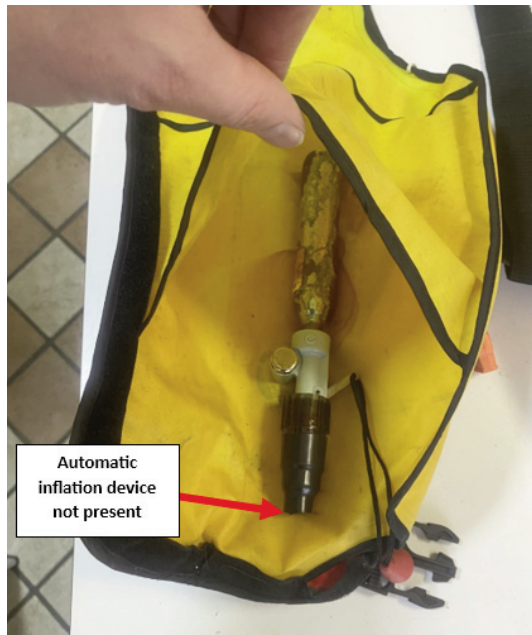
Photograph No. 6: Showing the condition of the PFD inflation device.

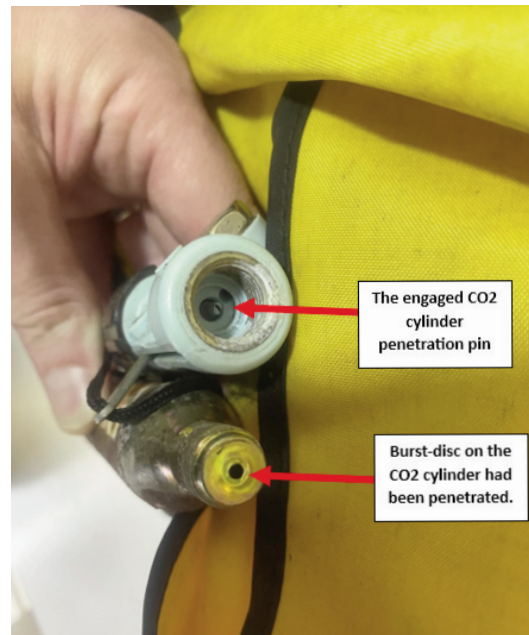
- 2.4.3 The carbon dioxide cylinder that should have contained the PFD inflating gas was empty with evidence showing that the PFD had previously been inflated.

Photograph No. 7: The Casualty's PFD showing the discharged CO2 cylinder.

- 4.5.4 This condition underscores the necessity for routine maintenance and compliance with safety regulations, which mandate that PFDs be inspected and maintained to ensure their readiness. The absence of a charged CO2 cylinder and any sign of recent servicing greatly diminished the PFD's operational effectiveness, ultimately impacting its ability to function as a lifesaving device.

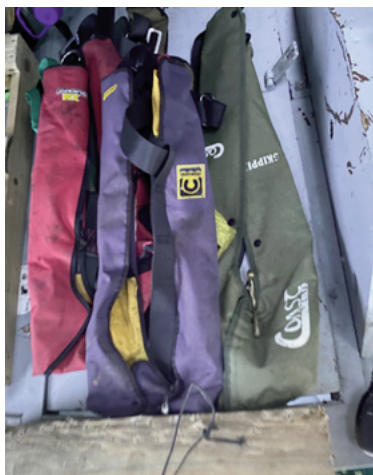
2.4.4 During the MCIB's inspection of the boat conducted 30 October 2023, three of four PFDs were observed onboard in poor condition. Closer inspection of one PFD revealed that its inflating device was 18 years past its service-by date. The PFD worn by the Skipper at the time of the inspection appeared in reasonable condition, and the Skipper informed the MCIB that his PFD was in date and had been recently serviced. This PFD was not inspected by the MCIB. The Skipper advised that he had disposed of the lifejacket that was past its service date.

Photograph No. 8: Three PFDs
observed onboard.

2.4.5 The Skipper advised that the other two defective PFDs were subsequently removed from service and replaced.

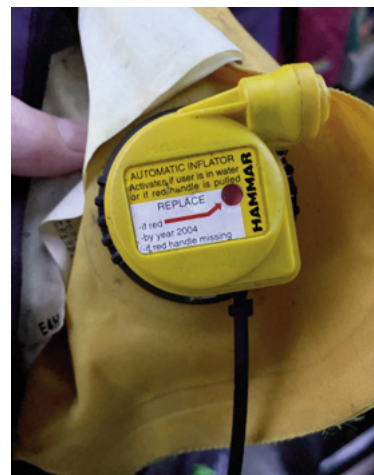
Photograph No. 9: Three of the four onboard PFDs in poor condition with one of the activation units over 18 years out of service.
