**REPORT INTO AN INCIDENT
INVOLVING THE
'FV DILLON OWEN'
OFF ARDGLASS HARBOUR
23rd OCTOBER 2019**

**REPORT NO. MCIB/295
(No.5 OF 2020)**

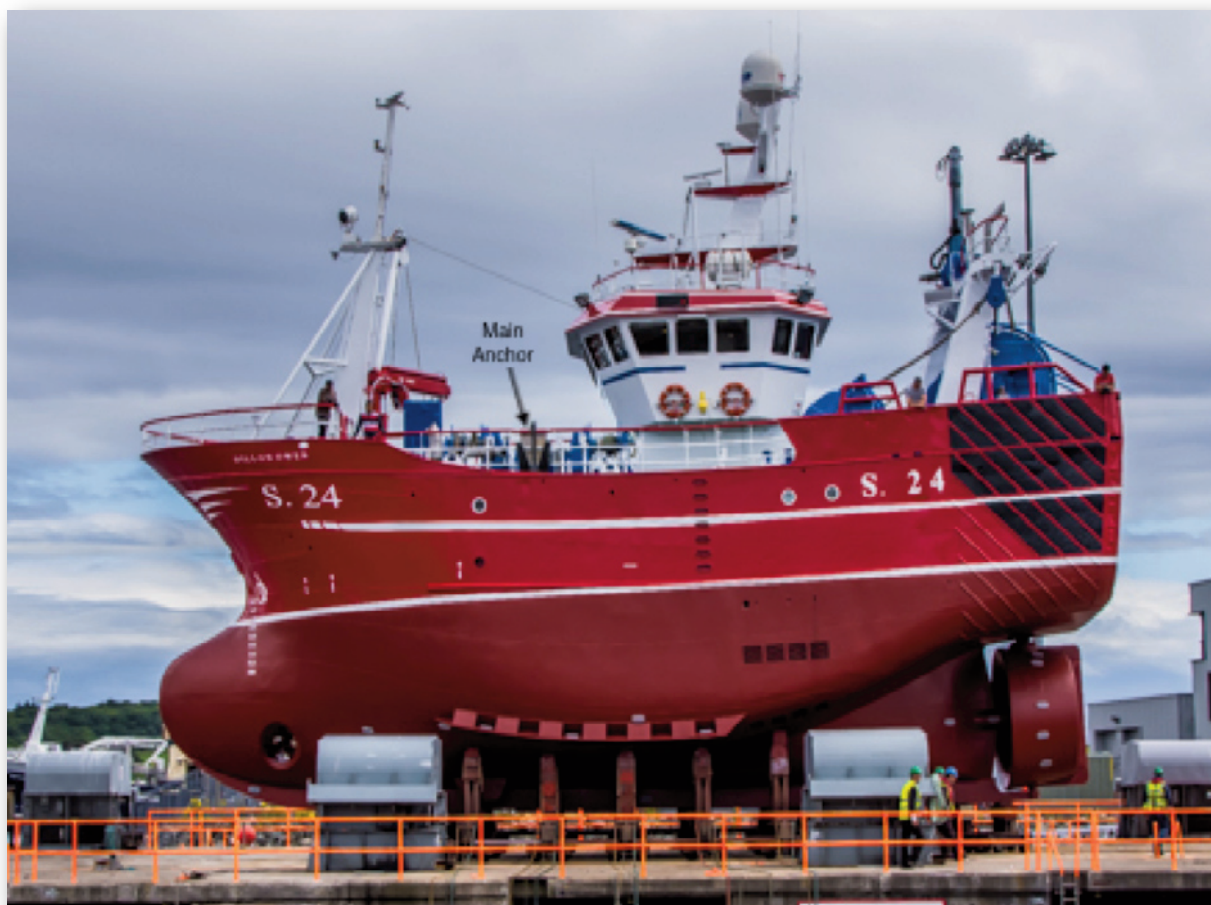
(see Appendix 7.1 Photographs No 1, No.2. & No.6).

Photograph No.1 - 'FV Dillon Owen'.

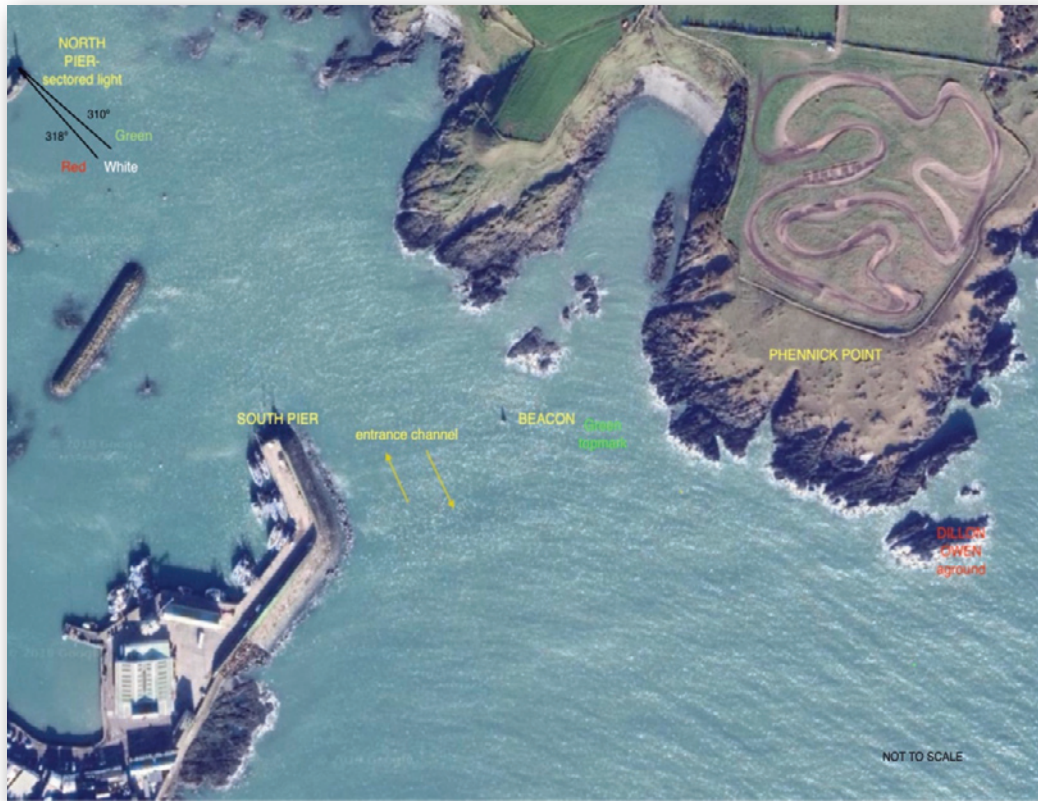
(see Appendix 7.3 Ardglass Harbour and approaches. Fig.3 and Fig.4).

Fig.3. Ardglass Harbour and Approaches (satellite image).

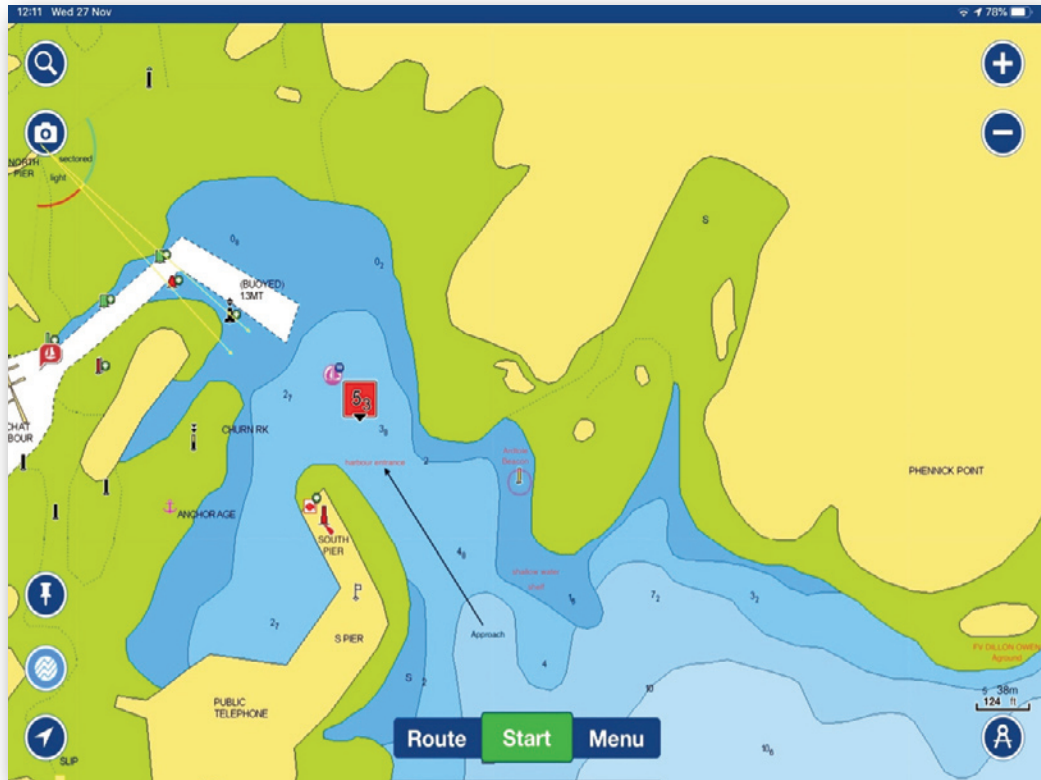
(see Appendix 7.3. Fig.4 Ardglass Harbour and Approaches (chart) and Fig.5 'FV Dillon Owen' - AIS track.)

Fig.4. Ardglass Harbour and Approaches (chart).

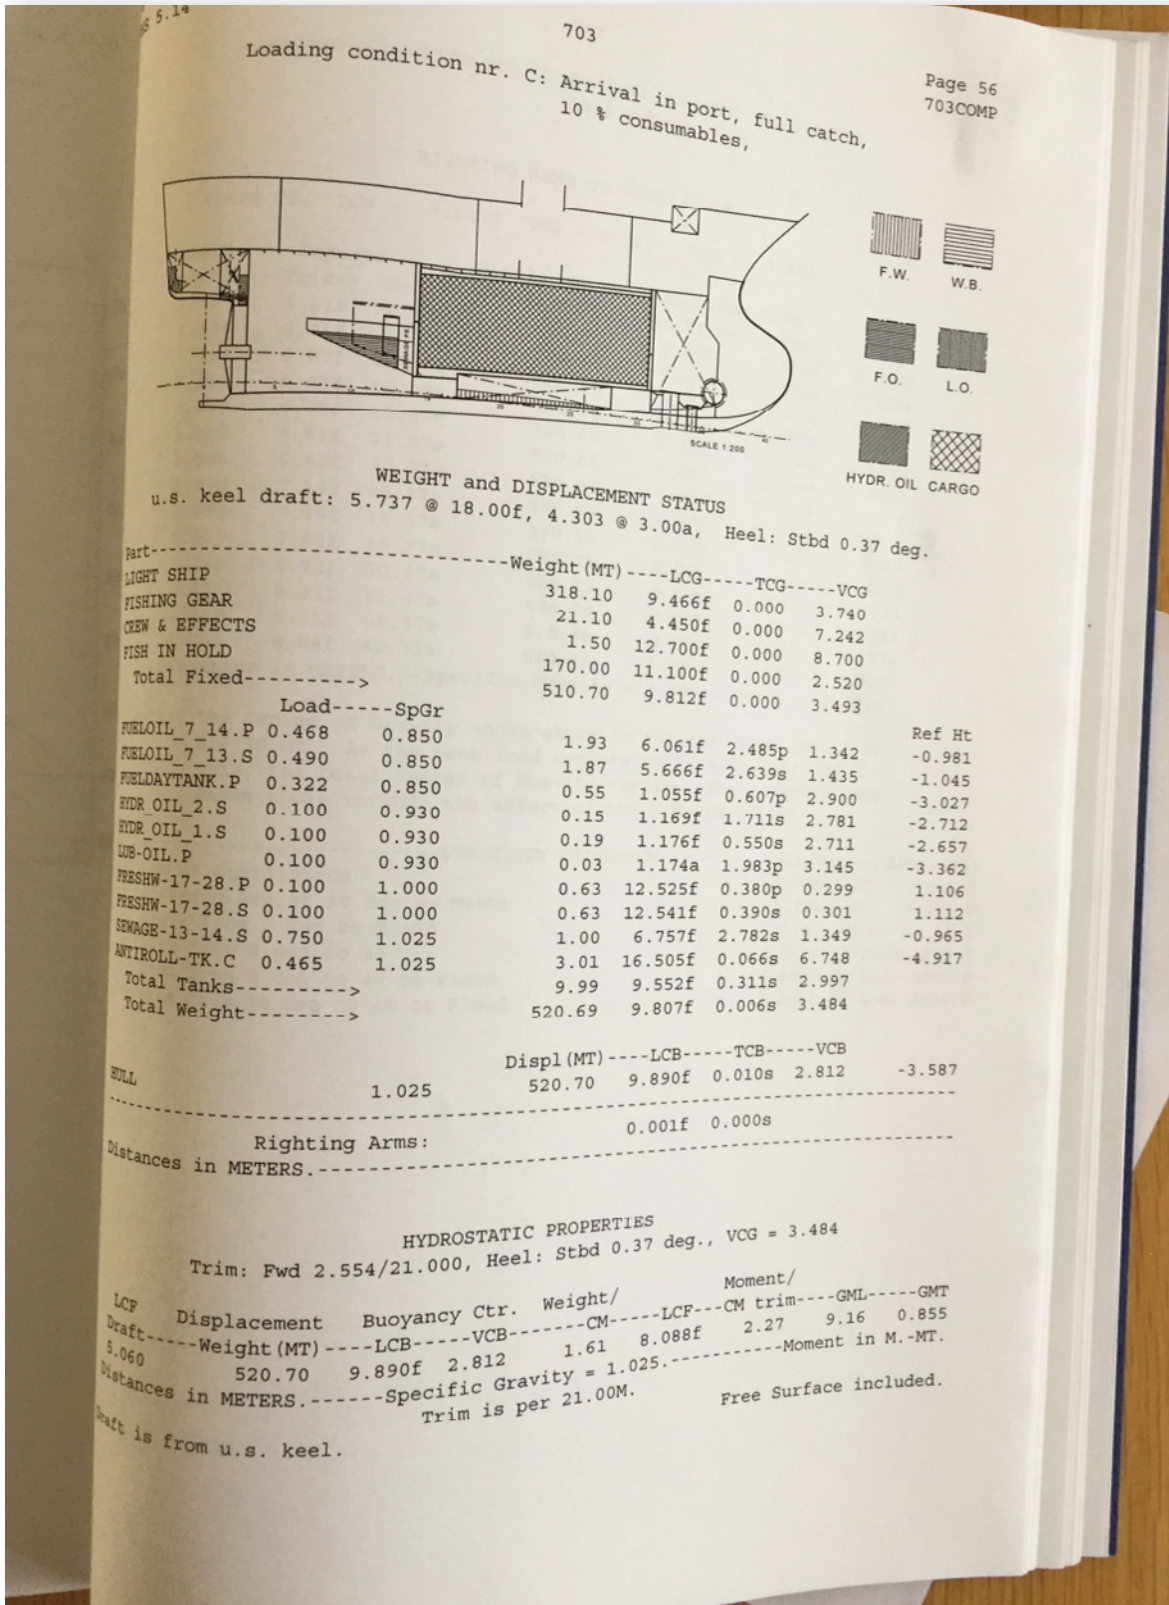
(see Appendix 7.6 Stability Notes - 'FV Dillon Owen'. Fig.10 and Fig.11).

Fig. 10. Estimated stability condition at arrival Ardglass.
