**REPORT INTO
A FATAL INCIDENT
INVOLVING THE VESSEL
'TOMMY R'
IN DUNMANUS BAY,
WEST CORK,
9th OCTOBER 2019**

**REPORT NO. MCIB/294
(No.8 OF 2020)**

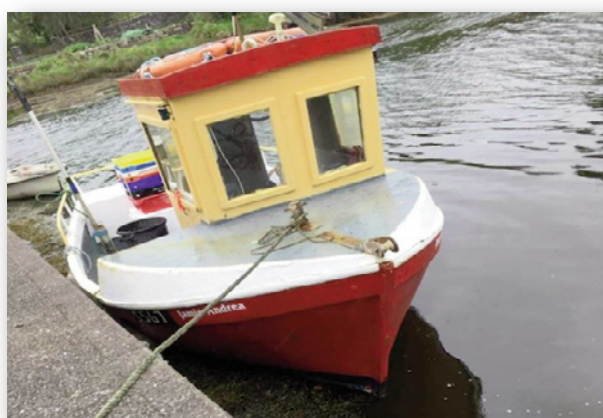
Photograph No.3 - *'FV Jamie Andrea'* S.567.

- 2.1.1 The boat *Tommy R* was previously a fishing vessel named the *FV Jamie Andrea*, registered number S.567 (see Appendix 7.2 Photograph No.3 *FV Jamie Andrea* S.567).

3.1.1 The *'Tommy R'* was previously named the *'FV Jamie Andrea'* S.567 and operated as a commercial fishing boat from 2014 up to August 2017 (see Appendix 7.2 Photograph No.3).

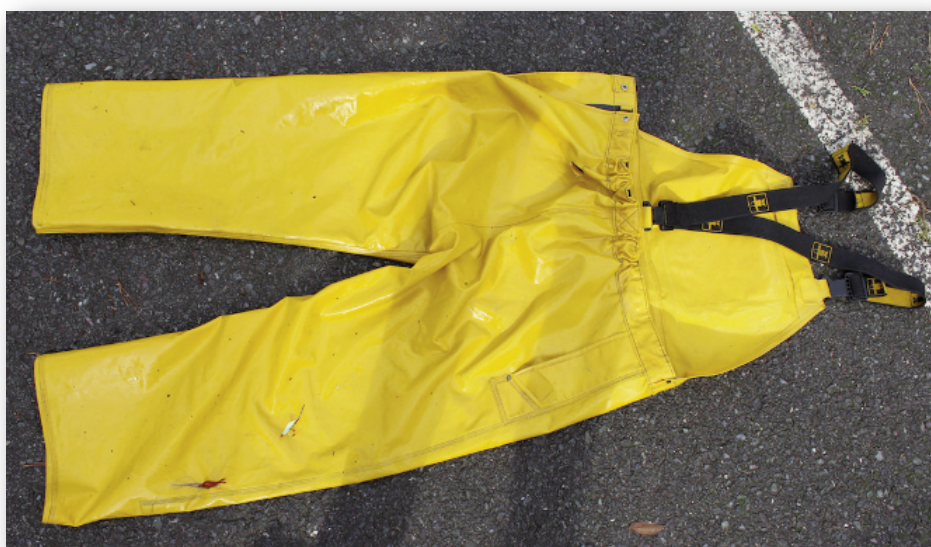
Photograph No.5 - Yellow leggings with fish lures attached.

(See Appendix 7.1
Photograph No.4 - Pollock Diveboard.
Photograph No.5 - Fishing board with mackerel lures.)

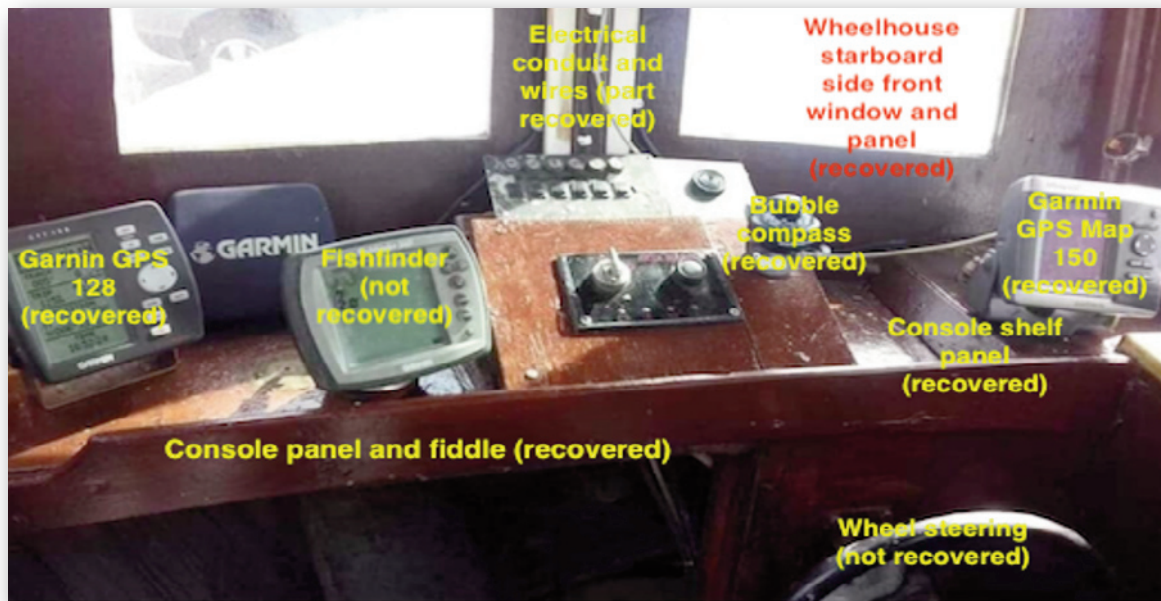
Photograph No.9 - Wheelhouse console.

sale. A list of items sold with the boat is not available but photographic evidence, witness reports and items in the wreckage identified as being part of the 'Tommy R' indicate the type and scale of navigation equipment provided with the boat when sold in 2019 (see Appendix 7.2 Photograph No.9 - Wheelhouse console).

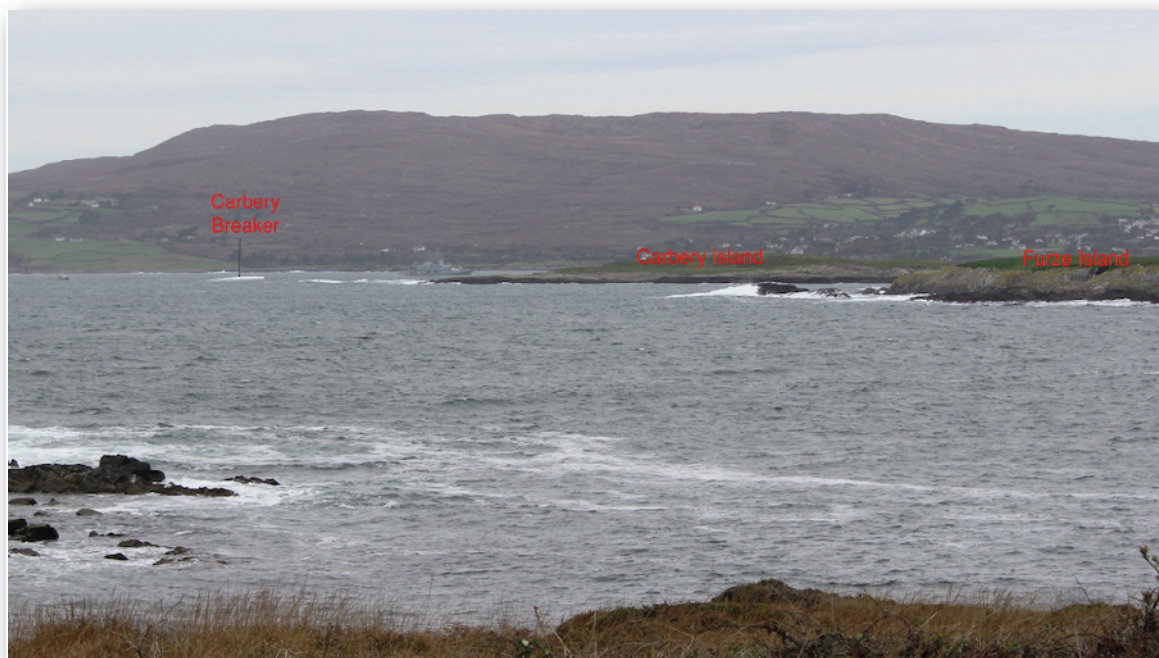
Photograph No.10 - Carbery Island and Breaker - 11th October.

(See Appendix 7.1 Chart 3. Satellite image - Wreckage Plume.
Appendix 7.2 Photograph No.10, Carbery Island and Breaker, 11th October.
Appendix 7.4 Chart 4. Diver searches 12th and 13th October.
Appendix 7.4 Chart 5. Satellite image - Diver search boat track and body location - 13th October.)

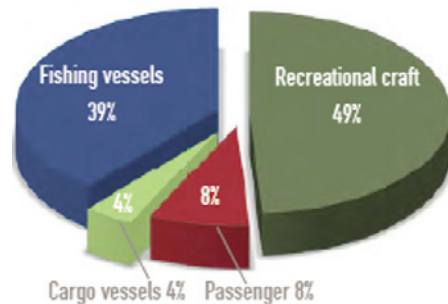
Figure 2: Percentages of maritime fatalities arising by vessel type

- Figure 2, Section 2 showed that the vessel categories most at risk in relation to fatalities are recreational craft which amounted to 49% of the total number of fatalities onboard Irish vessels.
