**REPORT OF THE  
INVESTIGATION INTO THE  
FAILURE OF THE PILOT  
LADDER FROM THE  
M.V. "ALEXIA"**

Published by The Marine Casualty Investigation Board  
18th April 2005

**EXAMINATION, SAMPLING AND TESTING BY  
REALISATION METHOD TO DETERMINE ROPE  
RESIDUAL STRENGTH AND LIKELY CAUSE OF  
FAILURE of PILOT'S LADDER from  
'MV ALEXIA'**

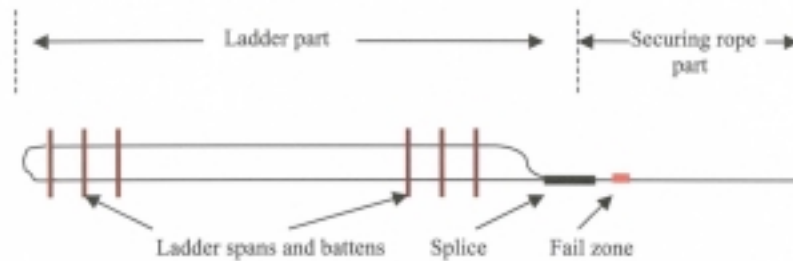
**Figure 1 Sketch of side view of ladder [representation only]**

Photos 1 –5 are photographs of the ladder supplied by DepCMNR. From these photographs and subsequent inspection by TTI, the ladder was found to have failed just above the splices in both legs.

The ladder is formed from two legs of rope [TTI-named Leg A and Leg B], each of which threaded through the ladder spans and battens, doubled back [ threaded again] and spliced to itself about 1000 mm above the uppermost span.

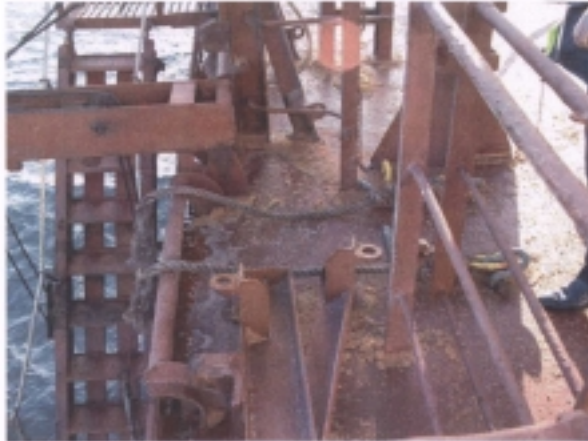
**Photo 2 Securing rope parts in situ**

Photograph 2 shows the securing rope parts in situ. It is assumed the photograph shows the attachment to the deck shackles at the time of the accident, and is not a reconstruction.

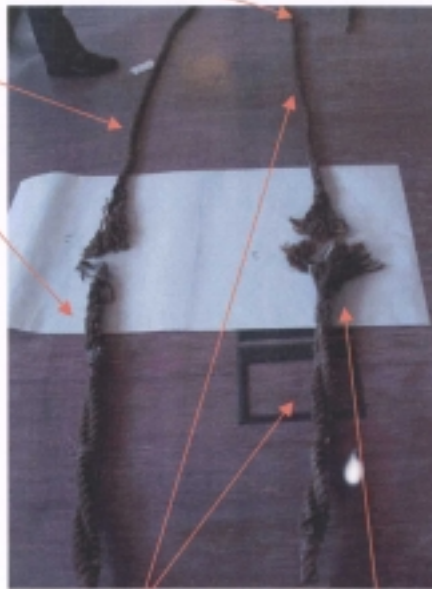
Leg B

Marker yarn

Leg A

Unravelled splice

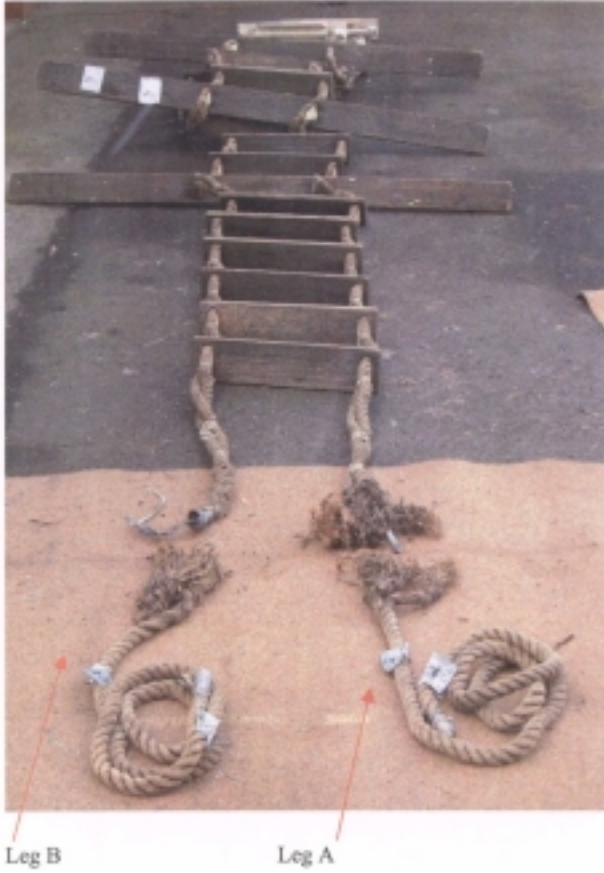
**Photo 6 General view of ladder as received.**

The following photographs are TTI photographs. Photo 6 shows a general view of the entire ladder assembly.

Leg B

Leg A

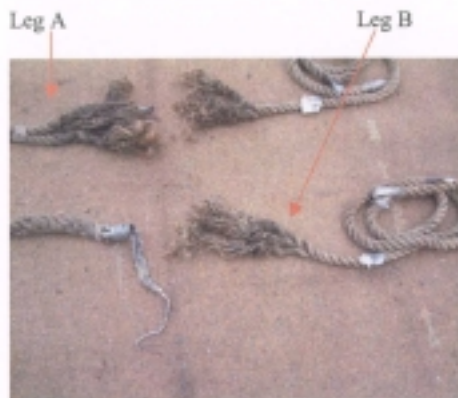
**Photo 7**

Photograph 7 shows the labelling of the securing rope parts.

As an editorial matter, it appears that the rope pieces, shown in photo No.7, are incorrectly identified. Leg A should refer to the top R.H.S. and not top L.H.S. of photos shown.

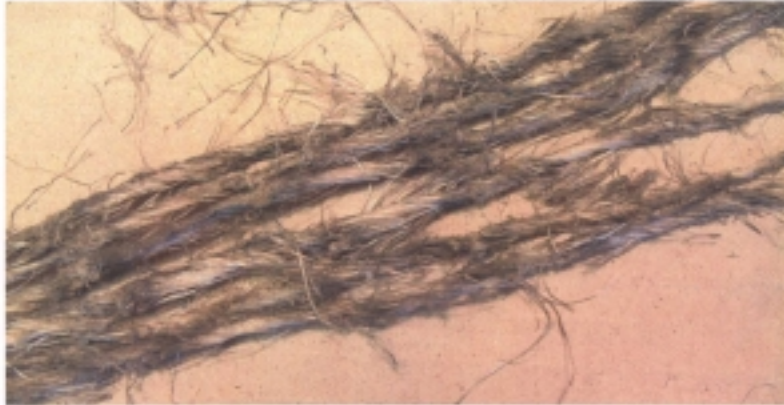
**Photo 13 Outer rope yarns**

Photograph 12 shows a strand from Item A opened out to reveal its constituent inner and outer rope yarns. Abrasion damage can be seen to the outer yarns, whilst the inner yarns are in relatively good condition. The amount of loose fibre released during the investigation is further evidence of the degree of damage suffered by the outer rope yarns.

Photograph 13 is a closer view of the outer yarns, and Photograph 14 is a closer view of the inner yarns

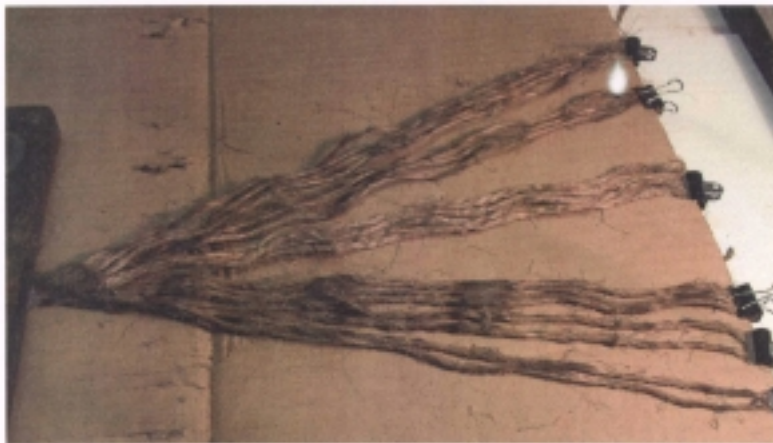
**Photo 16 General view of unwound strand from ladder part Item A'**

Photograph 15 shows the rope, and Photograph 16 shows an unwound strand from the rope.

Damage to the outer yarns is again clearly seen, as is the relatively better condition of the inner yarns.

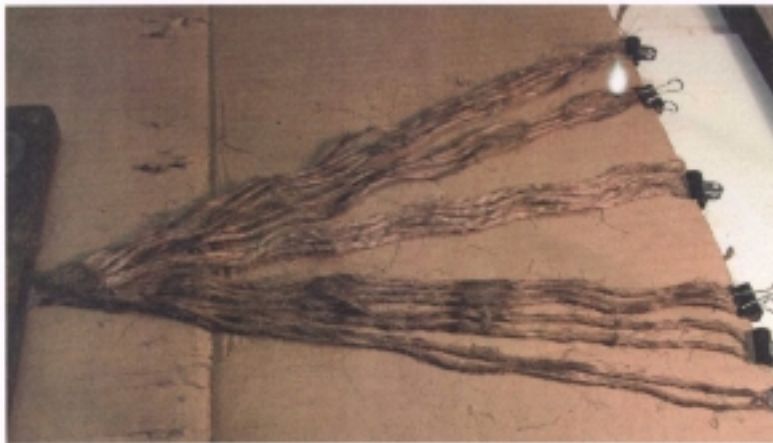
**Photo 16 General view of unwound strand from ladder part Item A'**

Damage to the outer yarns is again clearly seen, as is the relatively better condition of the inner yarns.

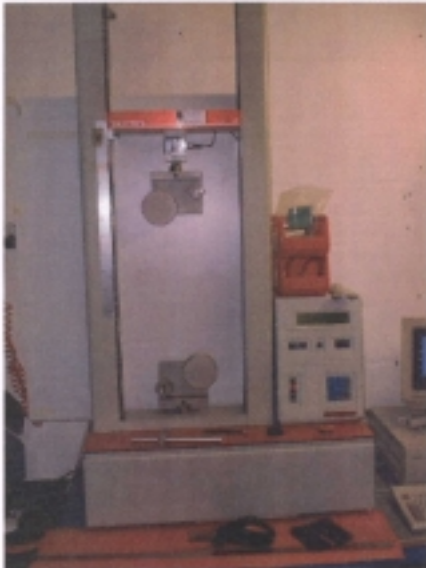
**Photograph 1 Bollard grips used for tensile testing**

Photo 8 shows the tensile testing instrument used to perform the tests. Bollard grips were used to clamp the samples.

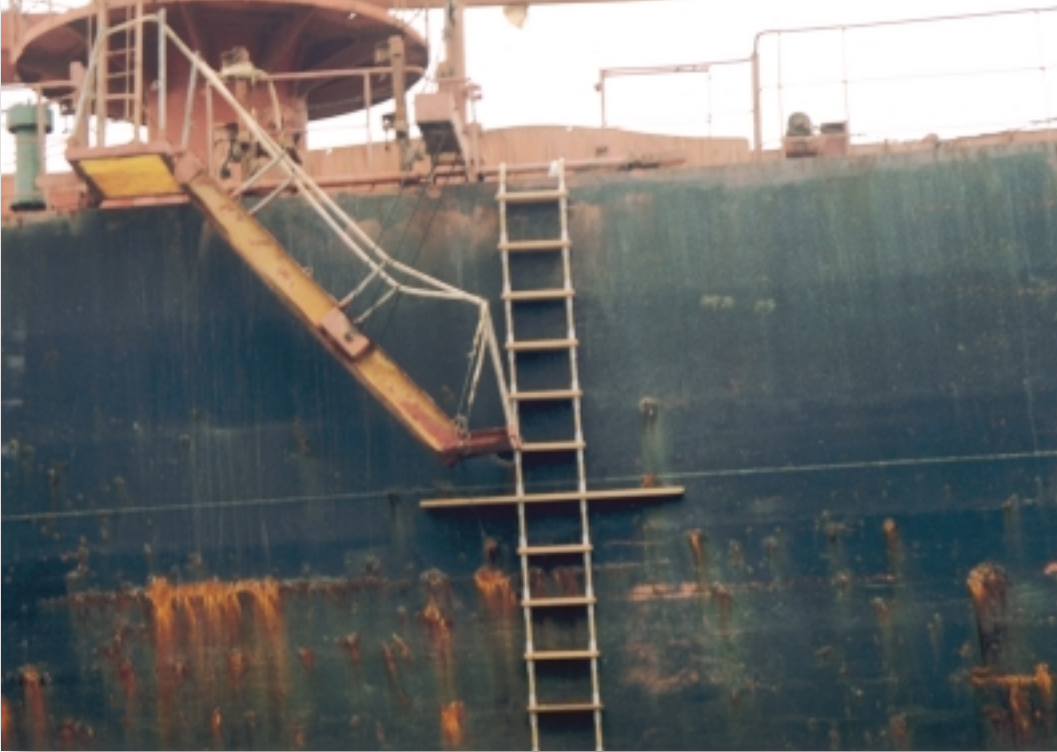
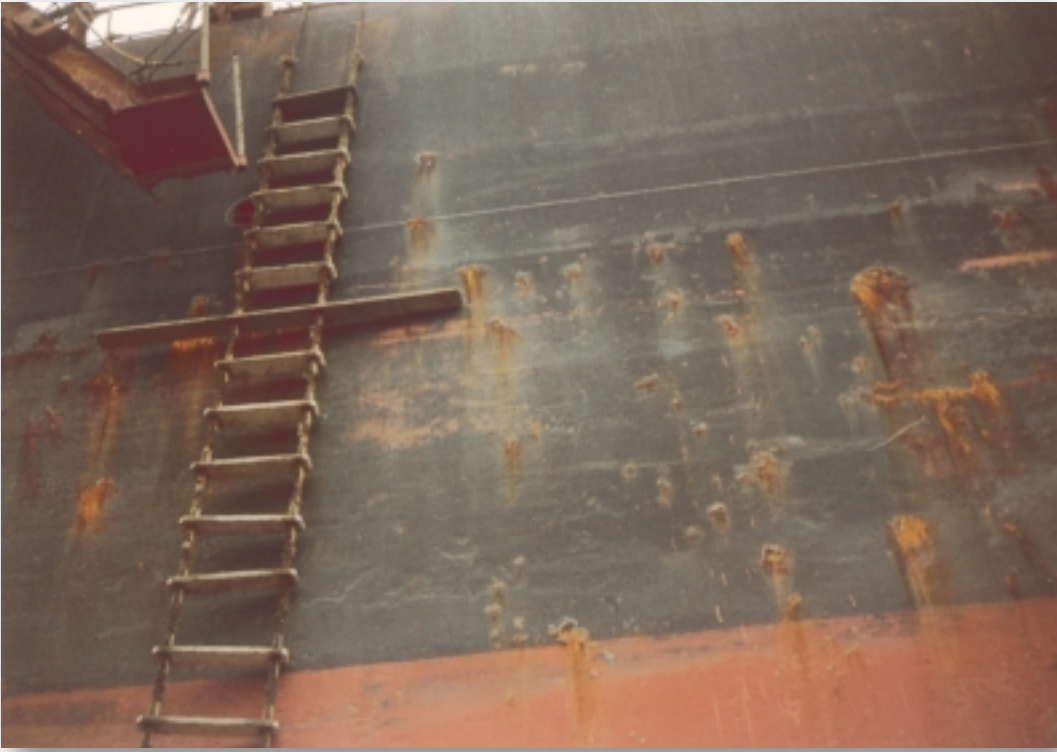
- 3.13 The weather at this time was South Westerly force 6.
- 3.14 An officer accompanied the pilot to the main deck.
- 3.15 The crew of the M/V "Alexia" had rigged a combination ladder (Pilot ladder in combination with a accommodation ladder) for the pilot to disembark on the port side. (See Photographs 1,2 and 3 at Appendix 8.4).

1 and 2. Combination Pilot Ladder arrangement "M/V Alexia".

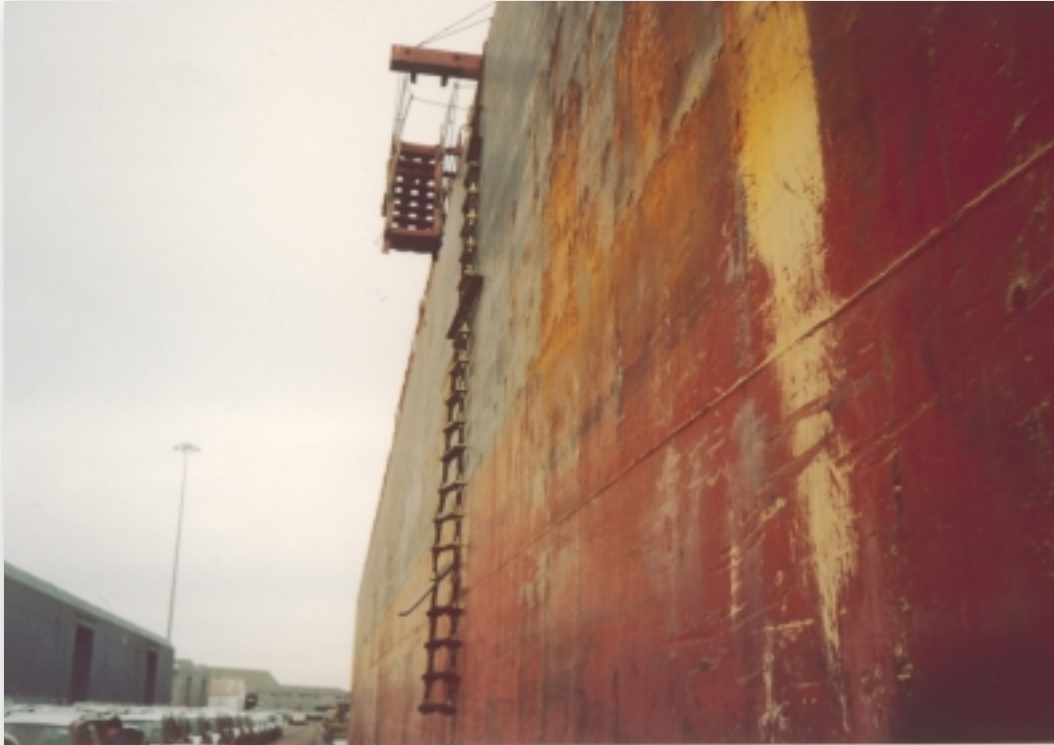
3. Port side M/V "Alexia" showing combination pilot ladder (takes from quay wall).

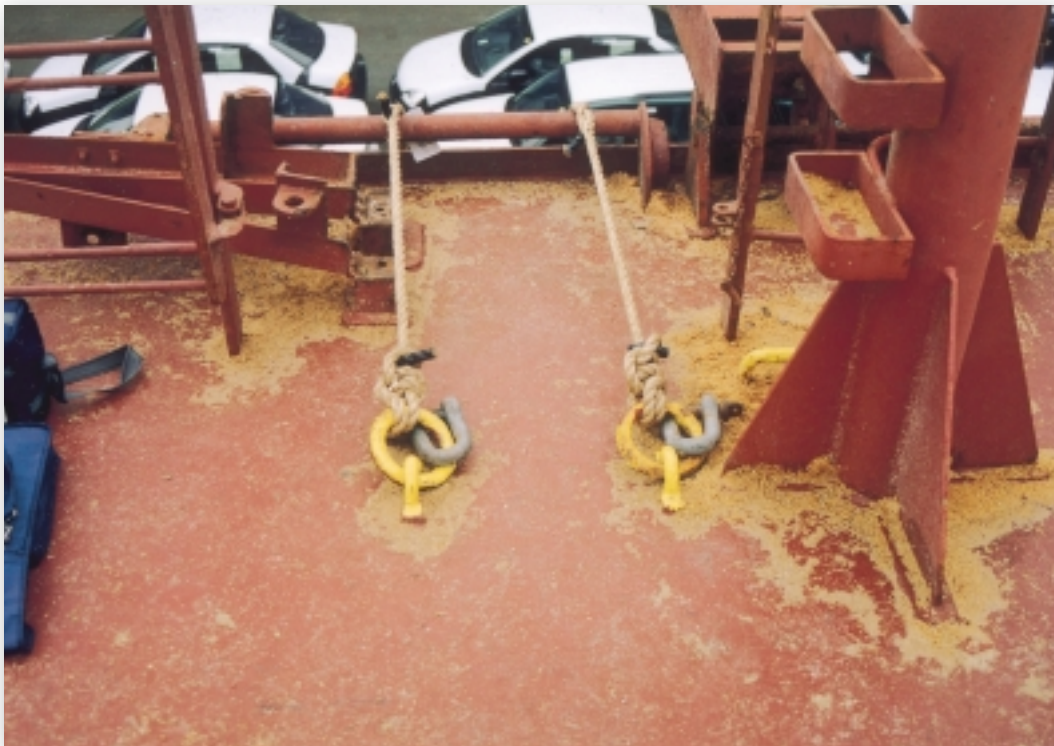
4. Port side M/V "Alexia" showing method of securing pilot ladder.

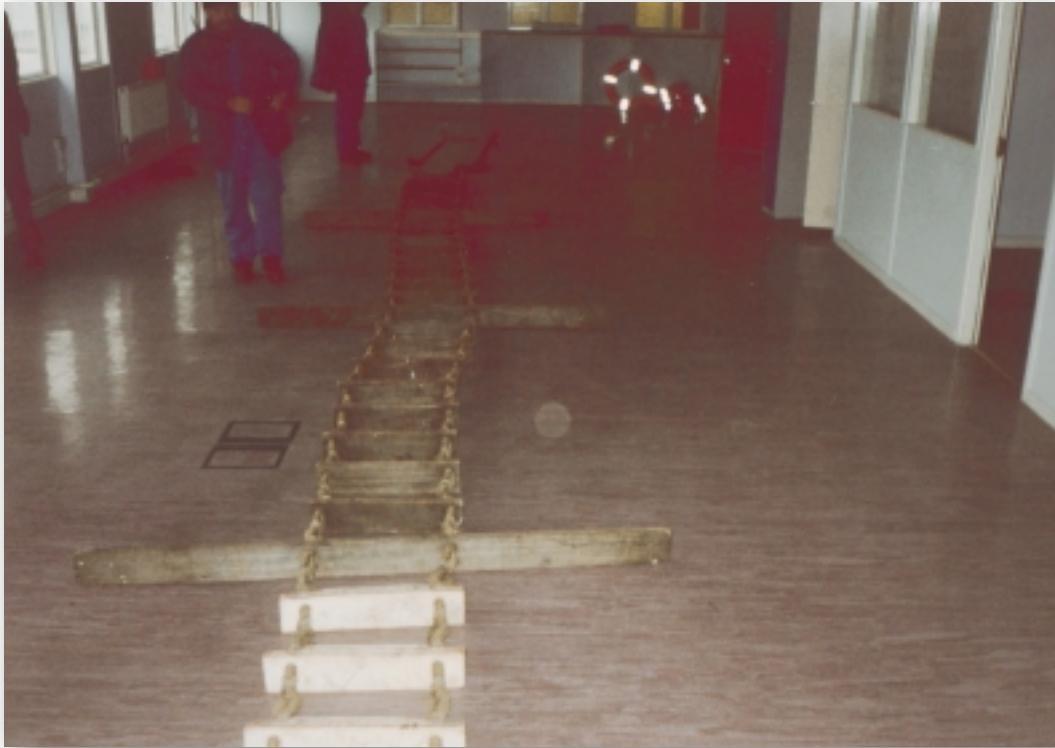
5. Crew of M/V "Alexia" identifying pilot ladder at Dublin Port office.

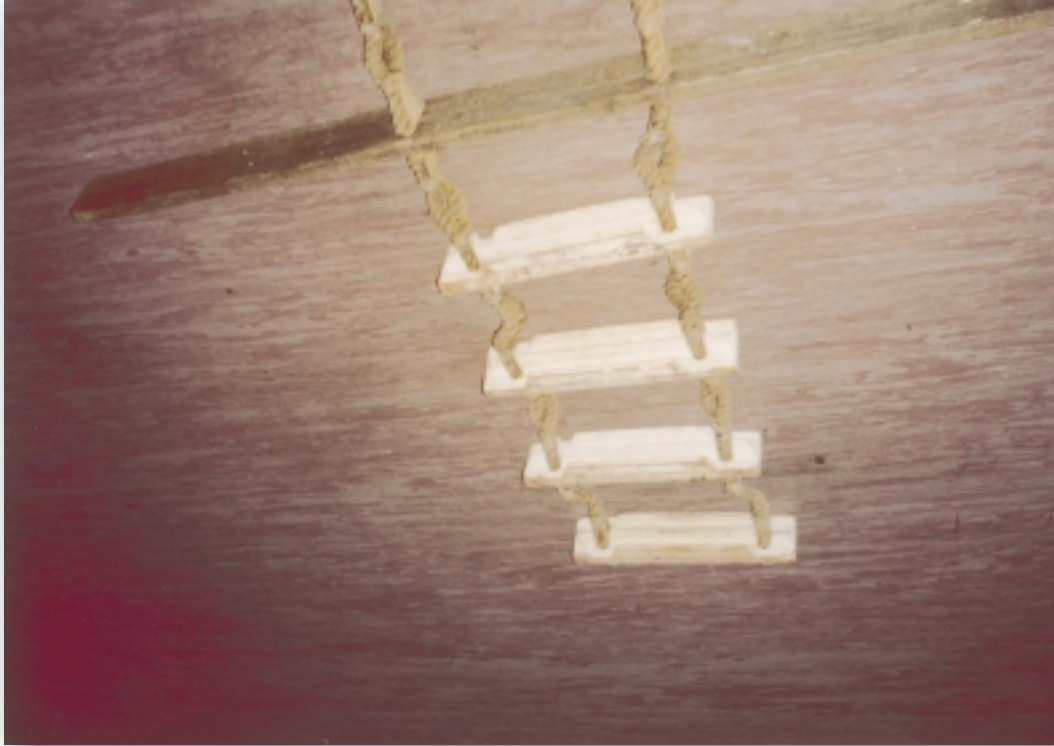
8, 9, 10, 11. Bottom section of pilot ladder from M/V "Alexia".

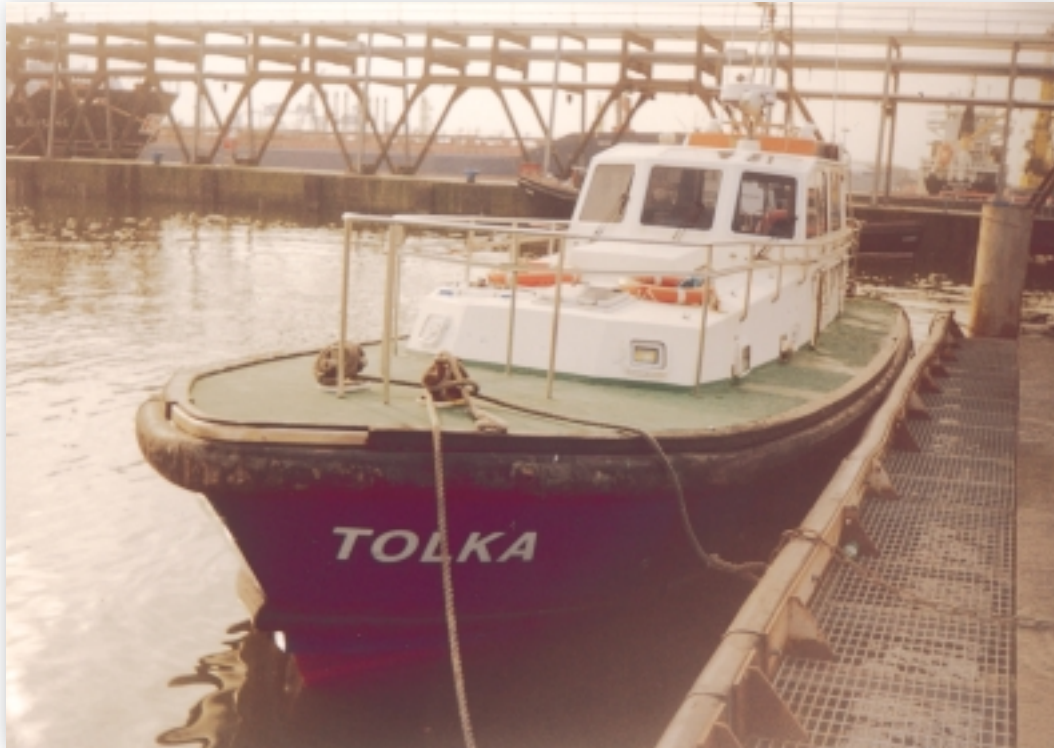
12. Tolka (Dublin Pilot No. 1)

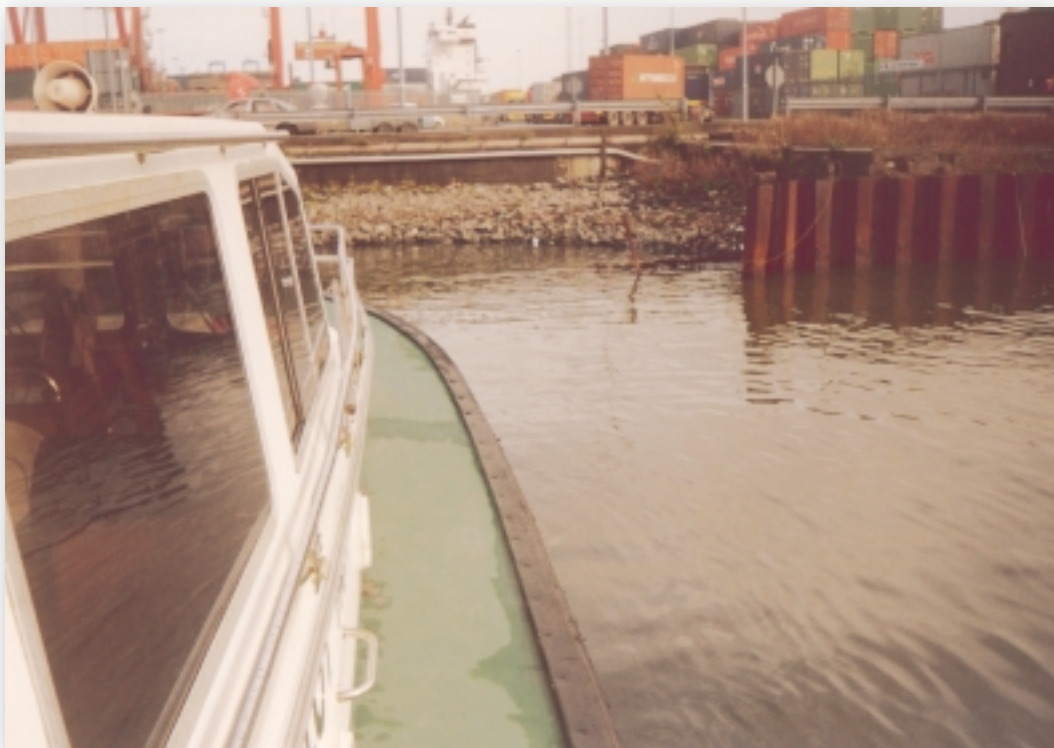
- 4.1 The pilot called the pilot cutter on VHF Radio Channel 12 as he reached the top platform of the pilot accommodation ladder.
- 4.2 The pilot cutter then came alongside the port side of the M/V "Alexia" (See Photograph No 13 at Appendix 8.4).

13. Tolka (Dublin Pilot No. 1) starboard side

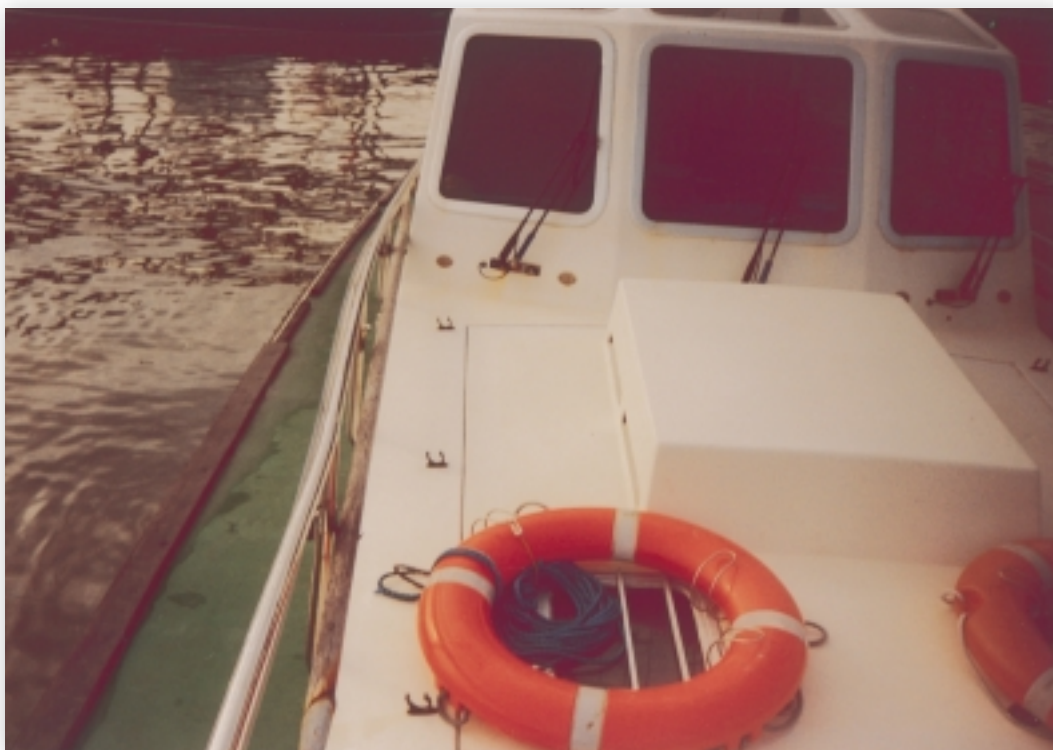
**Appendix 8.4****14. Tolka (Dublin Pilot No. 1) starboard side**

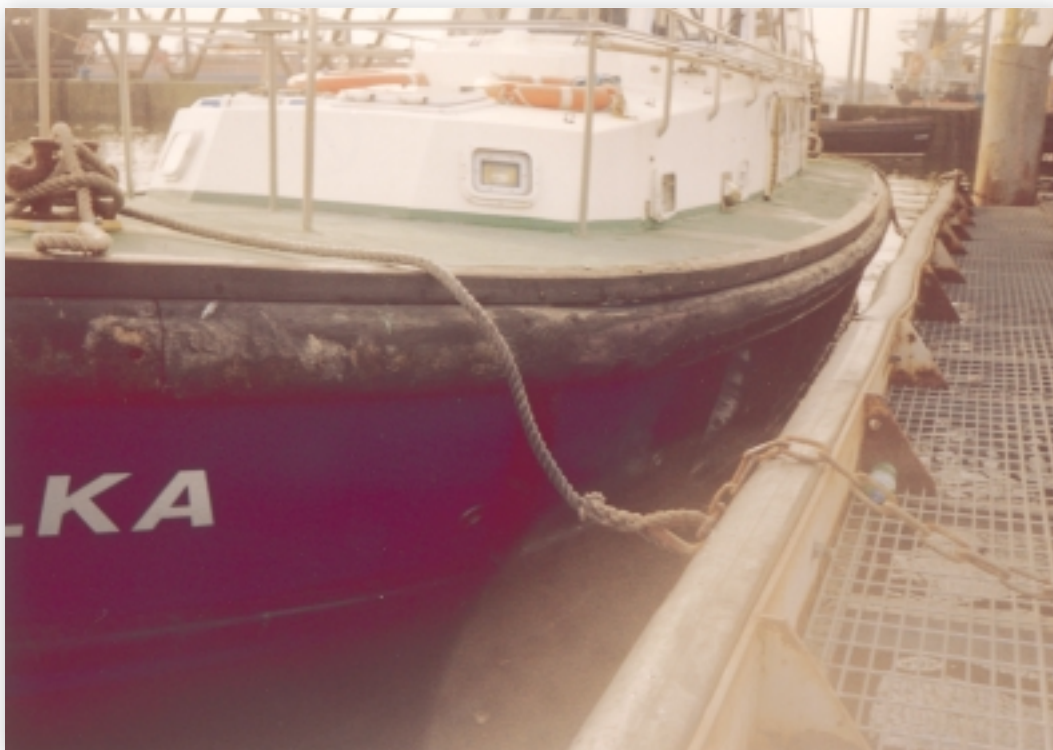
**15. Tolka (Dublin Pilot No. 1) rubber fendering (skirt)**
