**REPORT OF THE
INVESTIGATION INTO THE
LOSS OF THE
BRIGANTINE SAILING SHIP
STV "ASGARD II"
ON THE
11th SEPTEMBER 2008**

**REPORT No. MCIB/161
(No. 10 of 2010)**

Report MCIB/161 published by The Marine Casualty Investigation Board
27th September 2010.

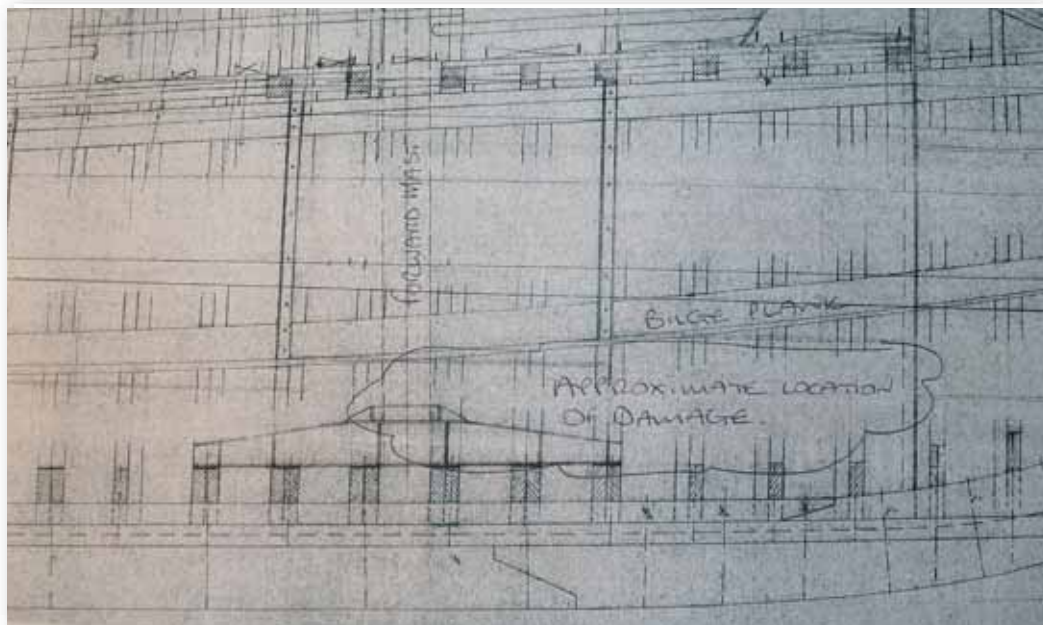
Fig 2 Construction Profile in way of foremast (location of three partial bulkheads are shown)

The following diagrams indicate the construction section in way of the foremast. Three partial steel bulkheads were located in way of foremast. Fig 1 shows the construction section in way of the foremast and Fig 2 shows the profile view of the construction arrangement in way of the foremast.

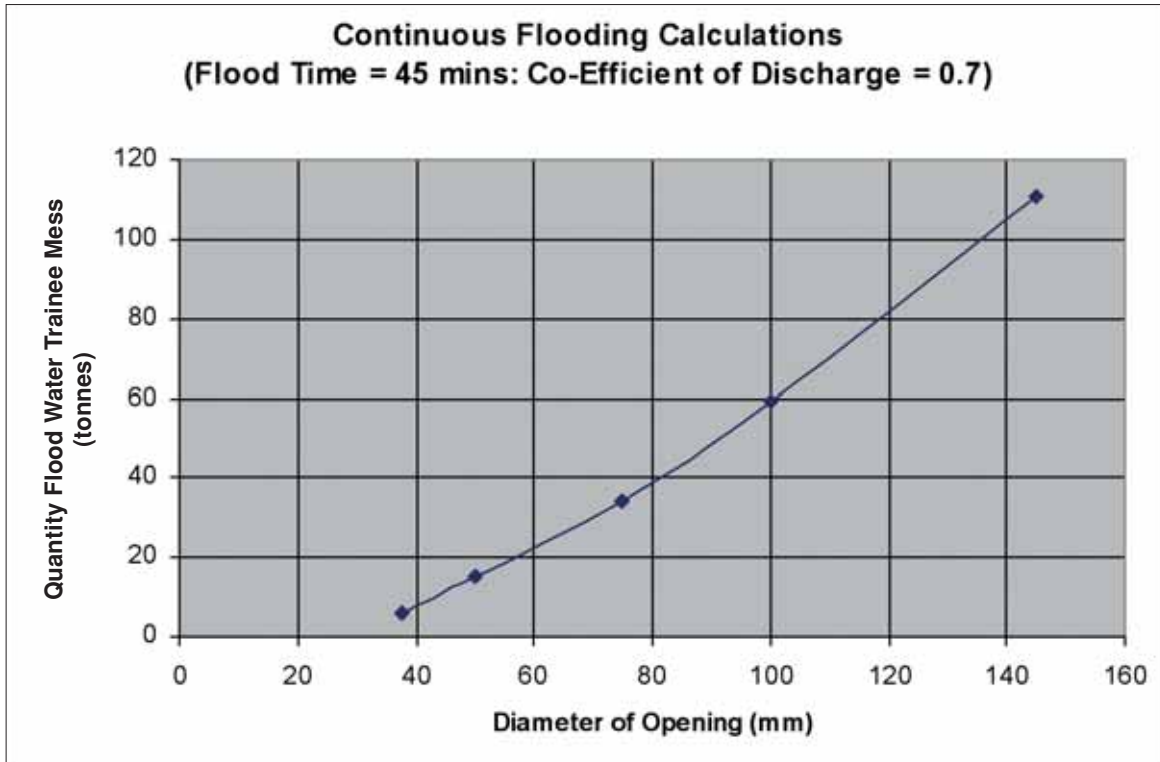
The results indicate an opening of 37.5 mm (1½") in diameter would result in 6 tonnes of water in the Trainee Mess at the end of 45 minutes. It is estimated that an opening of 145 mm (0.017 m²) in diameter would result in 110 tonnes of water in the Trainee Mess at the end of 45 minutes.

The maximum seacock diameter in the Trainee Mess was 37.5 mm (1½") in diameter and based on these calculations the failure of a single seacock in Trainee Mess was insufficient to flood the Trainee Mess in 45 minutes.

These calculations are based on a circular opening, an assumed co-efficient of discharge of 0.7, no bilge pumping of the Trainee Mess and no leakage of water into adjacent spaces. The values presented should only be considered as indicative but clearly show the flooding was not as a result of the failure of a 1½" seacock.

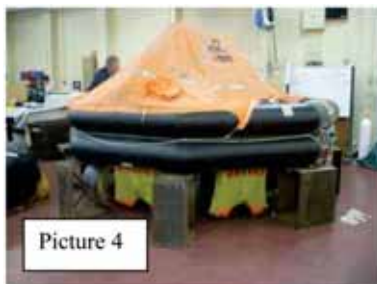
Picture 4

- The liferaft was elevated off the floor and placed on stands – See picture 4.
- Subject one (75Kilos) boarded the raft at the area in which the floor was still in tact.

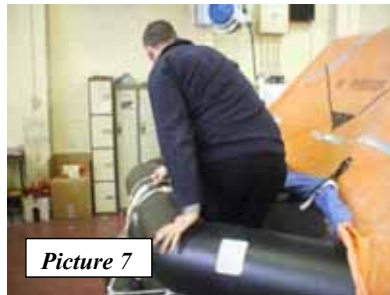
- In addition to the IMO Resolution A761 test requirements subject one then climbed onto the upper buoyancy and jumped into the raft sixteen times – No seam slippage or edge lifting was detected on the floor.
- Subject two (104 Kilos) boarded the raft and carried out the same exercise. See Picture 7 – No seam slippage or edge lifting was detected on the floor.

The strenuous seam testing regime carried out as described above on the intact section of the floor attachment, showed that even though the adhesive on this side of the floor was in a similar condition as the detached side, there was no detachment or slippage and the seam remained intact during the test.

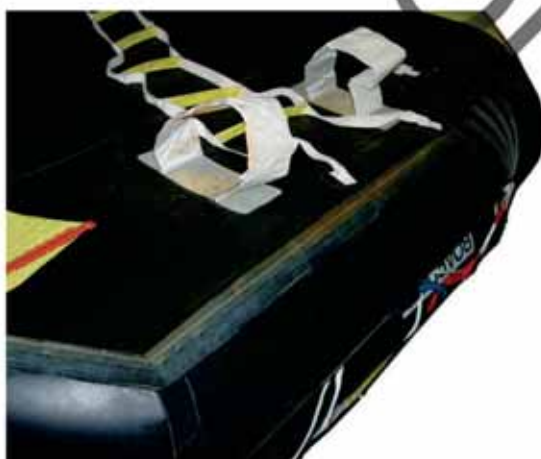
Throw over cylinder side of liferaft
FIGURE 1

Identify the side of the floor where the cylinder is attached, (FIGURE 1).

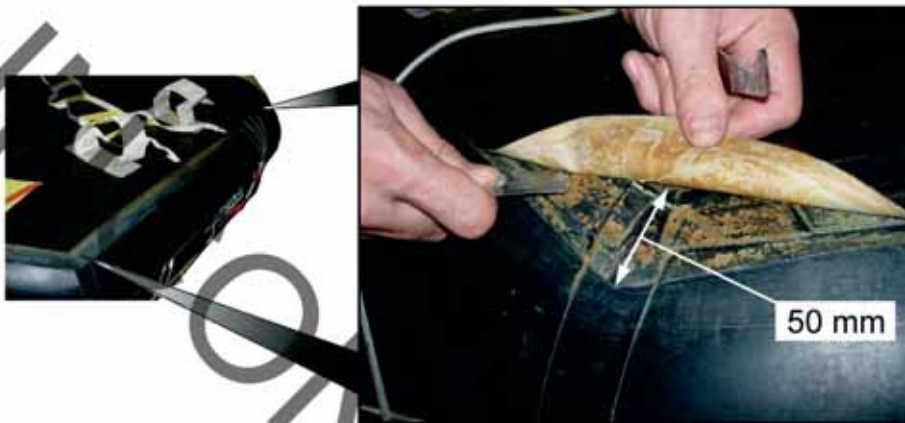
Attempt to separate floor from buoyancy
FIGURE 2

Identify the two corners of the floor edge as shown in, (FIGURE 2). Attempt to separate each of these two corners of the floor from the buoyancy using a spatula to lift the edge of the floor. The spatula should be used to initiate separation, to allow further examination by hand and finger pressure.

The floor should be separated from the buoyancy over a distance of 50mm. This allows the adhesive joint between the floor and the buoyancy to be inspected, (FIGURE 2).

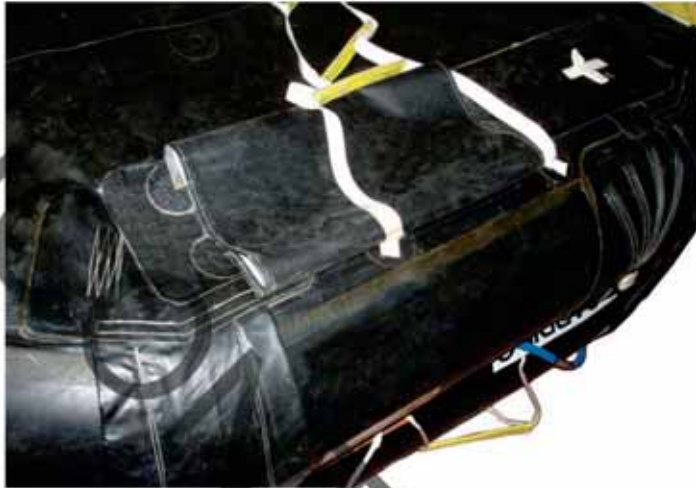
Davit launch cylinder side of liferaft
FIGURE 5

Identify the edge of the floor where the cylinder is attached, (FIGURE 5).

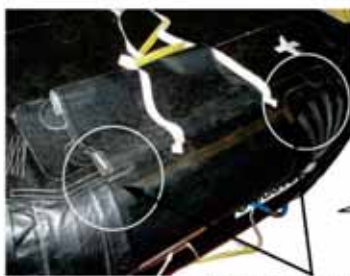
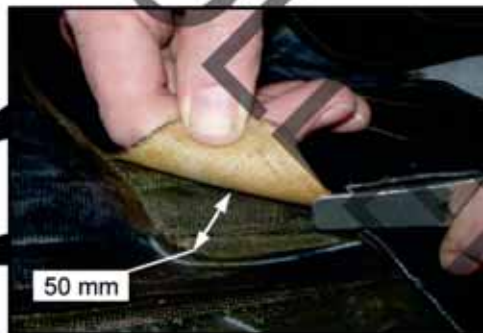
Corners with lifting patch
FIGURE 6

Identify the two corners of the lifting patches as shown in, (FIGURE 6). Using a spatula, attempt to separate each of these two corners from the floor. The spatula should be used to initiate separation, to allow further examination by hand and finger pressure.

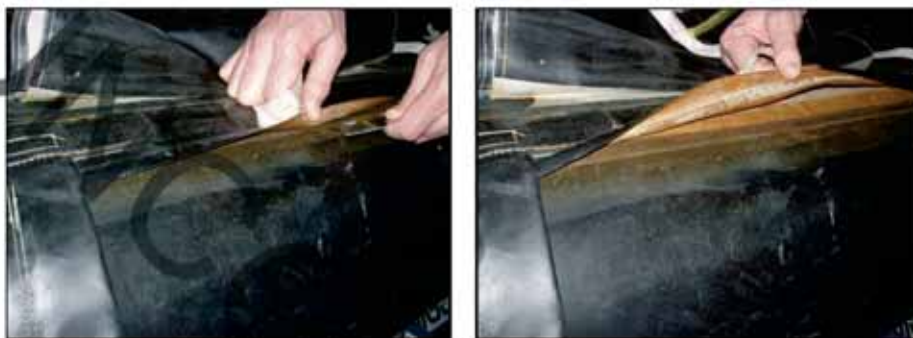
Inspect along the floor edge between the two lifting straps
FIGURE 7

The floor to buoyancy joint, must be inspected along the area between the two lifting straps, (FIGURE 7).
