**REPORT OF THE
INVESTIGATION INTO THE
INCIDENT ON BOARD
FV "ATLANTIC WEST" WITH
THE RESULTANT LOSS OF LIFE,
NORTH OF MAYO STAGS,
2nd JULY 2007**

REPORT No. MCIB/144

Report MCIB/144 published by The Marine Casualty Investigation Board
31st August 2009

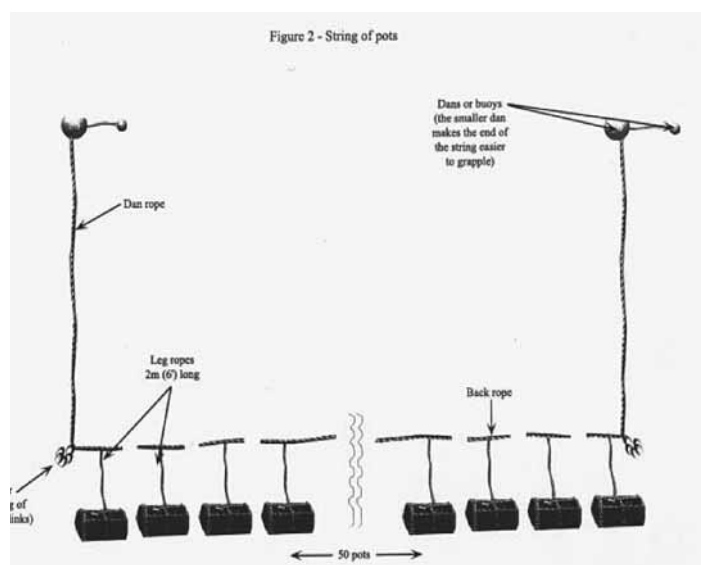
Six strings of pots were usually hauled and shot each day. There were 60 pots to each string (See illustration below). A maximum of one string was on board at any time during fishing, although sometimes two strings were carried when pots needed to be shifted to another area, but this was only carried out in fine weather. The pots were laid either east to west or west to east. The sea area being used was very popular with potters; there were about 6,000 pots there. To prevent the ropes from getting tangled, they were laid in the same direction. During hauling and shooting, the FV "Atlantic West" was steered by the auto-pilot.

A string of pots took about 6 minutes to deploy. There was 22 fathoms (40m) of back rope between each pot. The vessel was motored at about 6 knots, so a pot was deployed about every 7 seconds.
