**REPORT OF THE
INVESTIGATION INTO THE
COLLISION BETWEEN IRISH
REGISTERED TRAWLER
"PRINCESS GRAINNE" AND
PLEASURE CRAFT
"TOUCH - N - GO"**

The Marine Casualty Investigation Board was established on the 25th March, 2003 under The Merchant Shipping (Investigation of Marine Casualties) Act 2000

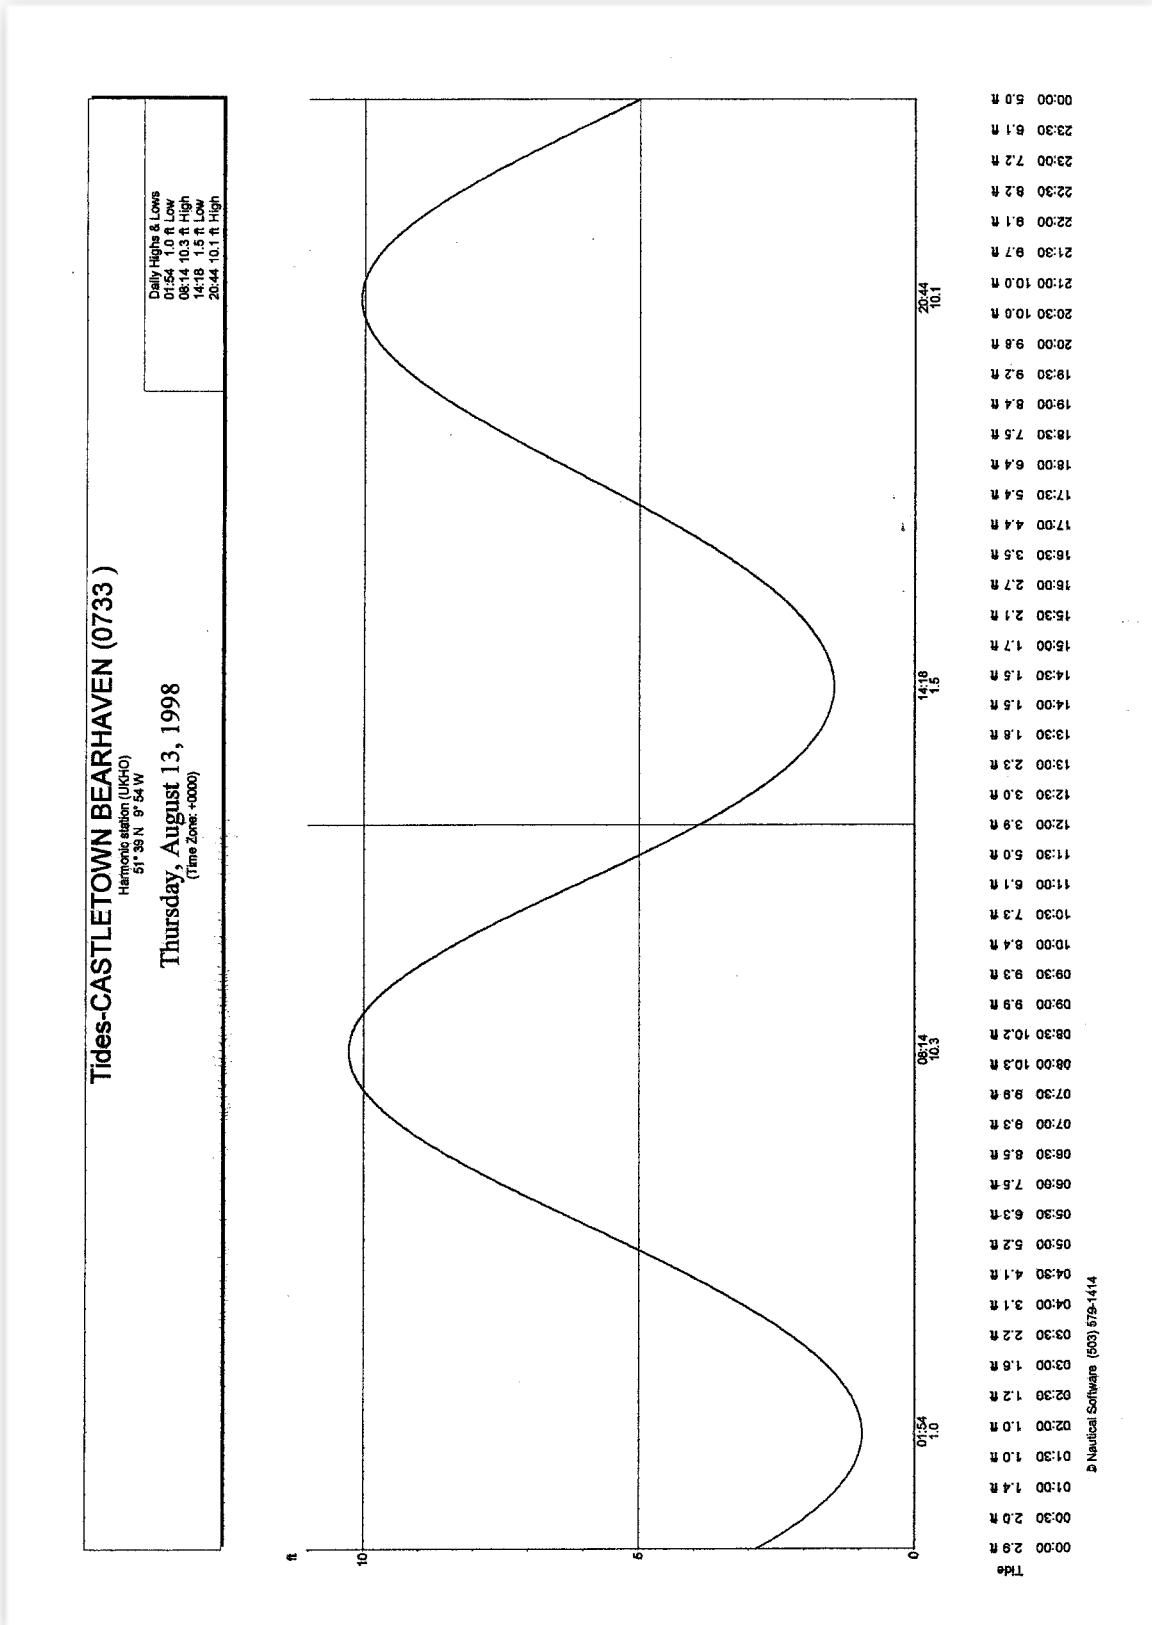
Appendix 8.4

Tide curve.

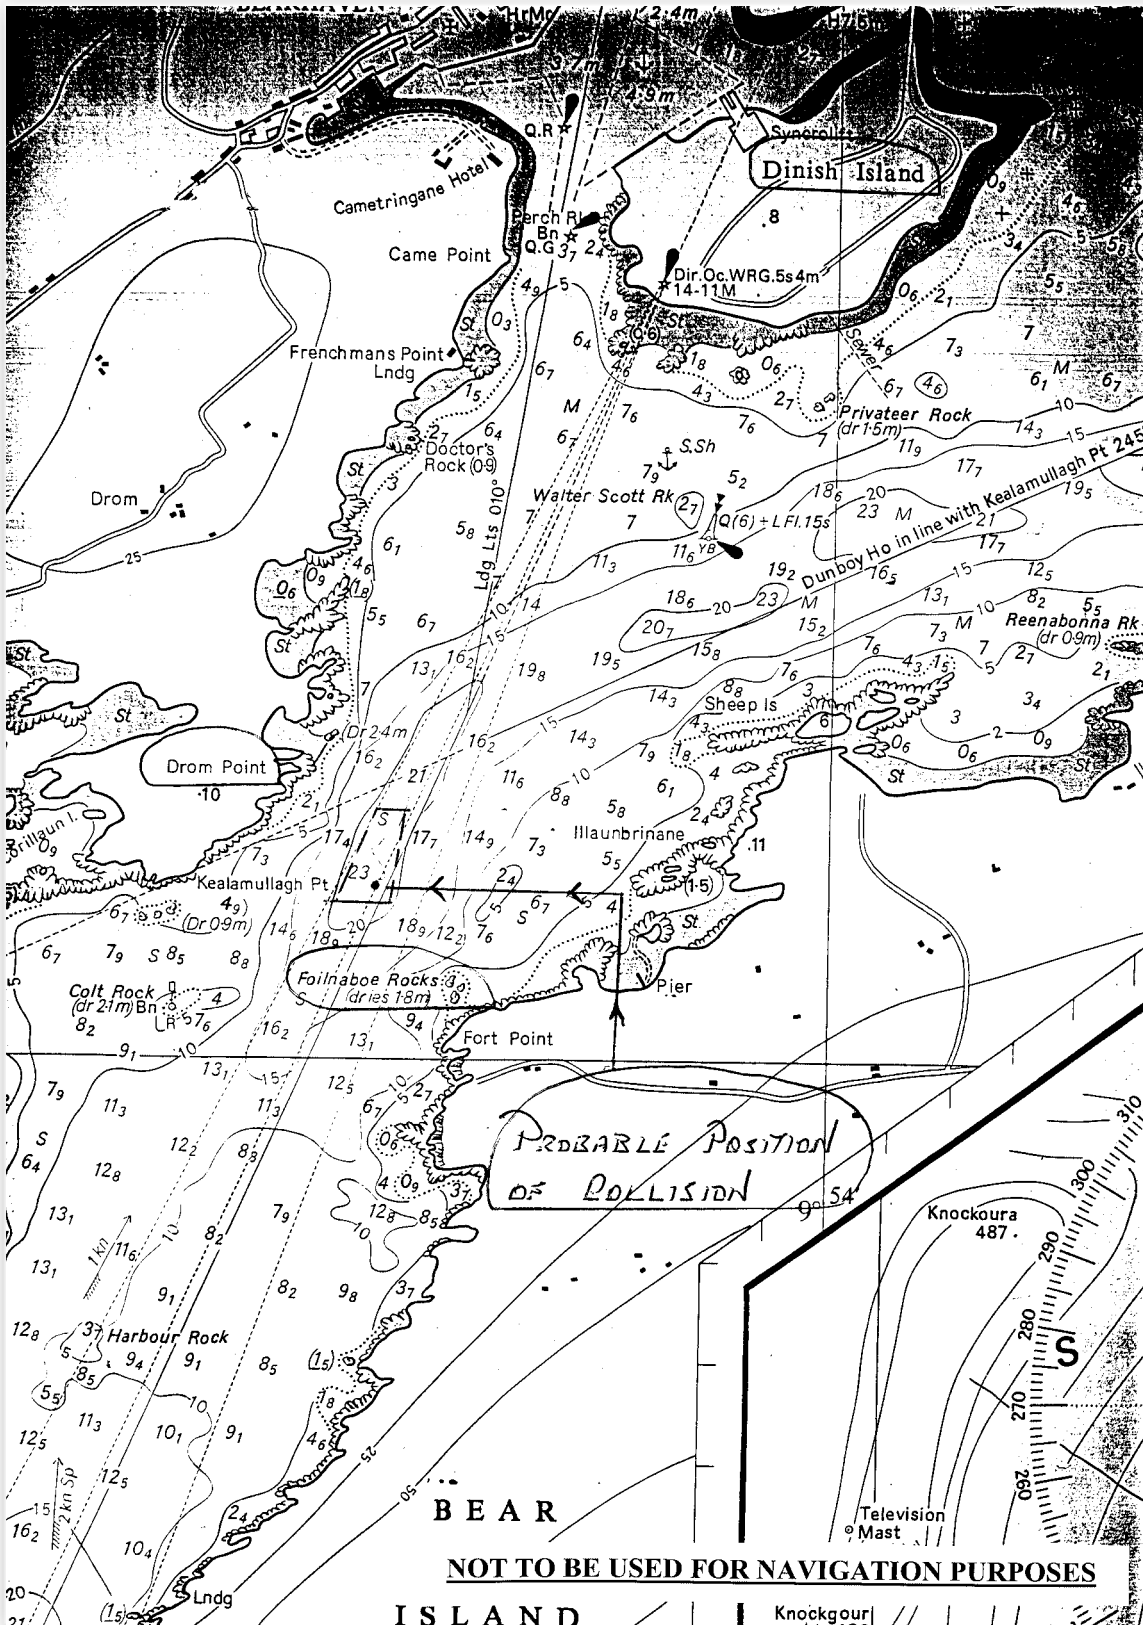
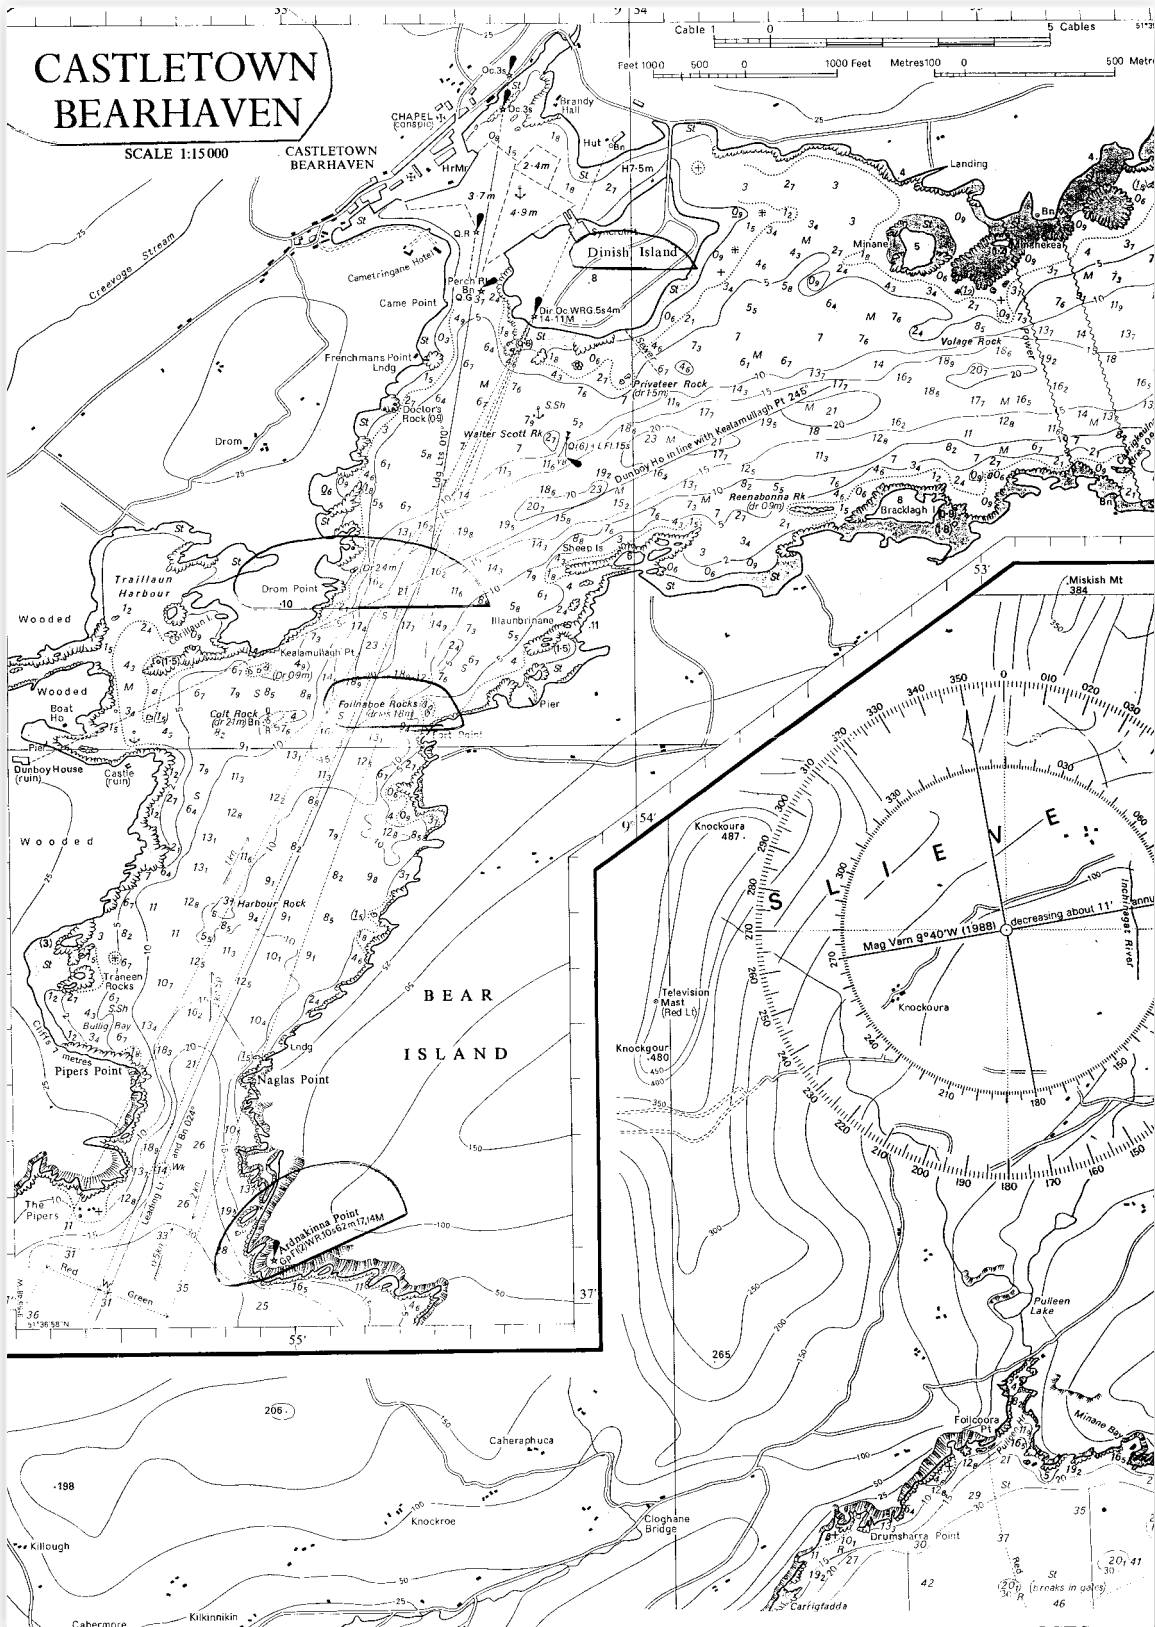
1. Underlining the scale in feet used to measure the offset lines from Drom Point.
2. Directional Occulting Light on Dinish Island indicating a narrow fairway sector flanked by light sectors of different colour.
3. Indicates the leading lights at 010^0 to clear Dinish Island and Came Point.
4. The point for alteration onto the leads above in 3.
5. Drom Point through which a line is drawn running $024^0/204^0$ with two broken lines offset to the east at 200 yards (600 feet) and 250 (750 feet) yards.
6. The 17₄ metres shoal stated by Mr. Bartlett as the position "Touch-n-Go" was at anchor.
7. The leads into the harbour of Castletownbearhaven.
8. Underlining the Red, White and Green sectors indicated in 2. above.
9. The spot marked by the Skipper of "Achilles" as being the position that "Touch-n-Go" was at anchor.

The source data for Admiralty Chart No. 1840 covering the area under consideration was obtained from Admiralty Surveys 1895 to 1914.

Global Positioning System is normally referred to the World Geodetic System 1984 Datum. Such satellite-derived positions obtained must be adjusted by given factors. The chart referred to in Appendix 8.6 was corrected to date for the time of the incident. This is a matter of comment, as the GPS was not used to obtain any position relevant to the incident.

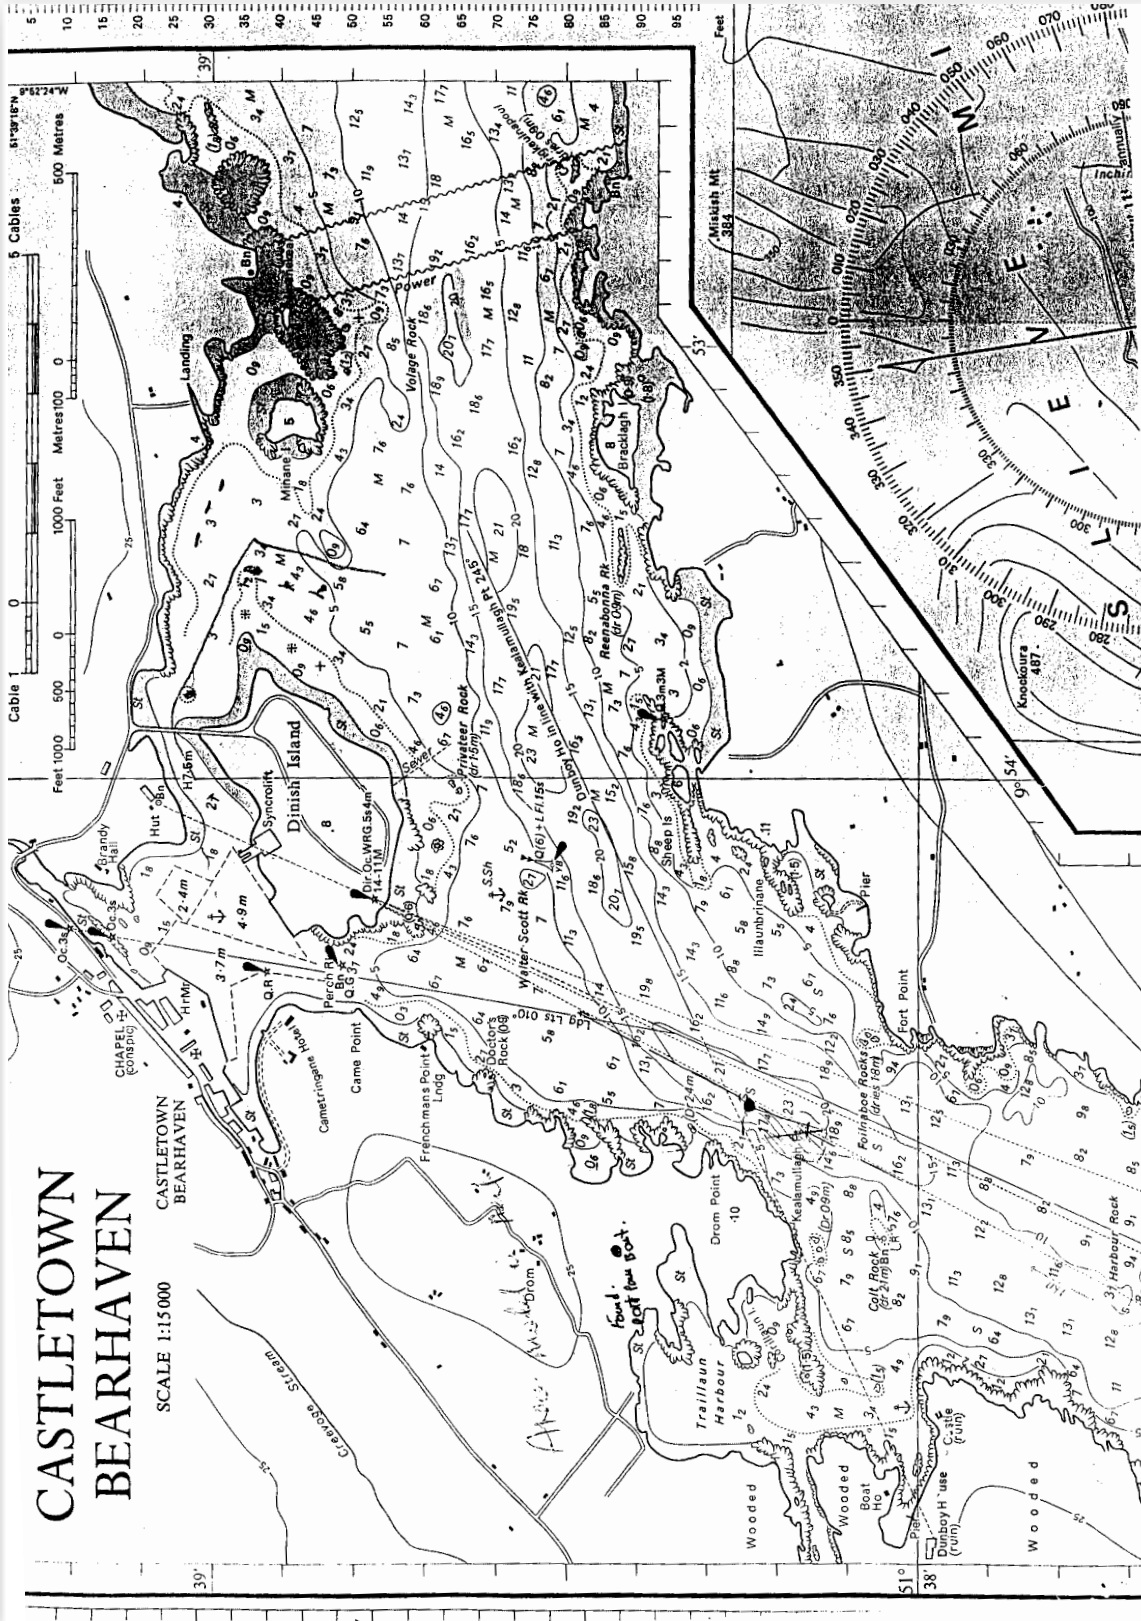
On Monday 24th August 1998, I was requested to dive by Mr C Bartlet. Owner of a capsized small boat off Drom pt outer harbour. And to look for and recover any items from the boat, after about 45 mins of the dive time searching seabed at 20mts depth I had found a fishing rod from the boat. Tuesday 25th August 1998 I resumed my search of seabed, and during this time I found 2 pieces of fibre glass with some markings which was later identified as being from the capsized boat, I also found a grappling hook, and a steel line holding frame and a small box of spark plugs dived again and did a sweep of the area, But found no more items. The position of the dive and area covered is marked on the enclosed chart; I took marks from outer leads and the building inside at Drom pt. The area being just on the outer line portside. Of the leading lights.marks that is just west of the line and in 20 metres of water.
