**REPORT OF THE INVESTIGATION  
INTO THE GROUNDING OF  
MV “HUELIN DISPATCH”  
ON PIERRE AU VRAIC  
21st SEPTEMBER 2012**

**REPORT No. MCIB/226  
(No.14 of 2013)**

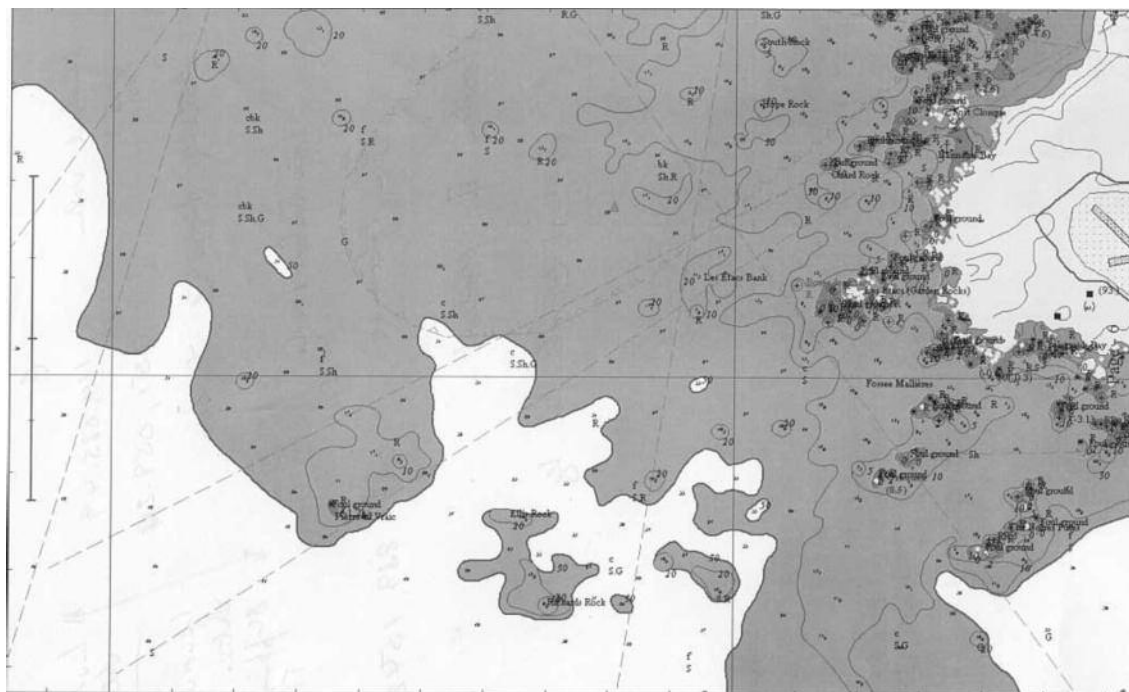
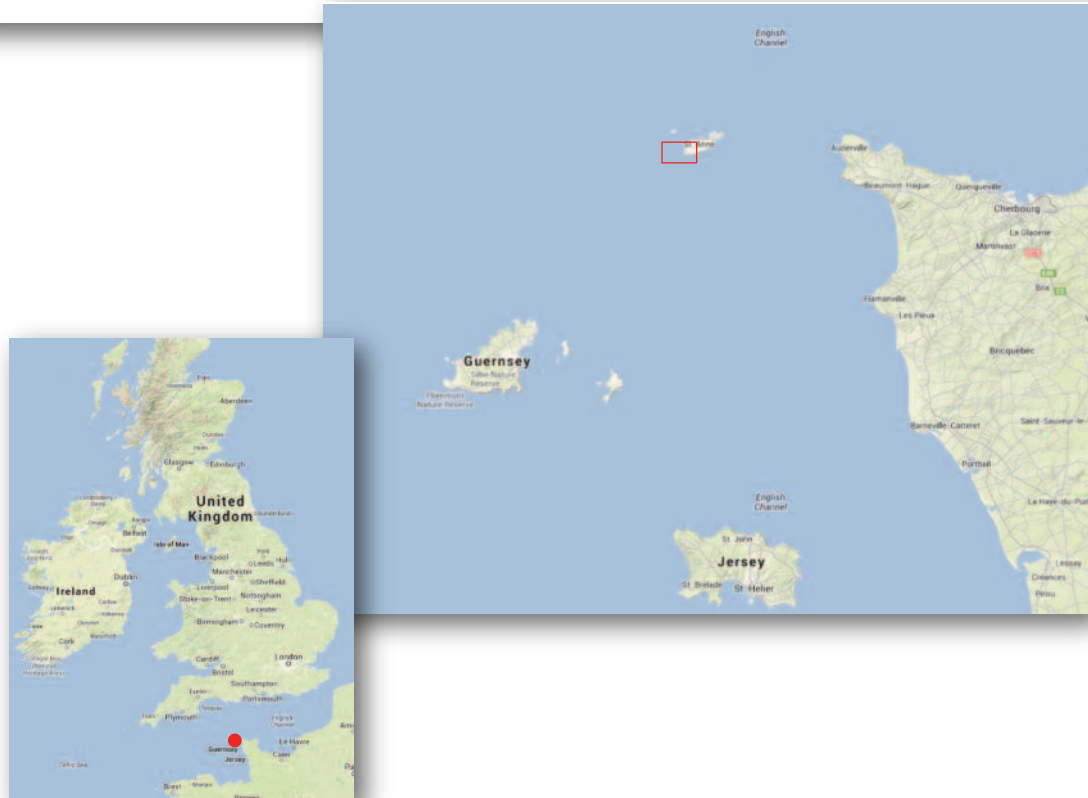
## Appendix 7.1 Large scale print from electronic chart showing “Pierre au Vraic”.

- 1.1 On 21st September 2012, the MV “*Huelin Dispatch*” was proceeding from St Peter Port in Guernsey towards Alderney Harbour, Island of Alderney. The vessel struck a charted rock, “Pierre au Vraic” located approximately 1.8 nautical miles southwest of Alderney, approximate position 49° 41’ N 002° 16.9’W (see Appendix 7.1).
