**REPORT OF INVESTIGATION
INTO DUAL FATALITY OFF
SKERRIES,
NORTH COUNTY DUBLIN
ON
1st APRIL 2011**

**REPORT No. MCIB/200
(No.4 of 2012)**

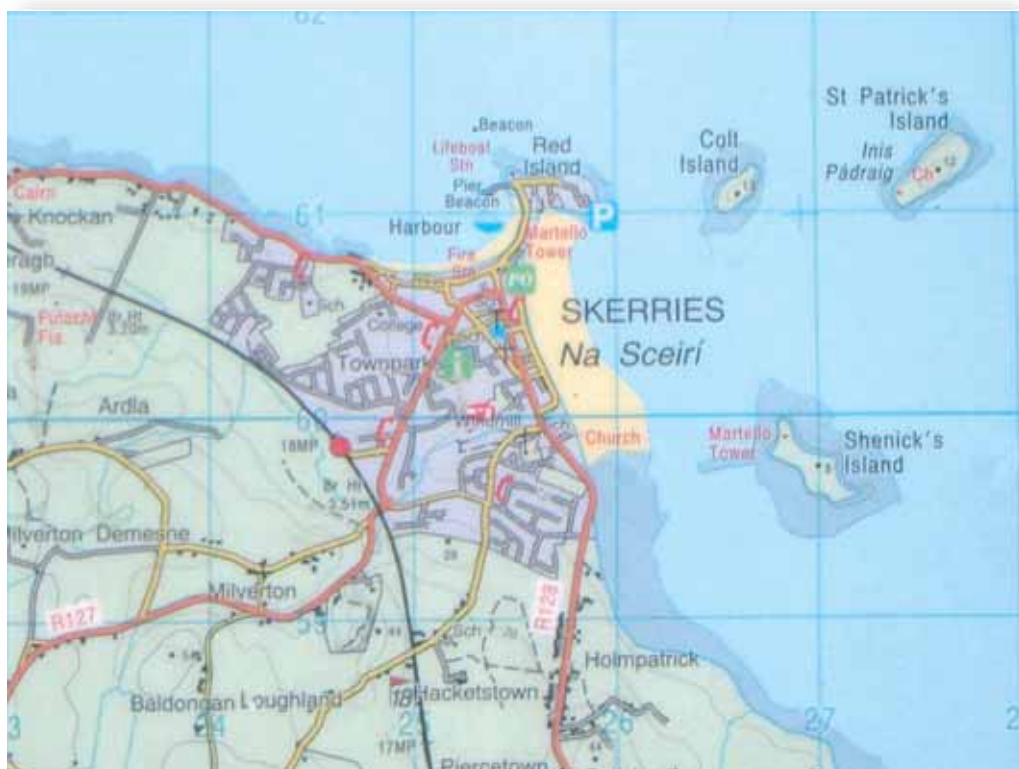
Photograph D
Extract of the chart for the Skerries area.

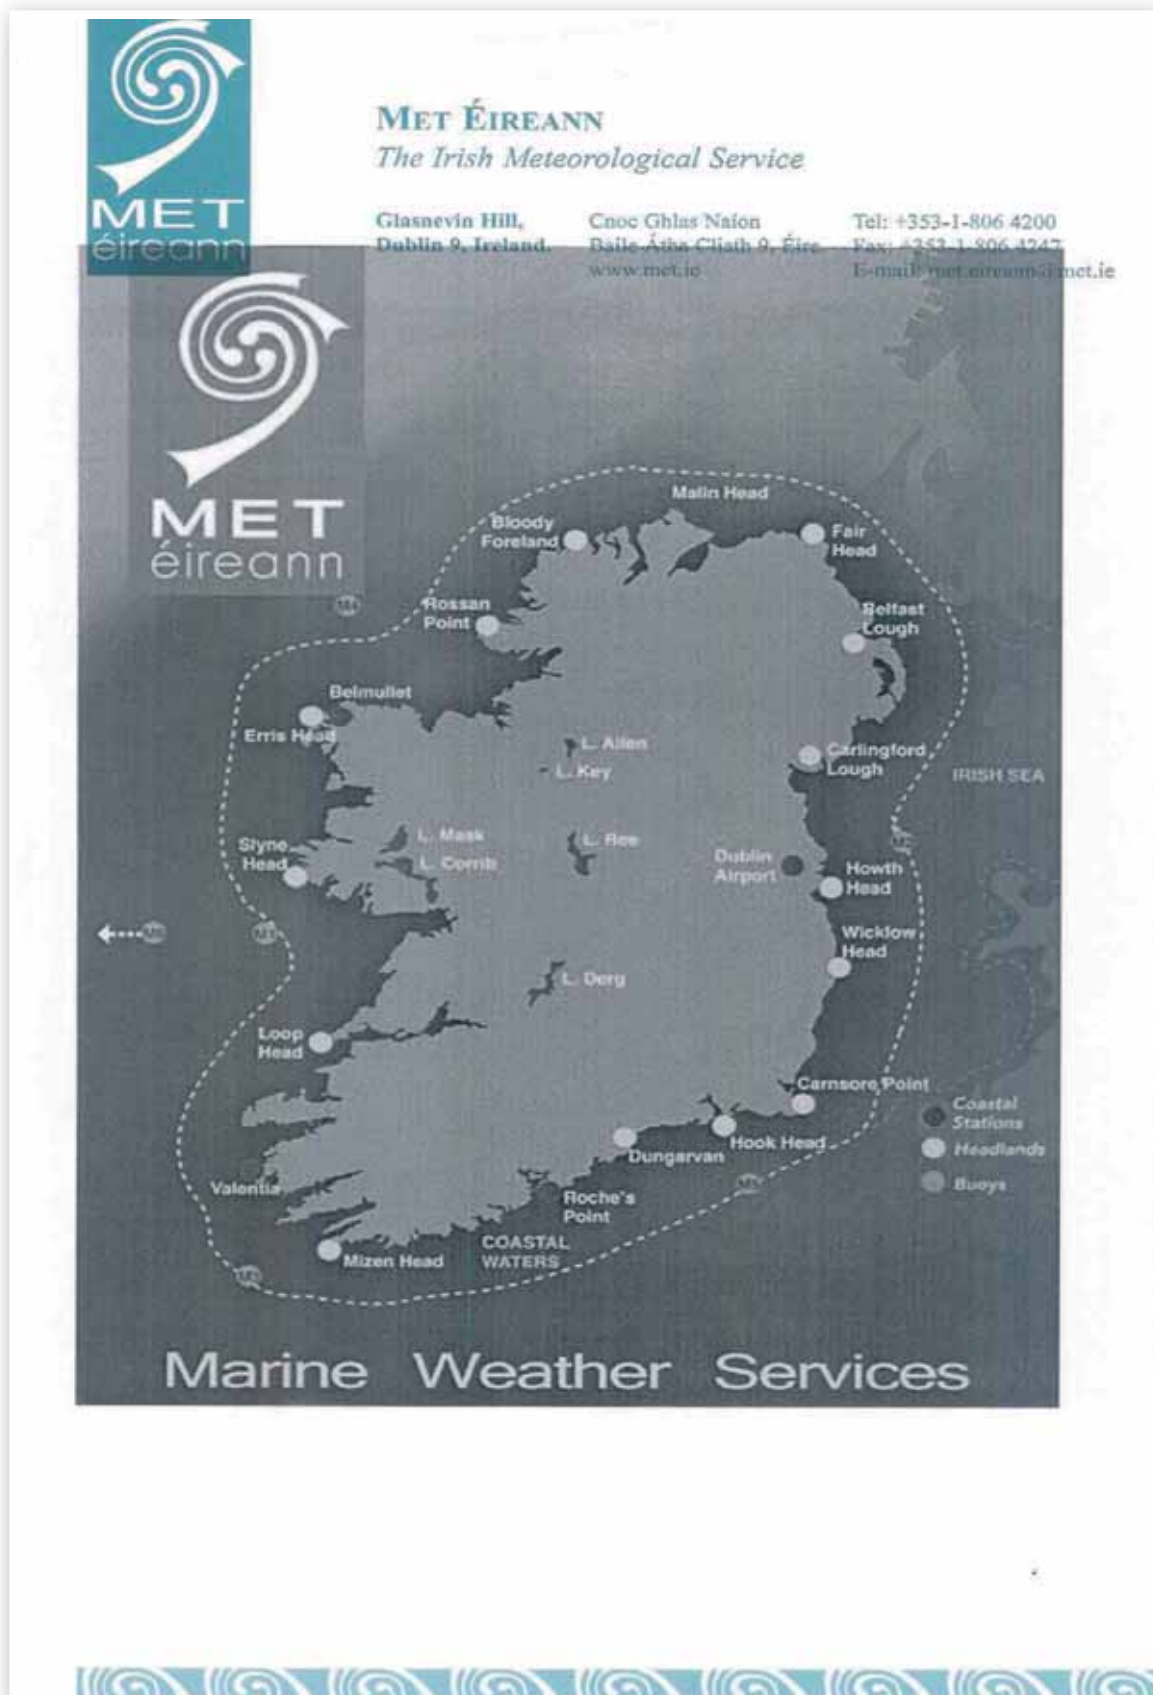
Appendix 8.3 Met Éireann Weather Report.

- 3.2 The weather conditions were deteriorating when the vessel left harbour. The Met Éireann report for the area for 12.00 to 18.00 hrs. was as follows:
- Winds: Southerly force 5 to 7 with gusts up to gale force 8.
 - Weather: A few light outbreaks of rain or drizzle but mostly dry and rather cloudy.
 - Visibility: Moderate to good.
 - Waves: Rough.
