Marine Casualty Investigation Board

**REPORT
OF THE INVESTIGATION
INTO THE GROUNDING OF THE
MV "LOCATOR"
OFF SAINT MACDARA'S
ISLAND, OFF THE COAST OF
GALWAY
ON 31st MARCH 2007**

REPORT No. MCIB/139

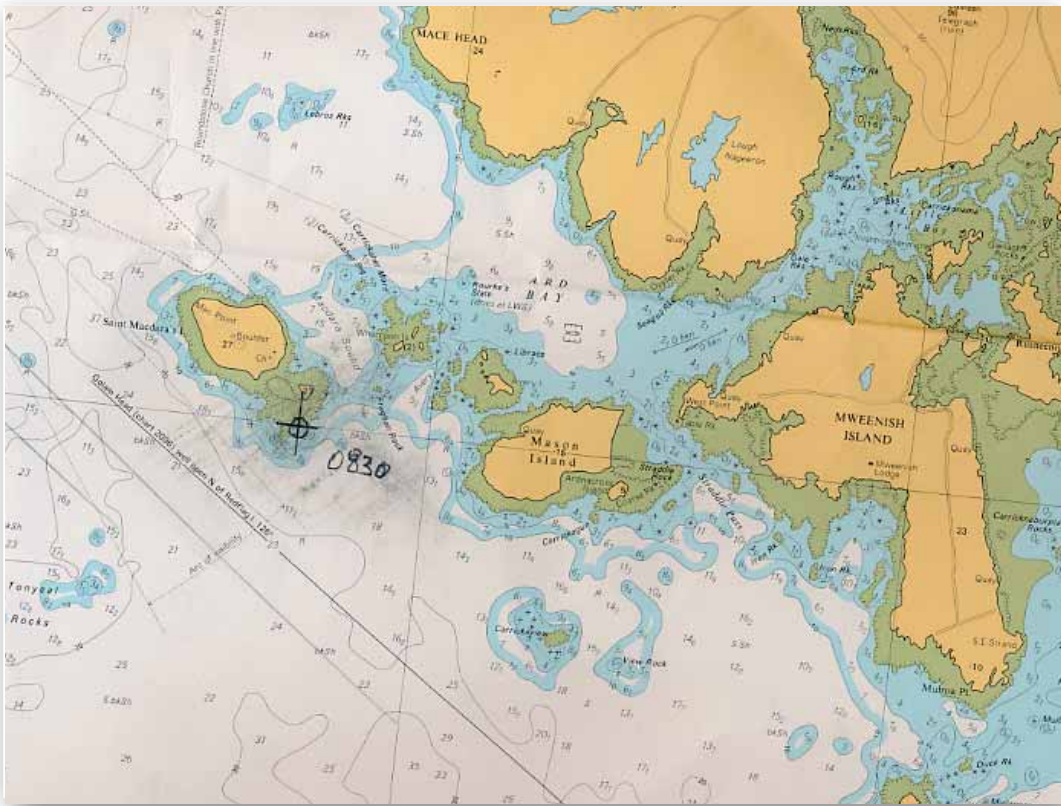
APPENDIX 8.1

Appendix 8.1 Section of Admiralty Chart No. 2709 indicating position of grounding at approximately 08.30 hrs. on 31st March 2007.

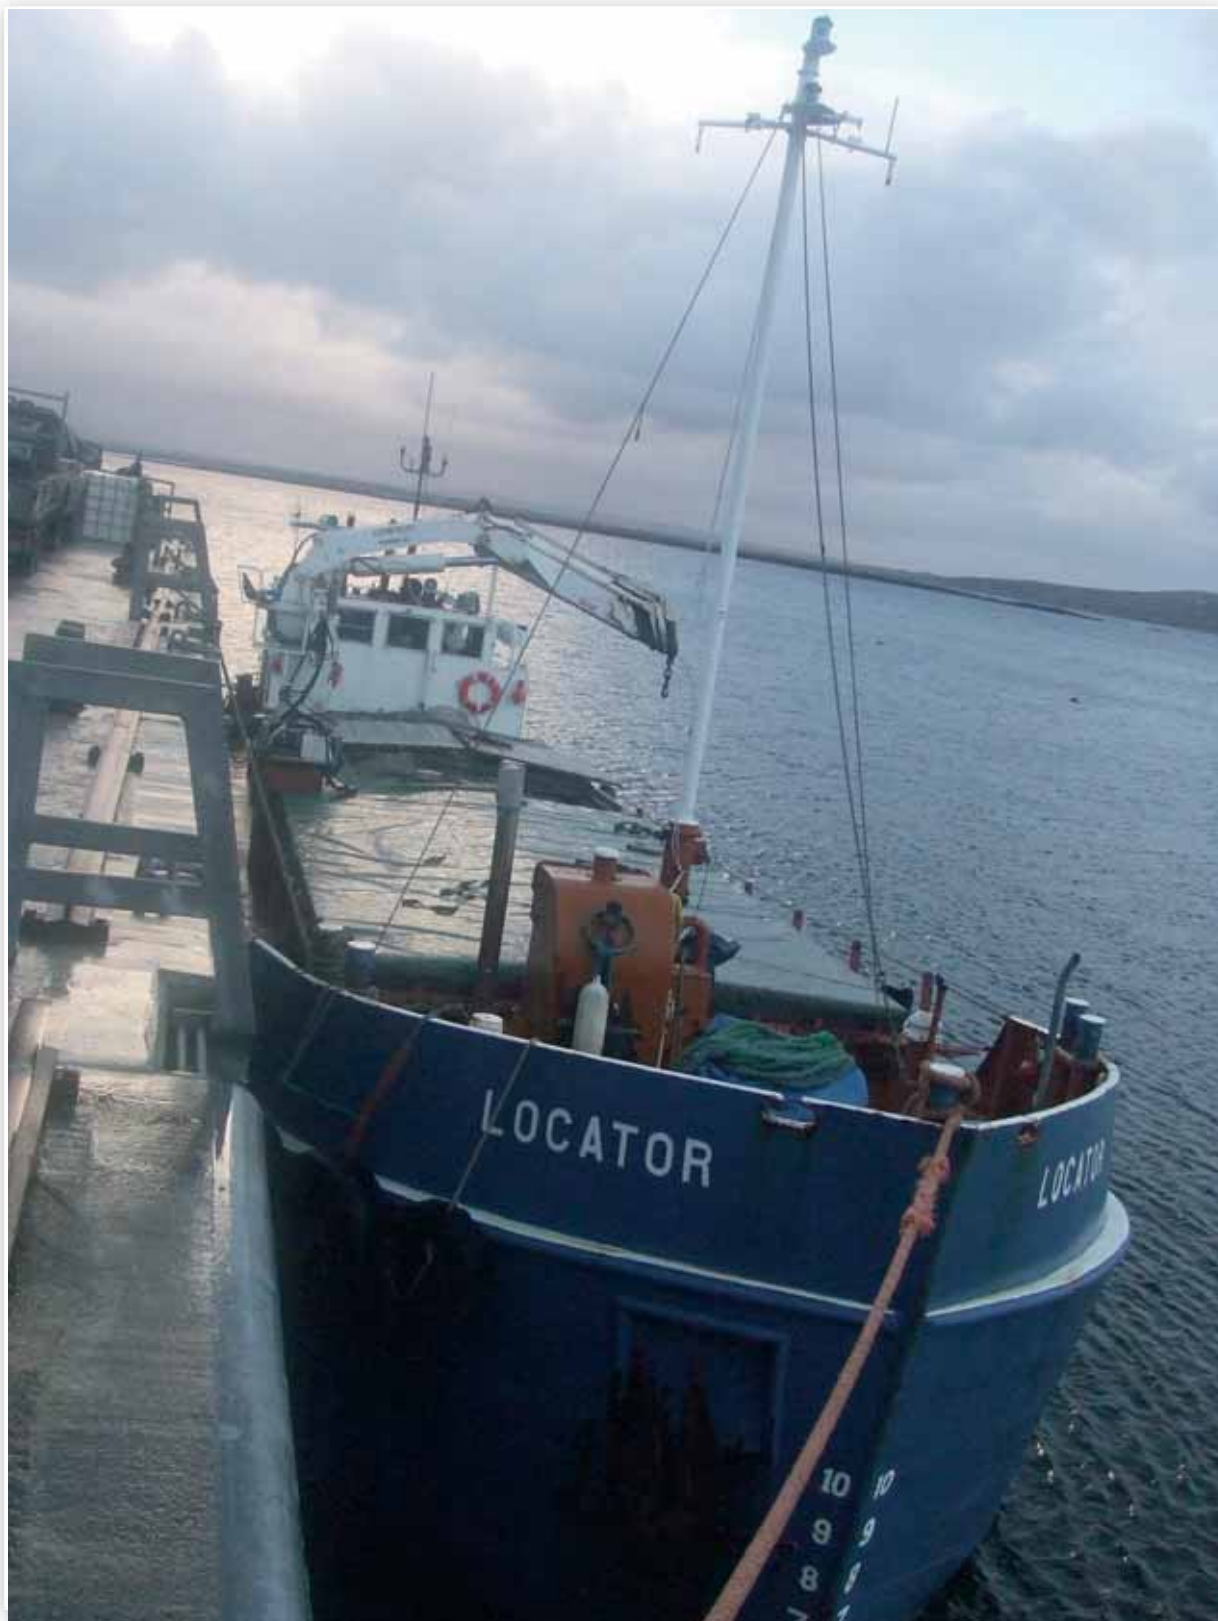
Appendix 8.2 MV "Locator" alongside at Kilkerrin Pier.
