**REPORT OF THE INVESTIGATION
INTO THE COLLISION BETWEEN
THE IRISH FISHING VESSEL
MFV “*STELIMAR*” AND THE
BAHRAIN REGISTERED TANKER
MV “*ALMANAMA*” OFF THE
SOUTH WEXFORD COAST ON 13TH
JUNE 2000.**

1. SYNOPSIS

On the 13th June 2000, off the south Wexford Coast a collision occurred between the Irish Fishing Vessel MFV “*Stelimar*” and the Bahrain registered tanker MV “*Almanama*”. Damage was caused to both vessels.
No injuries were sustained.

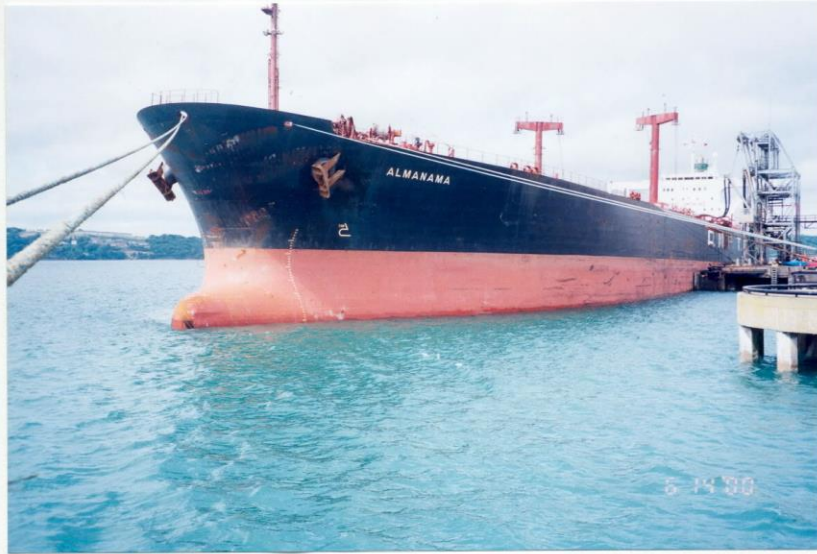
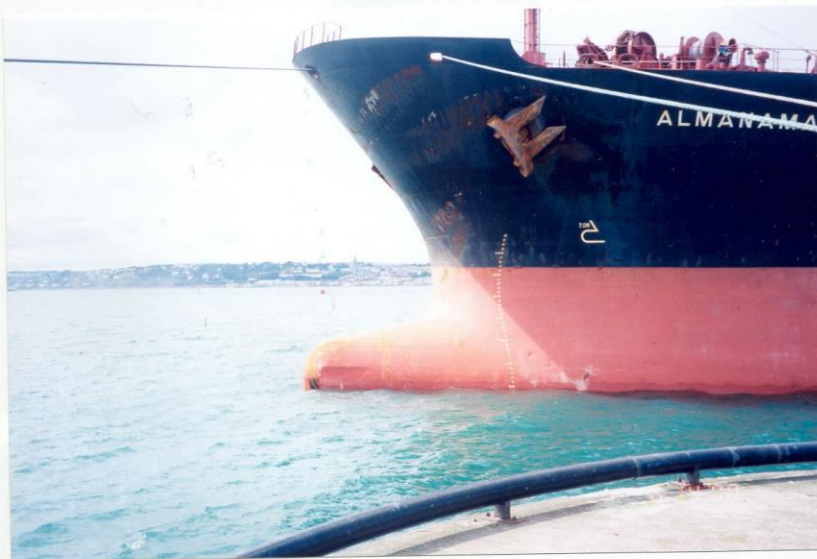
Appendix A.

- 5.13 Mr. Marrachli stated that he was alone on the bridge prior to the incident as the lookout was calling the next watch.
- 5.14 The damage suffered by the tanker consisted of an indent approximately 30 cm in length and 5 cm deep above the water line on the side of No 1 starboard ballast water tank.

Photographs of m.v. "Almanama".
