**REPORT OF THE
INVESTIGATION INTO THE
SINKING OF THE YACHT
"MEGAWAT" - 25 MAY 2005**

The Marine Casualty Investigation Board was established on the 25th March, 2003 under The Merchant Shipping (Investigation of Marine Casualties) Act 2000

Published by The Marine Casualty Investigation Board
5th December 2006

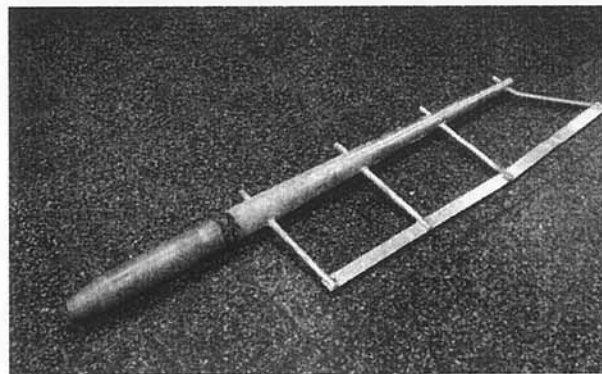
TEST REPORT 07/05

Damage evaluation of an Aluminium Rudder Shaft

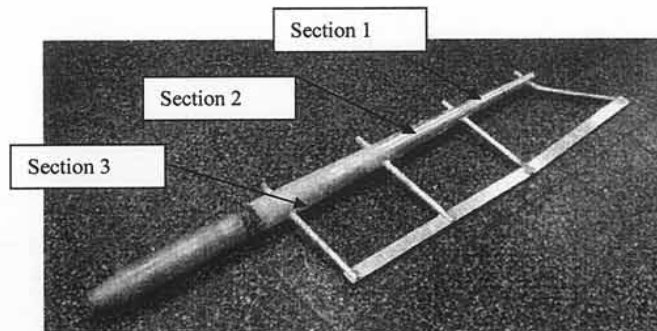
Fig. 3: Sections of the rudder shaft used for the production of the tensile test specimens

The specimens tested were taken from sections 2 and 3, the specimen production was done by quartering the sections and then cutting/turning the parts.
