**REPORT OF THE  
INVESTIGATION INTO THE  
DEATH OF KAYAKER ON THE  
RIVER GADDAGH, CO. KERRY  
ON 28th DECEMBER 2007**

**REPORT No. MCIB/155**

Report MCIB/155 published by The Marine Casualty Investigation Board  
Published on 7th April 2009

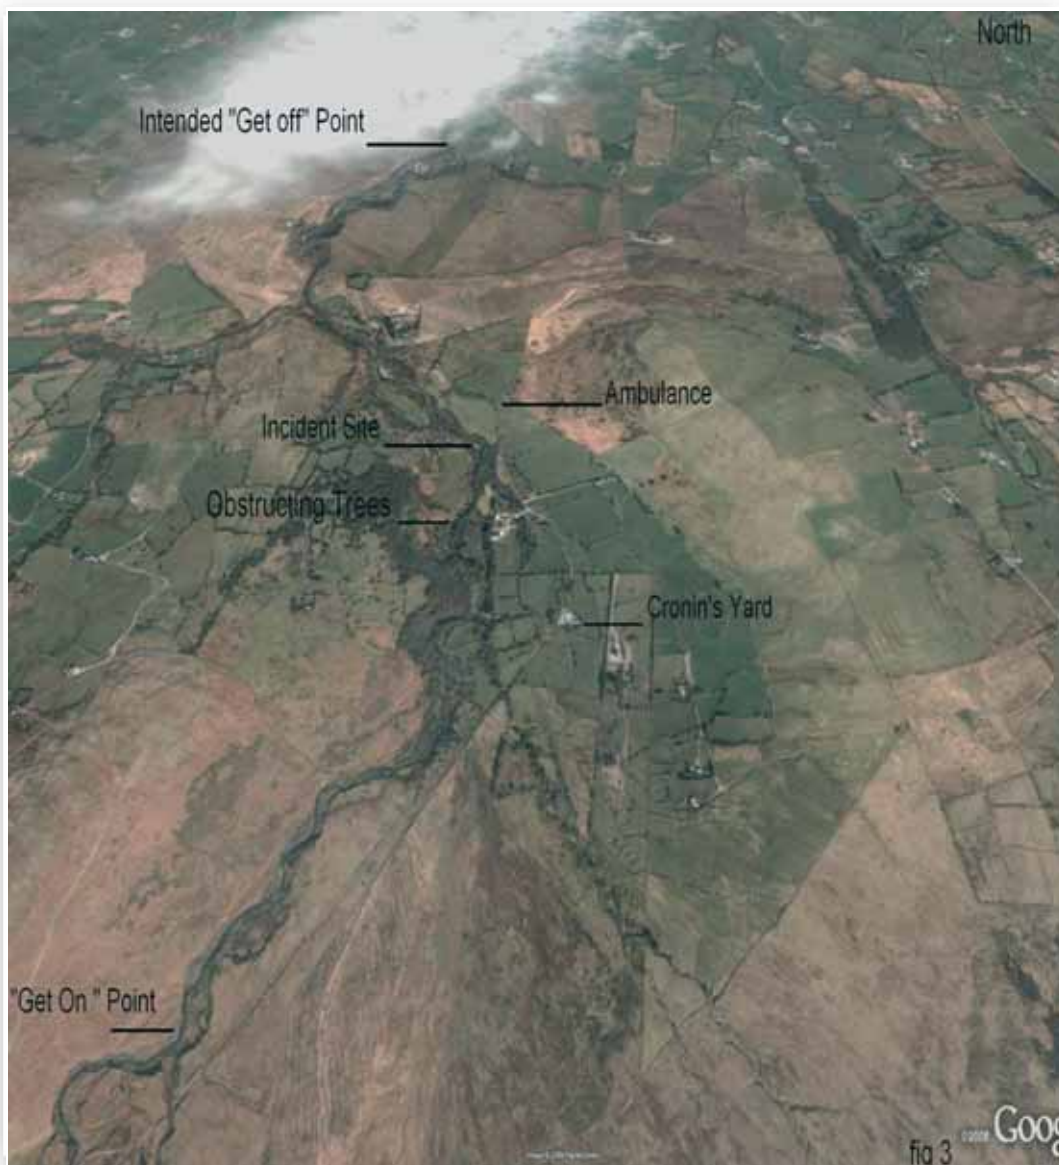
Appendix 8.1 Maps and Aerial Photographs of area.  
Fig. 3 - Gaddagh River aerial photograph.

- 4.2 By this point, the river intensity had diminished to some extent, and the gradient had reduced.  
Beyond the eddy the group was resting in the river banks which were heavily lined with trees, however the river itself appeared to be clear of obstacles, other than one tree noted as blocking the right hand bank.  
A short distance beyond their stop point, the river assumed a right hand bend, beyond which it was not possible for the group to view its aspect.  
Having discussed their options, the group decided to proceed to complete the second stage of their intended course. (Appendix 8.2, Fig. 3).

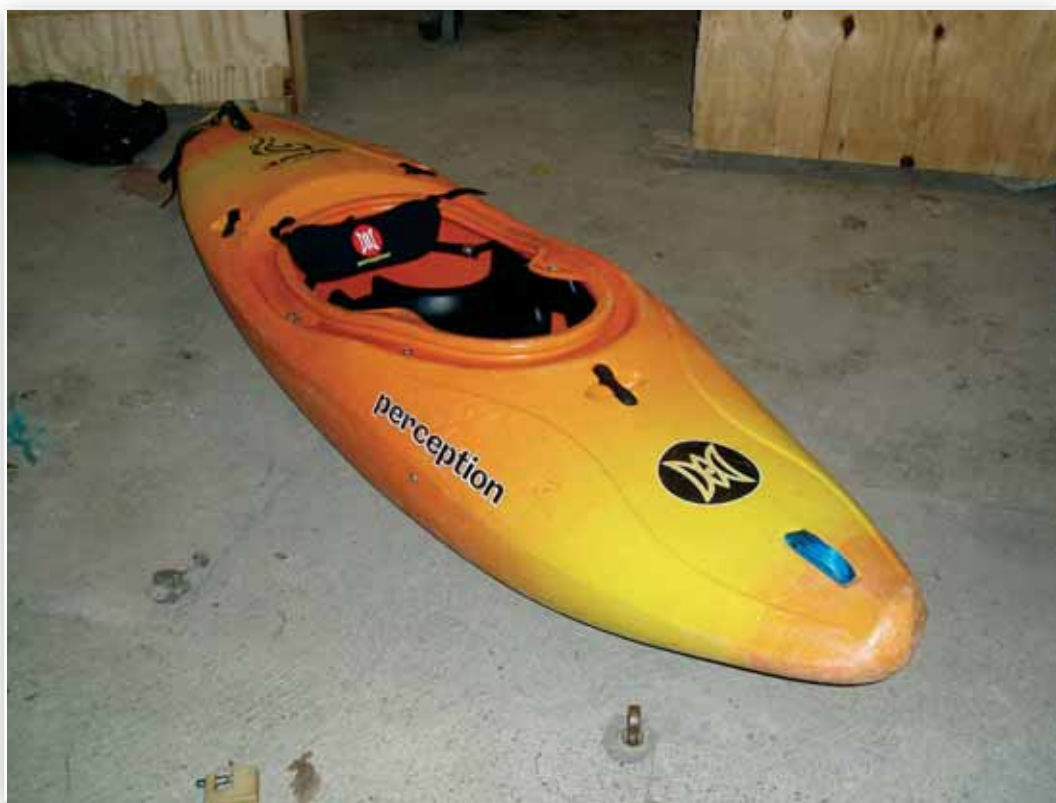
- 6.6 Inspection of the Creek boat following the incident revealed that other than minor previous damage to the bow area, it to be in satisfactory condition and fit for purpose.
