**REPORT OF AN INVESTIGATION  
INTO A MARINE CASUALTY  
INVOLVING THE  
PASSENGER VESSEL  
SEA BREEZE III  
IN OR AROUND  
THE SKELLIG ISLANDS,  
CO. KERRY  
ON OR ABOUT  
7 JULY 2024**

**REPORT NO. MCIB/339  
(No.6 OF 2025)**

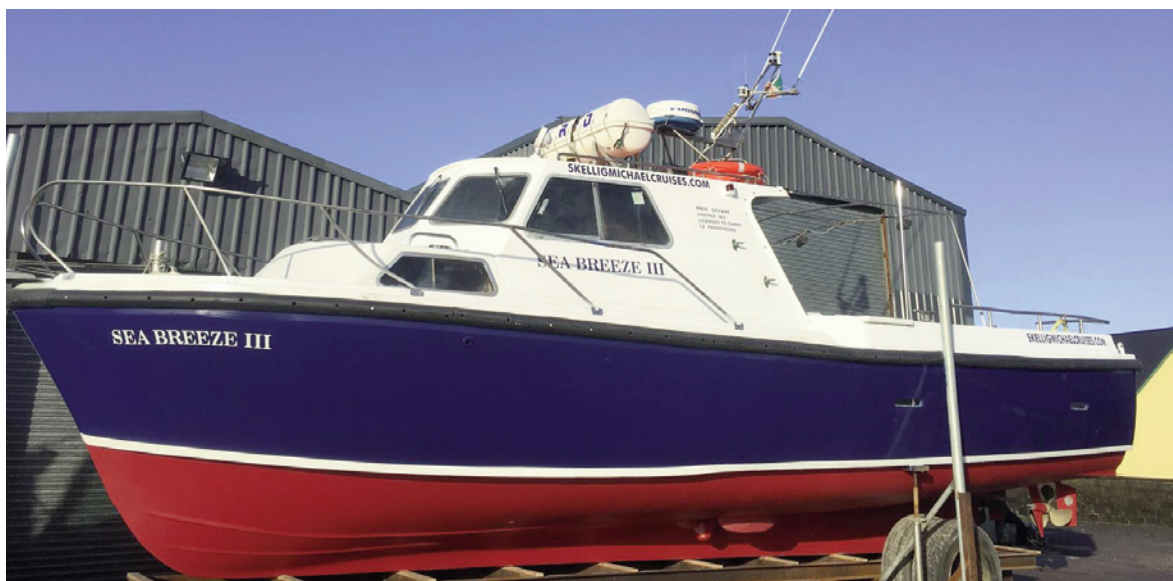
Figure 2: MV Sea Breeze III lying ashore Portmagee.

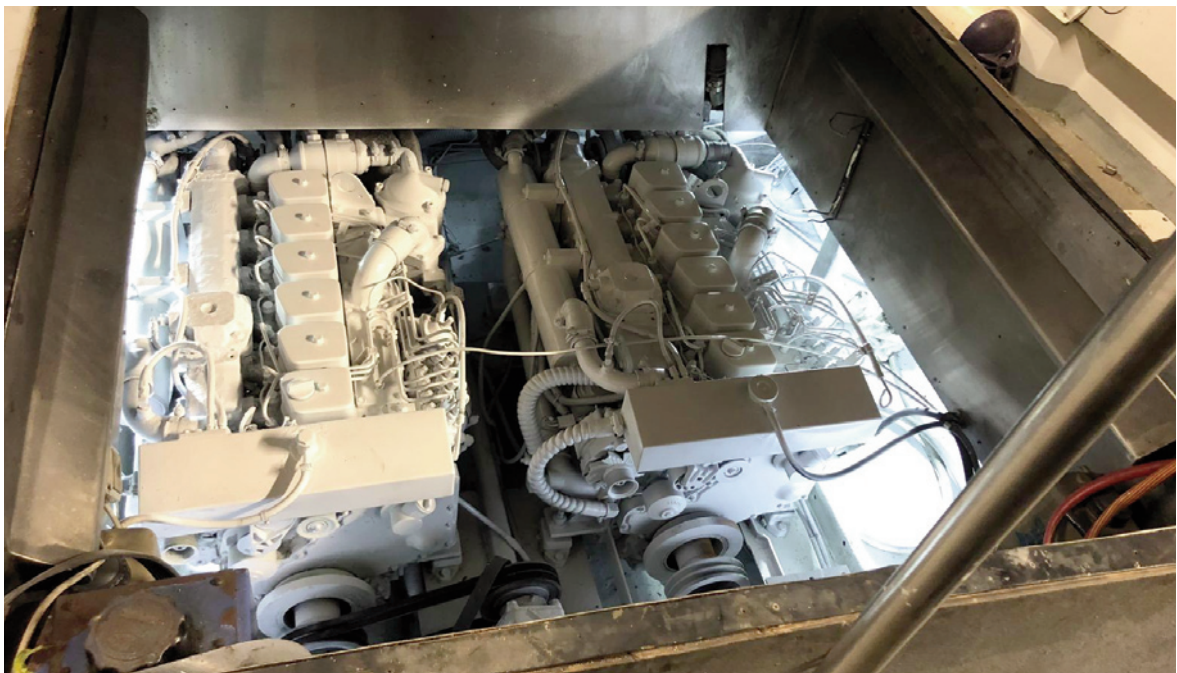
Figure 4: Engine compartment onboard Sea Breeze III.

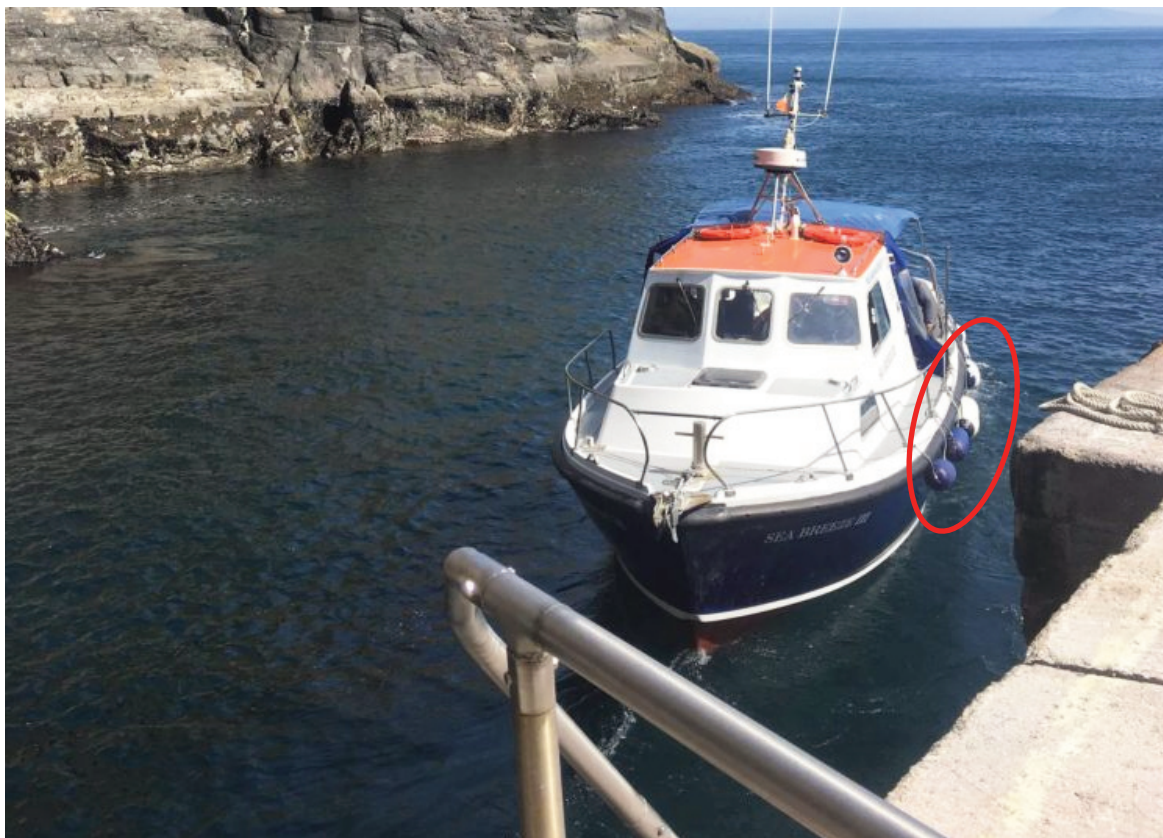
Figure 11: MV Sea Breeze III approaching the concrete landing dock on a previous voyage. Fendering arrangements visible on the port side.

- 3.9 The landing dock is not fitted with fenders, but rather each vessel carries its own fenders onboard. The Skipper advised that there was nothing unusual in his port side approach alongside. The weather conditions can sometimes make manoeuvring challenging, but on this occasion, berthing was speedily achieved. The Skipper was very clear that there was no hard impact with the landing dock, and this fact was confirmed by the Crewmember. The absence of a passenger list meant that it was not possible to interview the passengers to confirm this point or to ascertain if any passenger had video footage of the landing.

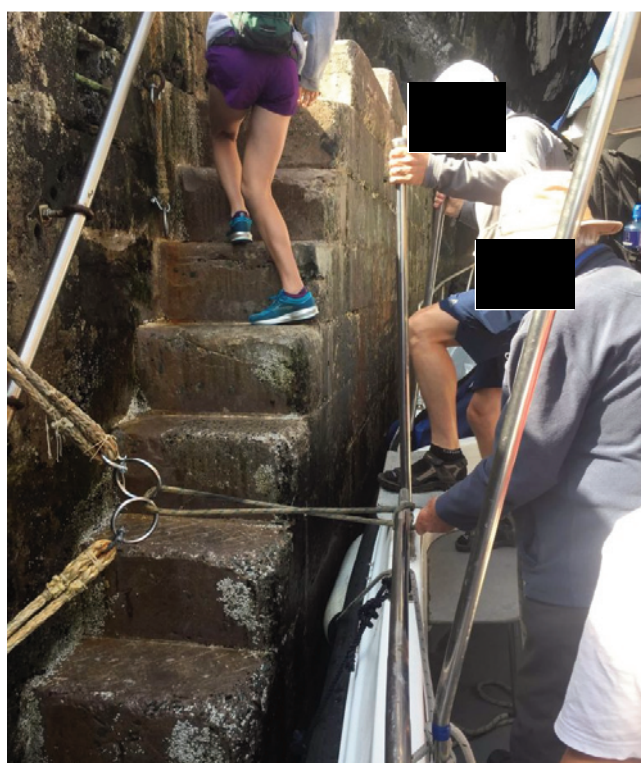
Figure 12: Landing arrangements at Great Skellig on a previous voyage of MV Sea Breeze III.

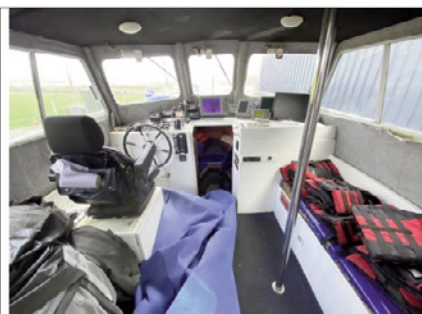
Fig. 1

5.2 The interior finish is in fair condition (Fig. 1).

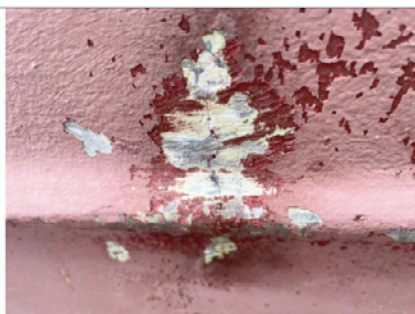
Fig. 2

6.1 The surface is antifouled and the paint finish is well adhered to the hull. The hull is in sound condition with no evidence of major impact damage. There is a small repaired section on the port side around the toilet through hull fittings and there is a crack showing (Fig. 2).

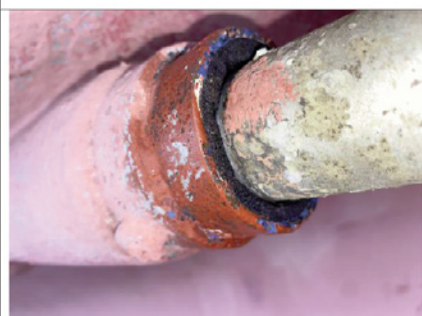
Fig. 3

6.2 The three blade propellers are secure and in good condition. The propeller nuts are secure and fitted with locking pins. The outrigger and P brackets are secure. The cutlass bearings on the port side and the forward bearing on the starboard side are showing signs of the rubber degrading (Fig. 3). The aft starboard fitting has been replaced recently but there is some play in it. The shafts are turning freely with no evidence of bending. There are rope cutters fitted. The spade rudders are secure.

*“14.1 Replace the cutlass bearings.*

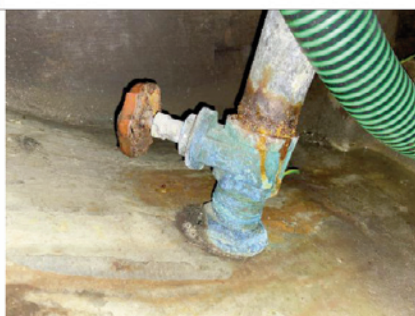
Fig. 4

12.3 The through hull fitting for the fire pump intake is showing some corrosion at the upstand pipe and the valve is not moving (Fig. 4). The toilet intake and discharge valves are showing some corrosion and the valves are not moving (Fig. 5).

*13.3 Ensure all through hull fittings are secure with freely operating valves. The fire pump intake pipe, seacock and through hull fitting should be replaced. The toilet seacocks should be replaced. All seacocks serviced/replaced and all tested and working.*
