**REPORT OF INVESTIGATION
INTO
LOSS OF A CREWMEMBER
OVERBOARD FROM
MFV "SKELLIG LIGHT II"
ON
28th DECEMBER 2008**

**REPORT No. MCIB/165
(No. 4 of 2010)**

Report MCIB/165 published by The Marine Casualty Investigation Board
17 June 2010

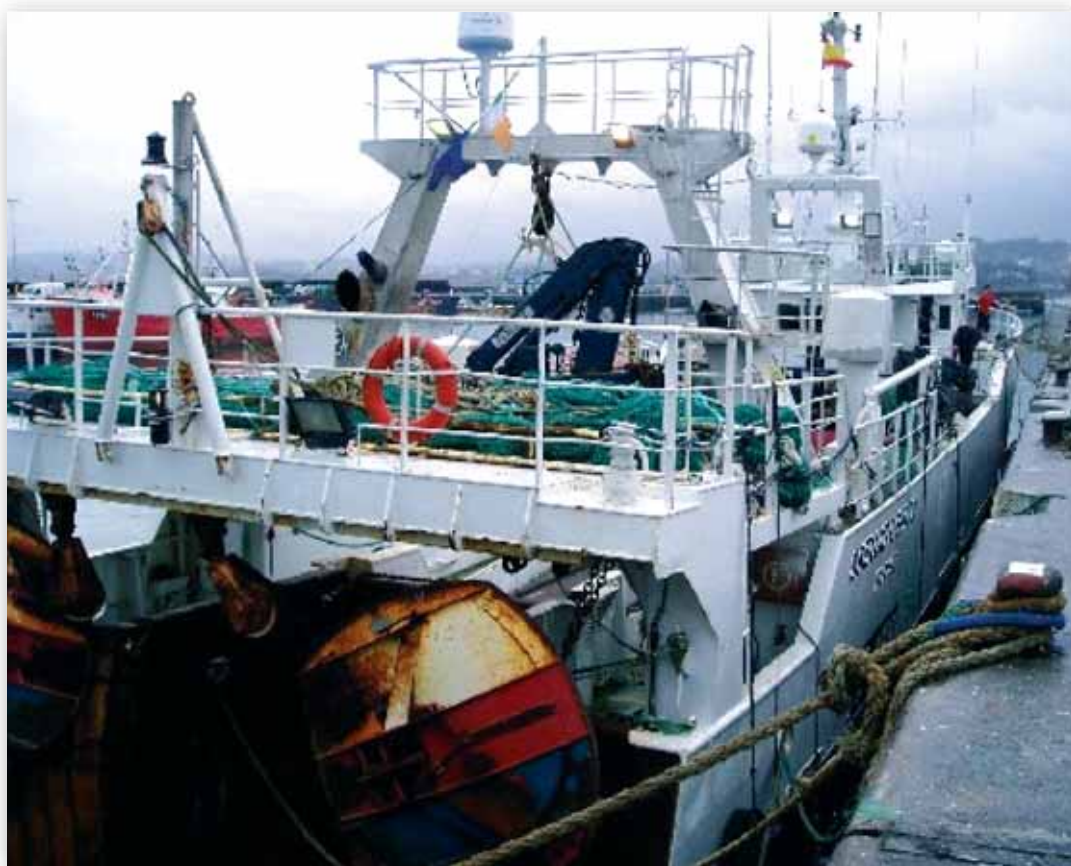
MFV "Skellig Light II" alongside at La Coruna, January 2009.

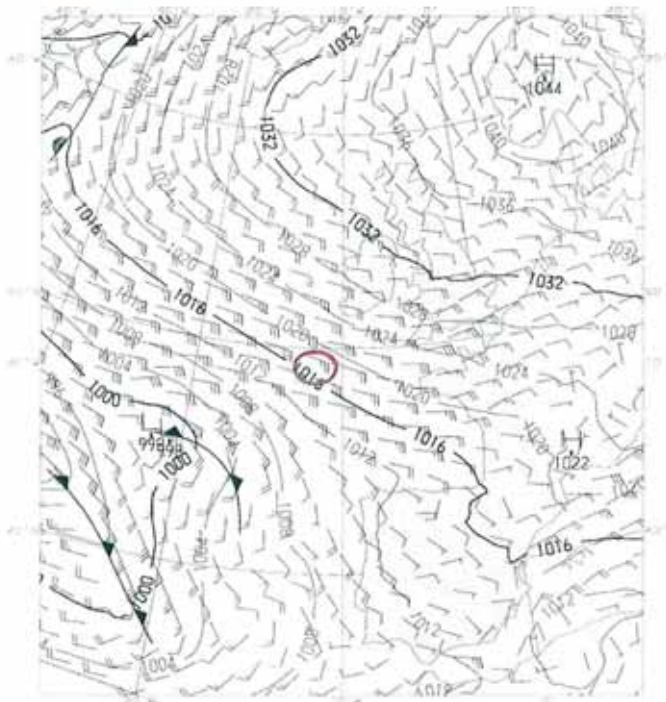
2) Weather chart for Sunday 28 December 2008 at 12:00 hours with area around 49°14'N 11°36'W highlighted

Met Éireann : WeatherDial : Product Number 000	
	Main Sea Level Pressure / 10-Metre Wind	
	Analysis valid on Sun 28 Dec 2008 at 12 UTC	
	[Based on data from Sun 08 Dec 2008 at 02 UTC]
