**REPORT OF INVESTIGATION
INTO THE SINKING OF THE
FV “STRATH MARIE”
OFF INISHOWEN HEAD,
CO. DONEGAL
ON
14th MARCH 2008**

**REPORT No. MCIB 158
(No. 3 of 2010)**

Report MCIB 158 published by The Marine Casualty Investigation Board
18th June 2010

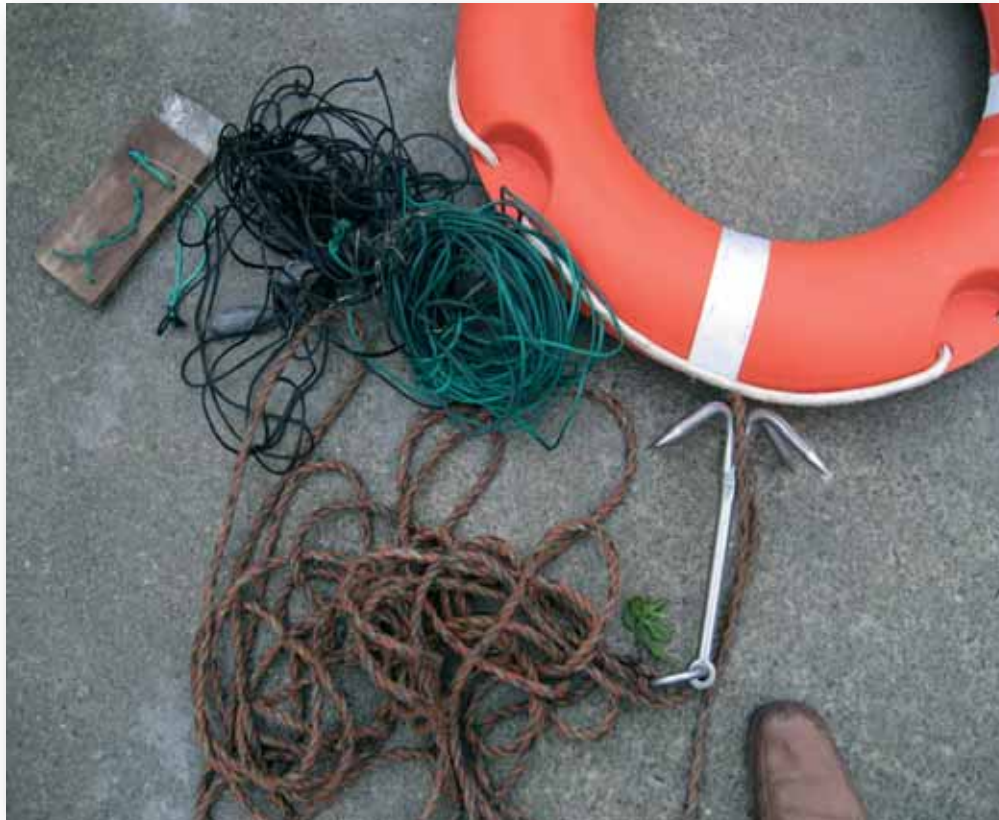
- 5.2 On 16th March 2008 weather conditions precluded search for wreck and debris.
- 5.3 On 17th March 2008 at 13.40 hrs. Greencastle Coast Guard RiB launched to accompany FV “Lady Nuala” to haul pots of “Strath Marie”. First five strings were recovered without undue difficulty and were found to have bait in the pots. At 16.07 hrs. Coast Guard reported possibility of wreck in position 055° 15.64'N 006° 57.8'W. After grappling at end of last row of pots, tangled ropes, pots and fishing gear were recovered. There was also a smell of oil. Pots were found not baited. (Refer to Appendix 9.3 for position on Admiralty Chart 2811). Other loose items such as hand fishing lines known to have been onboard the “Strath Marie” also surfaced free and were collected.
