Marine Casualty Investigation Board

**REPORT INTO THE LOSS
OVERBOARD OF A
CREWMEMBER
FROM THE
MFV "GIRL GERALDINE"
ON 4th AUGUST 2007**

REPORT No. MCIB/146

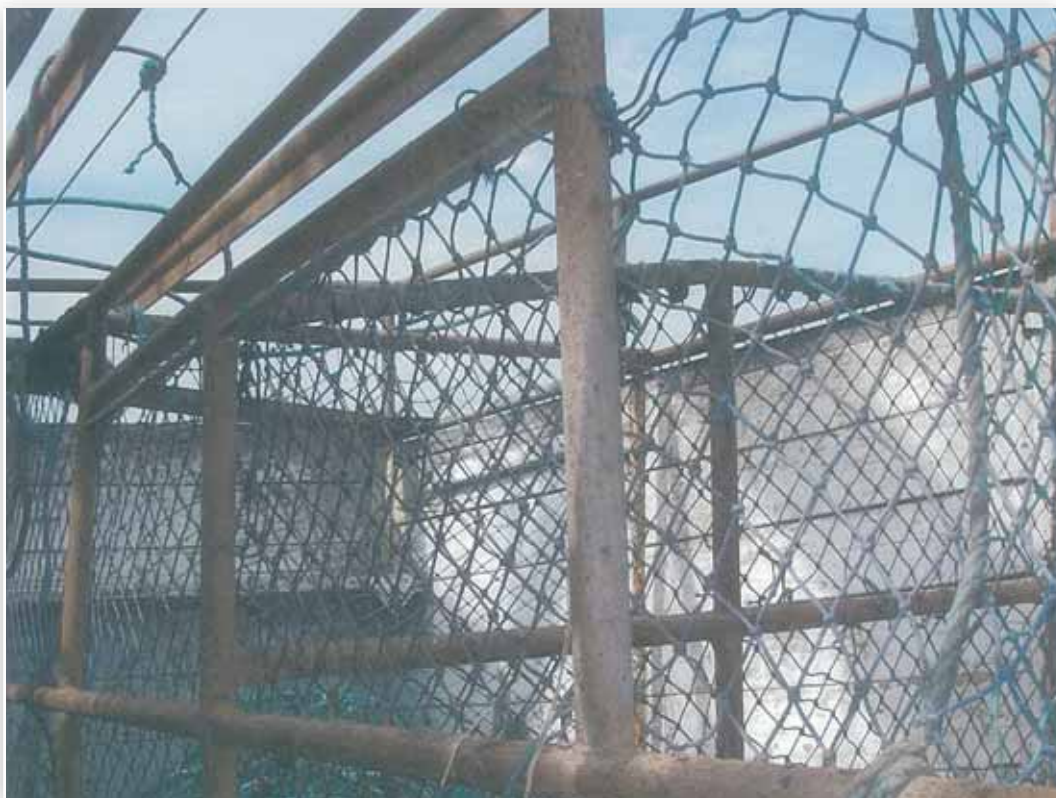
Appendix 8.4 8.4(2) MFV “Girl Geraldine” - Starboard aft net pound

- 4.1 The last net in the starboard aft pound was nearing its end at approximately 23.00 hrs. Just prior to the incident Mr. Jurgis Stanys was seen standing on the main deck forward of the net pounds and clear of all lines.
- 4.2 A shout was heard from this area and Mr. Jurgis Stanys was seen being dragged over the stern rail atop of the starboard net pound. There was no witness to the events just prior to the sighting of Mr. Jurgis Stanys being seen as mentioned in point 4.1. The position of the vessel was 51 34.0 North and 007 18.0 West. Depth of water was 40 fathoms.
- 4.3 The engines were put astern and the vessel brought about. Mr. Jurgis Stanys was recovered from the water in approximately 7 to 8 minutes with the bight of the net rope tail knotted around his left leg. His cause of death was drowning.

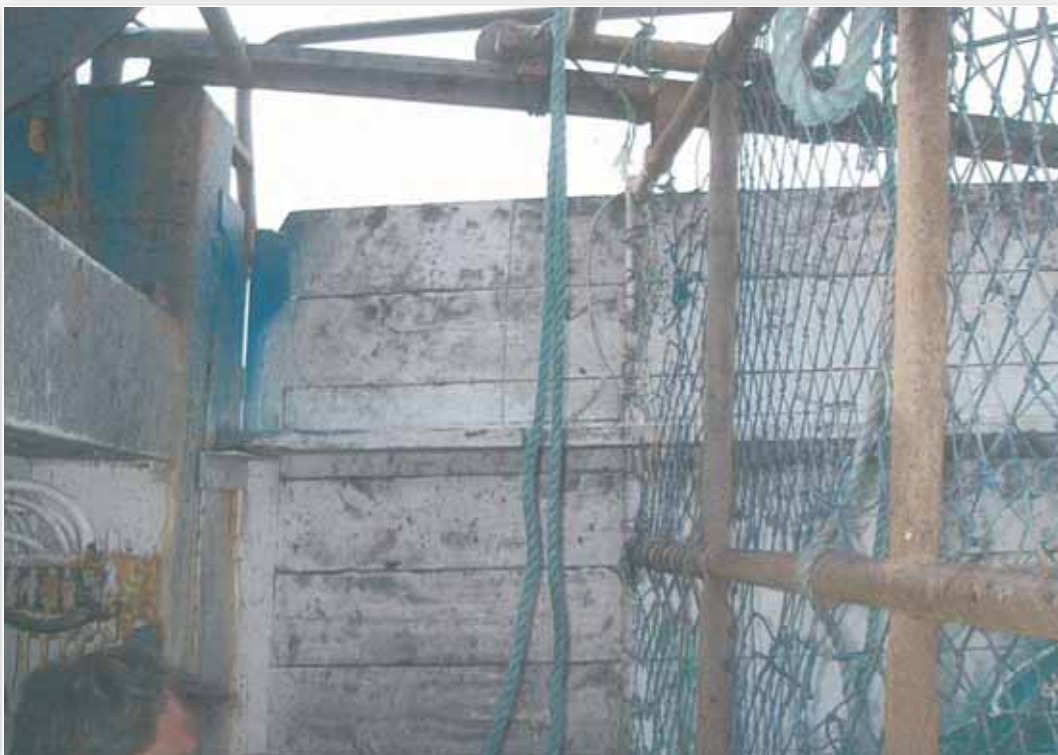
- 3.7 The weather throughout this period was South West Force 3 to 5 (See Appendix 8.2 - weather report).
- 3.8 Mr. Jurgis Stanys was in position on the main unexposed deck and his job was to monitor the run of the net from the starboard aft net pound.

Appendix 8.4 8.4(4) MFV “Girl Geraldine” - Area of protected deck area where Mr. Jurgis Stanys was standing prior to the accident

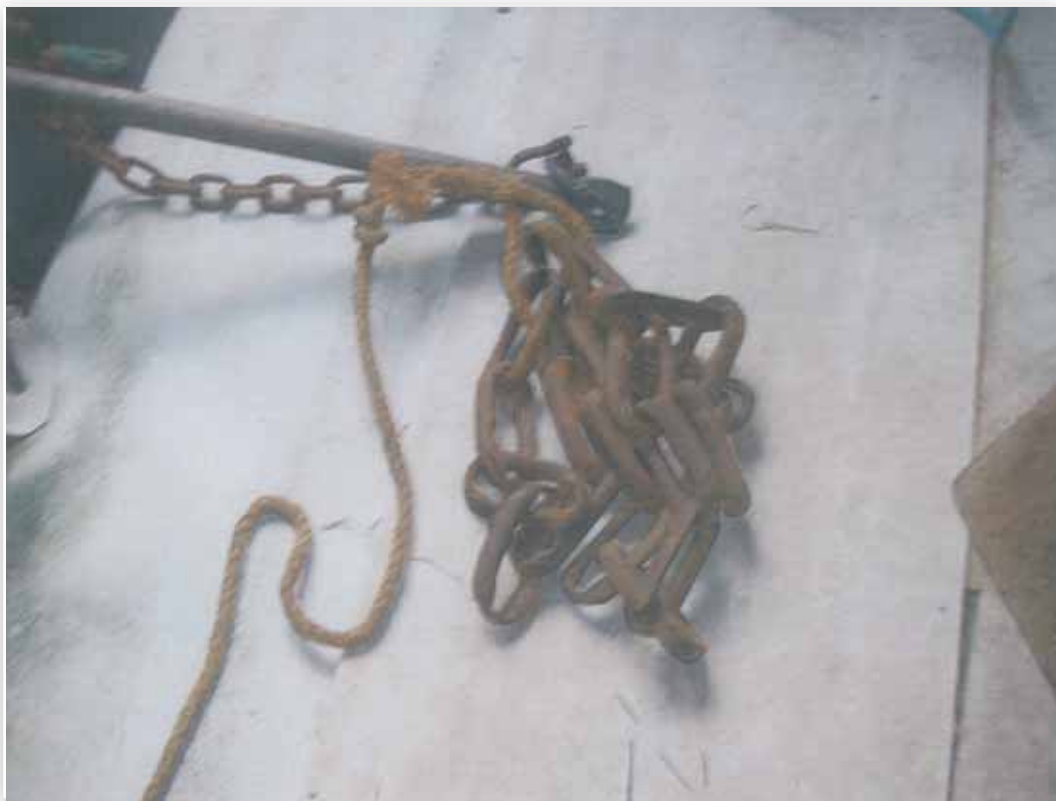
Appendix 8.4 8.4(5) MFV "Girl Geraldine" - Anchor for nets.

- 3.5 The vessel then continued to shoot nets till the time of the incident at about 23.00 hrs.
- 3.6 The method of fishing was to set several independent nets of approximately 1.8 miles long, anchored to the sea bed with 30 fathoms (55 metres) of line to a 30kg anchor, and marked with 90 fathoms (165 metres) of rope to a buoy.
